Report of investigation  
into the fatal accident  
on board the Hong Kong registered ship  
*m.v. "Winner"*  
in the position  $12^{\circ} 46.15' \text{ S}$ ,  $46^{\circ} 48.0' \text{ E}$   
on 9 March 2006

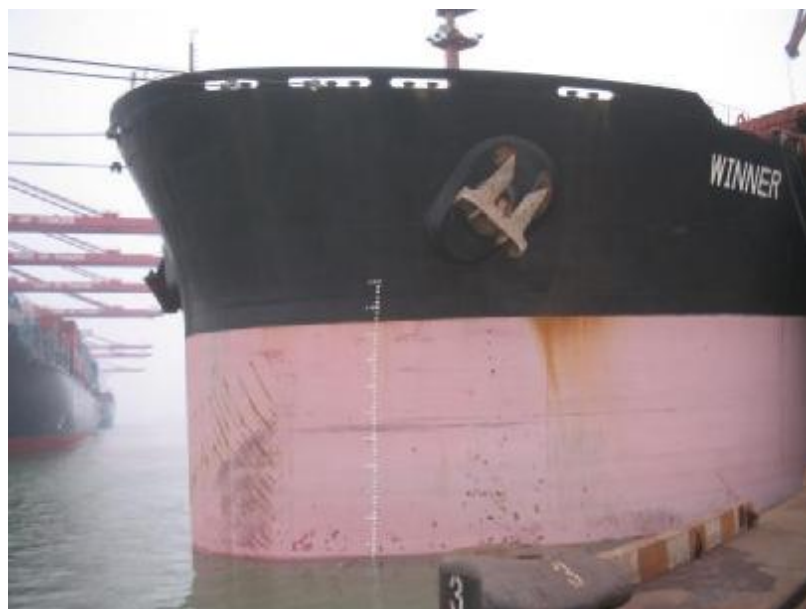
Fig.1: The bow of the bulk carrier "*Winner*"

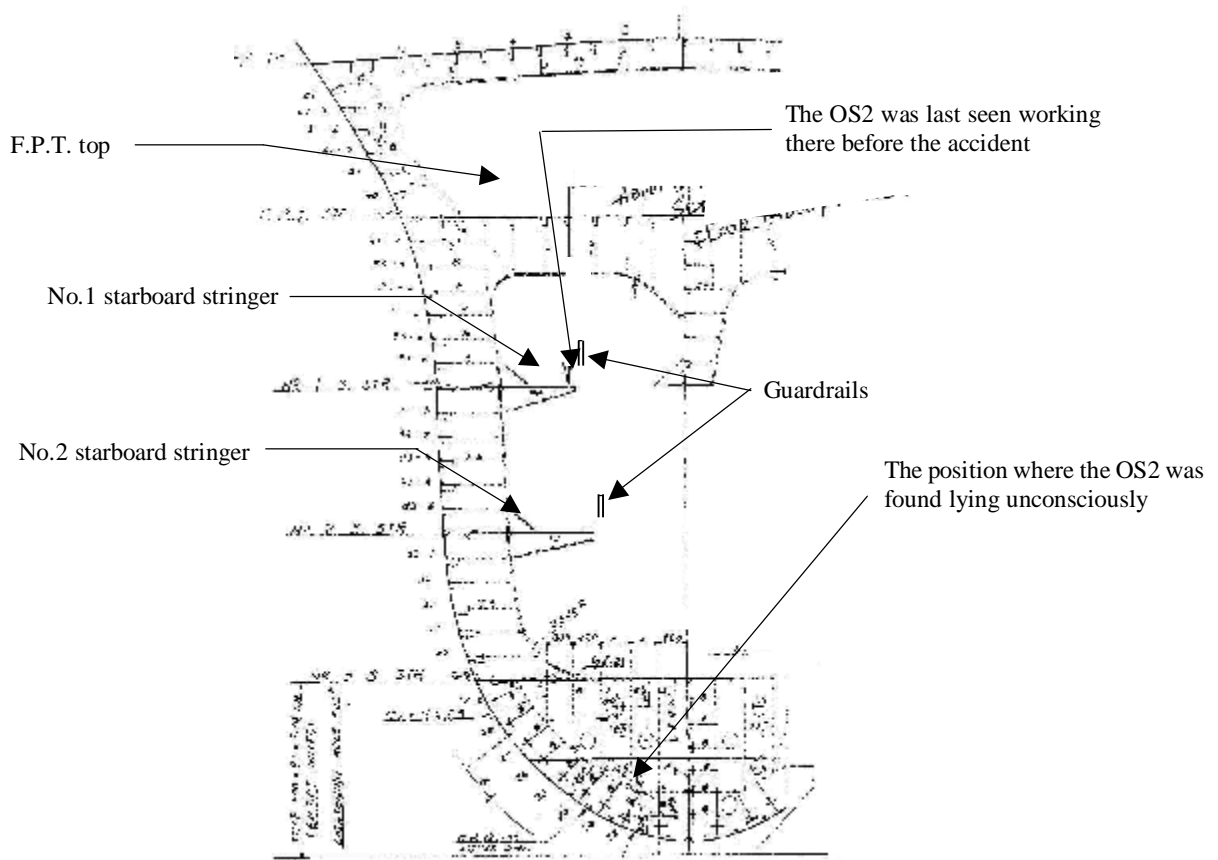
- 4.4 At about 1600, another Ordinary Seaman (OS3) came down from the main deck to the F.P.T. to assist the team there. He noted that only the Bosun and the OS1 were working on the stringer but the OS2 was not there. They looked around and could not find the OS2. They then informed other crewmembers to the F.P.T. and started searching. They finally found the OS2 lying unconsciously at the bottom of the F.P.T. at about 15 metres below the working position.

Fig.2: The positions of the OS2 before and after the accident.

- 5.12 At the time of the accident, the OS2 was working alone and no one witnessed how he fell down to the bottom of the F.P.T. Based on the physical findings on the scene, due to insufficient lighting and slippery floor in the area, the OS2 was believed to have slipped and stumbled over the guardrail and fell into the bottom of the F.P.T.

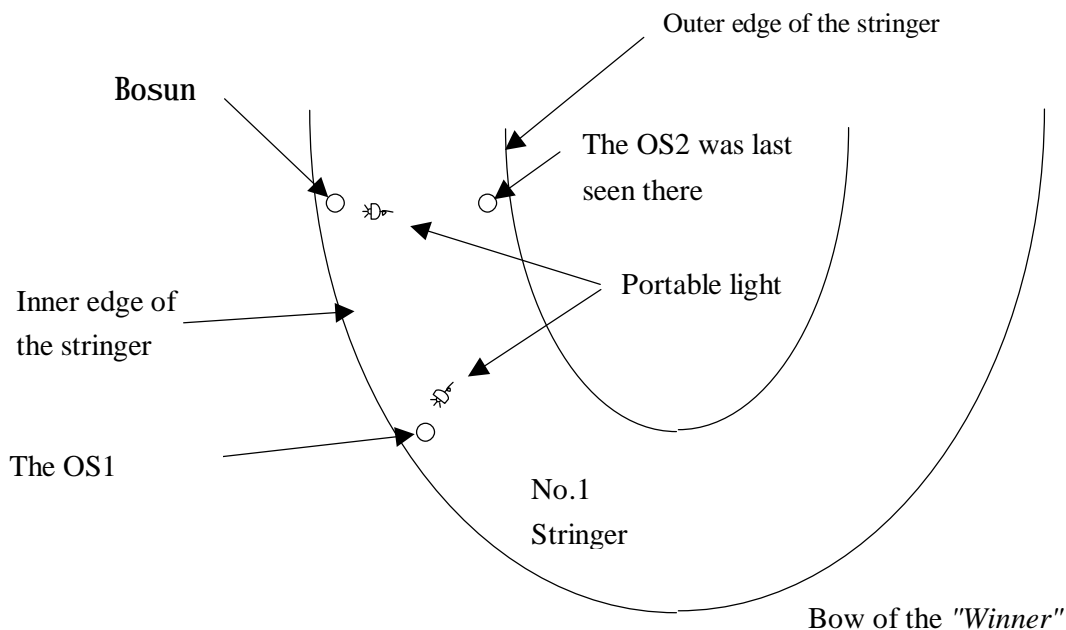
- 5.4 As the F.P.T. was an enclosed area, natural illumination could not reach the F.P.T. The three crewmembers used two portable lights to illuminate the working area. The lights were being used by the Bosun and the OS1 who were working at about 5 metres away from the OS2. Therefore, the working area of the OS2 was under poor illumination.

- 5.7 The three crewmembers were carrying out maintenance work inside the F.P.T. All of them were at some distance apart. The Bosun and the OS1 were working near the shipside shell while the OS2 was assigned to sweep off the rust debris close to the outer edge of the stringer. (See figure 3)

Fig. 3: The positions of the working team prior to the incident
