Report of Investigation
into the Collision Between a
Panamanian Vessel
“Chang Shin” and a PRC Vessel
“You Shun” with One Fatality
on 23 March 2006

The Hong Kong Special Administrative Region
Marine Department
Marine Accident Investigation Section

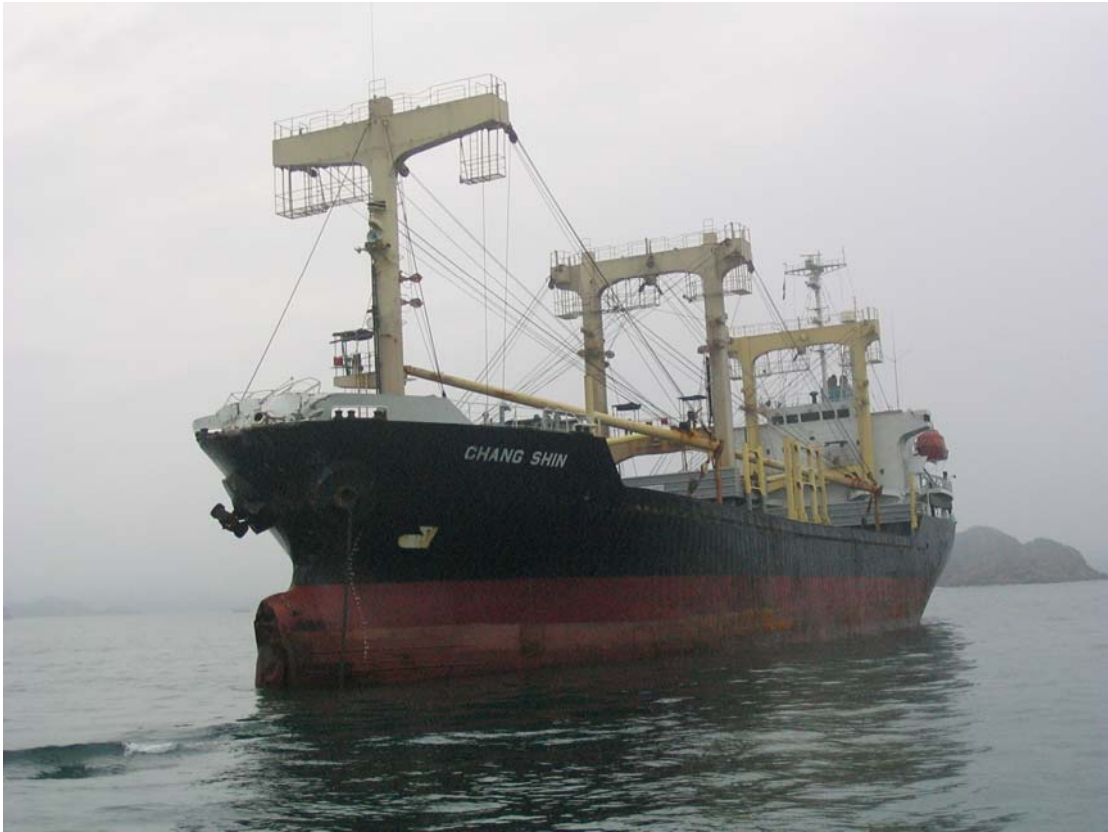
Figure 1 – Photograph showing the damages on the bow of *Chang Shin*

4.1.6 The bow and bulbous bow of *Chang Shin* sustained heavy damage (Figure 1).

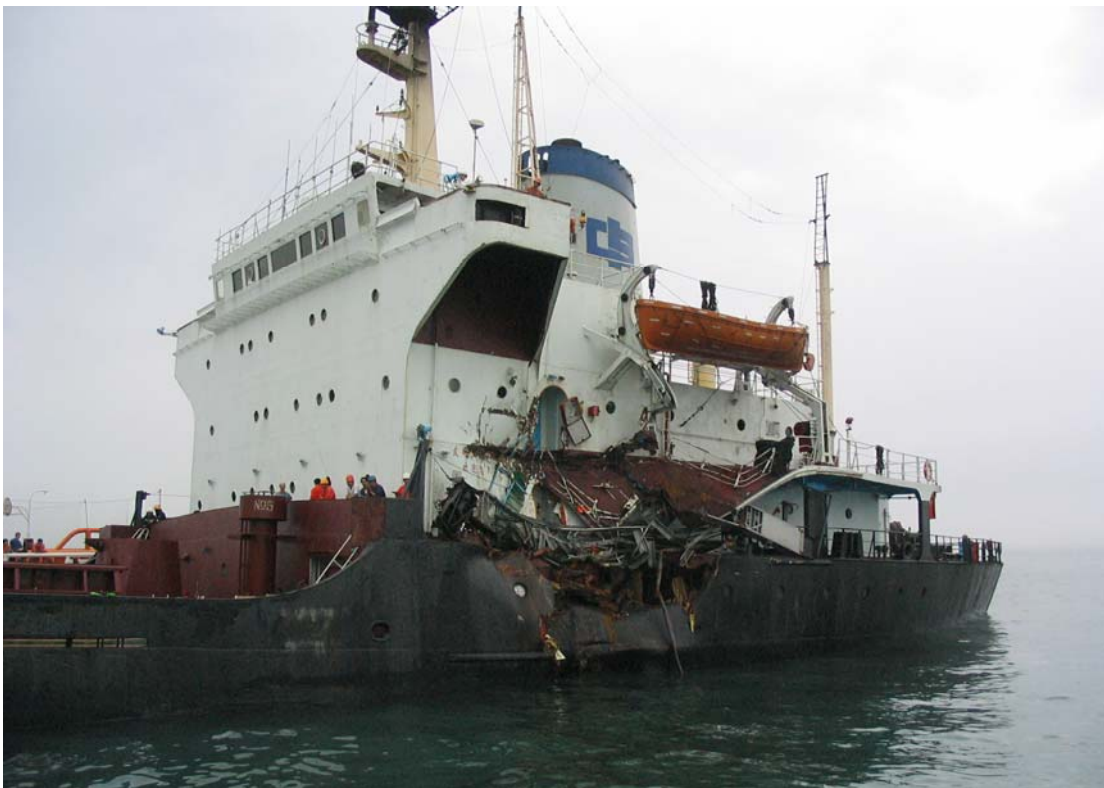
Figure 2 – Photograph showing the damages on port quarter of *You Shun*

4.2.6 The port quarter of *You Shun* sustained very serious damage (figure 2).

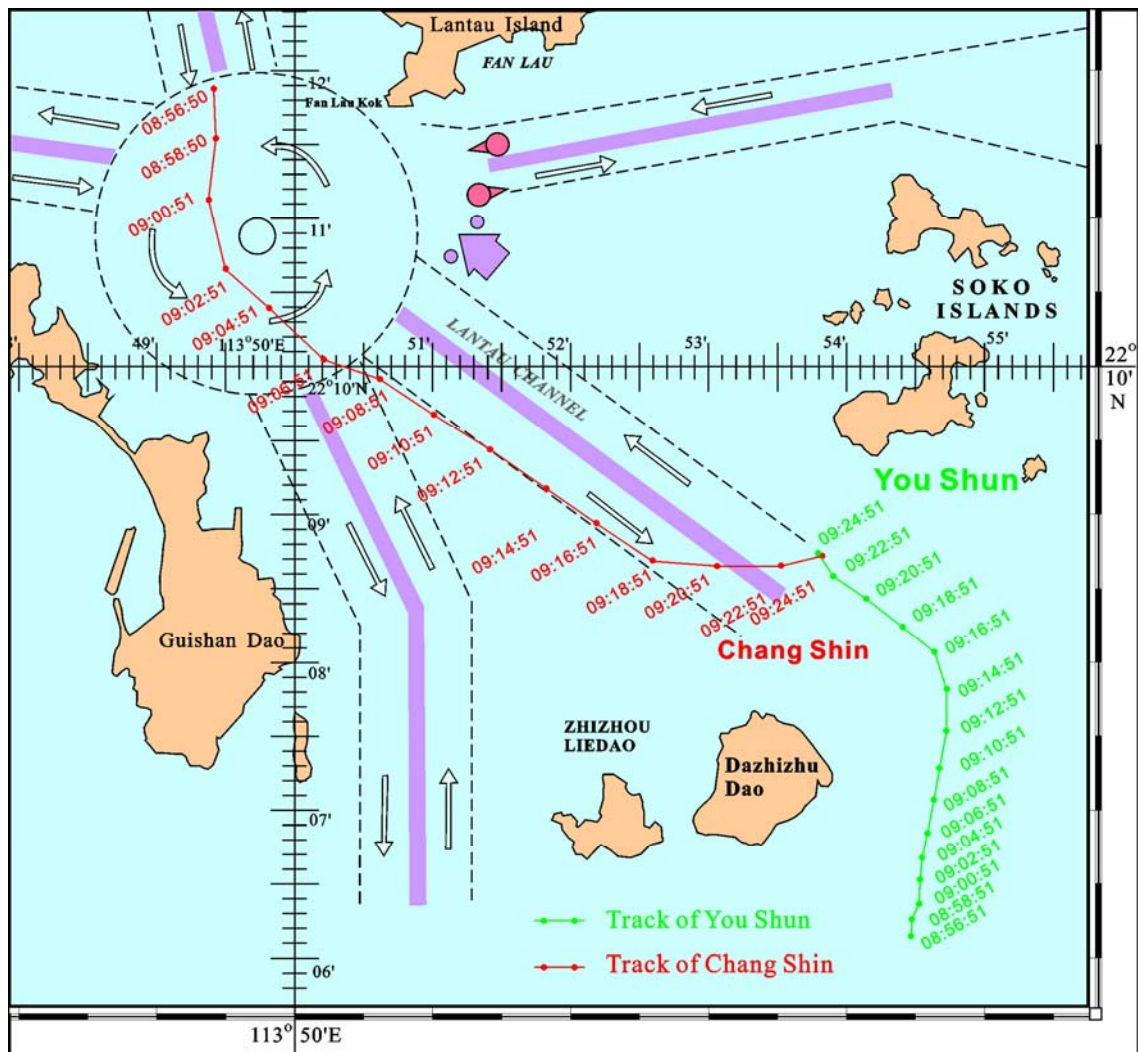
- 5.6.3 The distance between *Chang Shin* and *You Shun* was only 0.54 nautical mile i.e. 1,000 metres and 0.2 nautical mile at 0922 and 0923 respectively.

- 5.6.4 VTC Radar Plot showing the collision tracks of *Chang Shin* and *You Shun* is shown in Figure 3.

Figure 3- VTC Radar Plot showing the collision tracks of *Chang Shin* and *You Shun*
