Report of investigation  
into the incident on  
man overboard from  
the locally licensed open sampan  
*"P40412K"* near  
Fat Tong Kok  
on 10 May 2006

The Hong Kong Special Administrative Region  
Marine Department  
Marine Accident Investigation Section

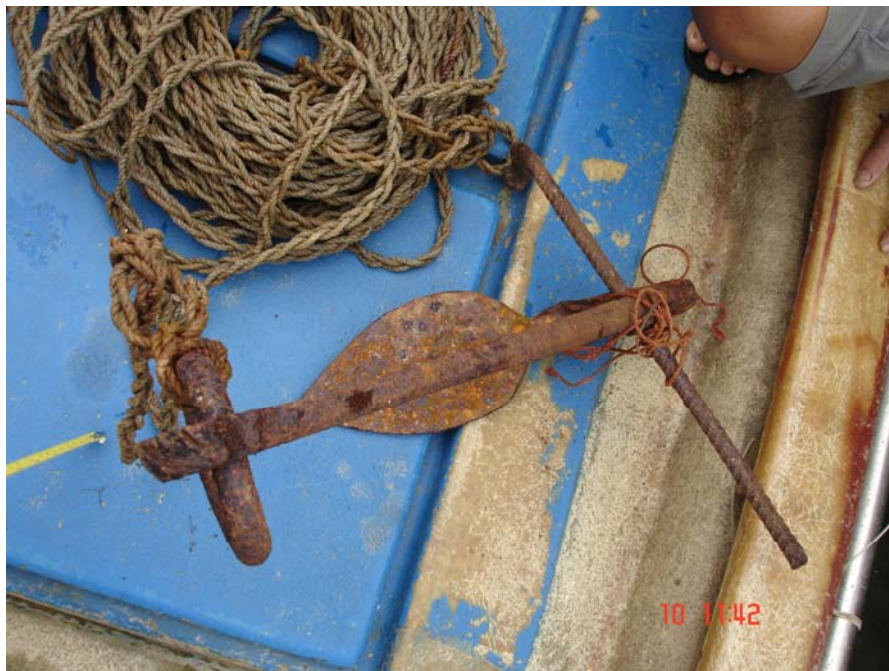
Fig. 3: The anchor of *the Vessel*

5.9 *The Vessel* was equipped with an anchor with a weight of about 7 kg (see figure 3). It was secured at the forward of *the Vessel* with a synthetic rope of about 90 feet in length. The rope was coiled on the deck of *the Vessel*. When anchoring, the Master had to lift up the anchor manually and dropped it into the water. During the course of operation, it is possible that he lost his balance on the slippery deck surfaces or the weight of the anchor threw off his balance when dropping the anchor. It is also possible that he was tripped and pulled by the anchor rope while it was running out.

- 6.3 The spouse saw the incident at 10 metres away but she was not sure how and why the Master fell overboard. The exact cause of the accident could not be established. Based on the available evidence, it was possible that the Master lost his balance on the slippery deck surface or the weight of the anchor threw off his balance when dropping anchor. It was also possible that he was tripped by the anchor rope while it was running out into the water.

- 7.1 A number of man overboard accidents occurs on board local sampans each year. In most cases the victims' lives could be safeguard had they worn a lifejacket when on board. It is recommended that the lessons learnt from this accident could be brought up in the Navigation Safety Seminar held by the Harbour Patrol Section of the Marine Department, with a view to address the concern to the wider public and the industry.
