Report of Investigation  
into the Manoverboard Incident  
of a Passenger onboard  
Fishing Vessel "M60767C"  
on 8 June 2006

The Hong Kong Special Administrative Region  
Marine Department  
Marine Accident Investigation Section

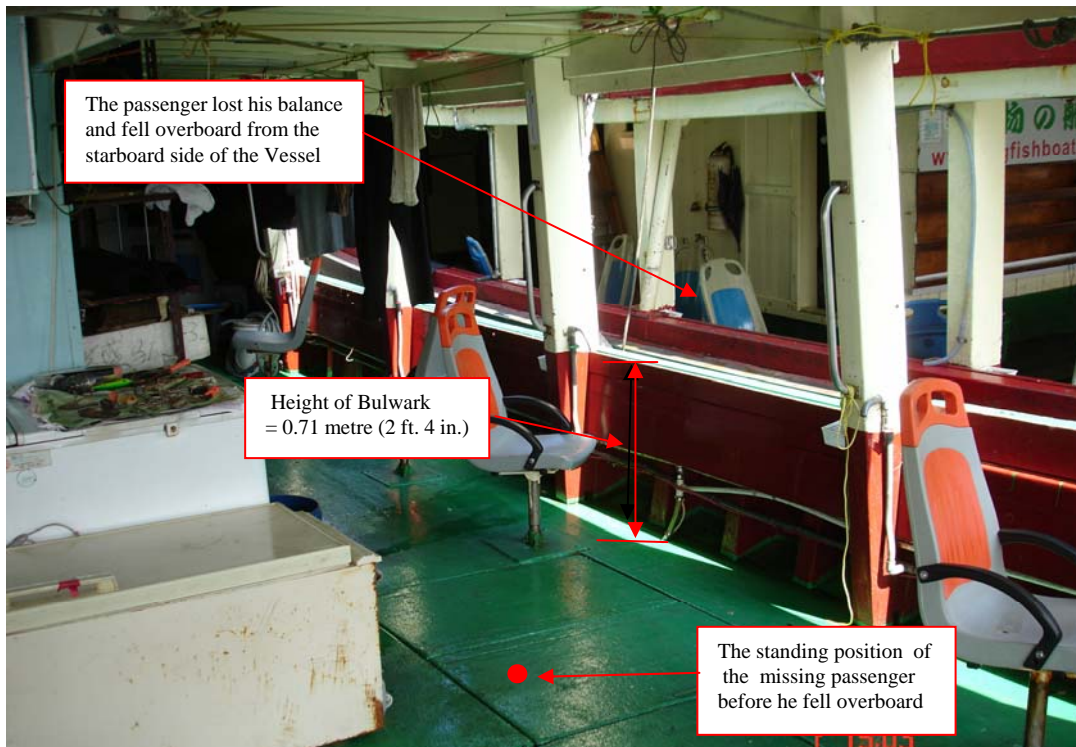
- 5.4 The passenger 'A' was not a crew member on board *M60767C*. He was one of the passengers who sailed on the Vessel to go for fishing and was not expected to be aware of the dangers of falling overboard when the Vessel was rolling. Under the above circumstances, the Master of *M60767C* should give prior warning to the passengers on board and asked them to put on lifejackets and not to stand too close to the bulwark when the Vessel was rolling in exposed area. According to the witnesses, a heavy wave had struck the port side of the vessel and the vessel was caused to heel to starboard side suddenly with a large angle. The passenger 'A' who was standing near to the starboard bulwark lost his balance and fell overboard (Figure 2). Although two other passengers who were in the vicinity tried to prevent him from falling overboard but in vain.

Figure 2- Diagram showing the standing position of the missing passenger and the position from where he fell overboard

- 5.5 The bulwark had a height of 0.71 metre (2 ft. 4 in.) above deck (Figure 2) which might not be sufficient to protect the people from falling overboard in rough sea. When the Vessel was rolling suddenly to a large angle, a passenger who was not aware of the risk might be thrown overboard.

- 7.1 A copy of this report should be sent to the Master of *M60767C* drawing his attention on the findings of this incident and urging him to obey the law by not carrying passengers on his vessel.
- 7.2 A Marine Department Notice should be issued to draw the attention of the fishing vessel operators on the lessons learnt and advise them not to carry any passengers on their vessels as stipulated in the vessel's licence.
