Report of investigation
into the incident on
the fatal injury of a crewmember
on board the dumb steel lighter
"Millions Harvest No.2"
on 17 July 2006

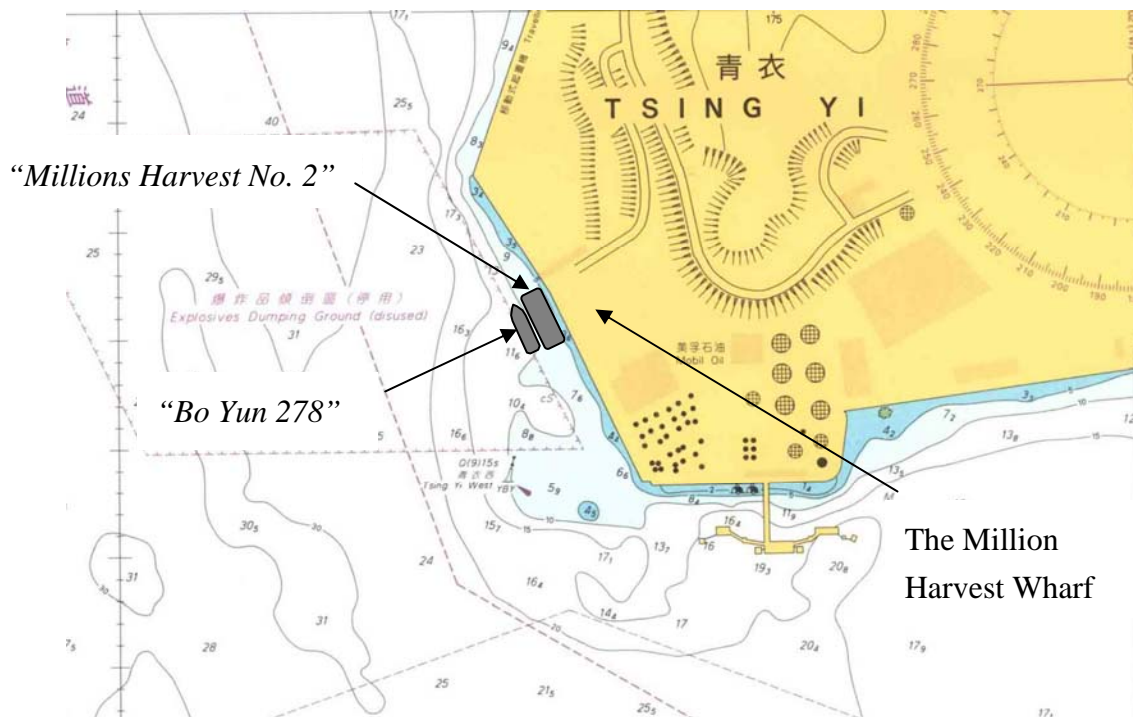
Fig. 2: The position of the vessels at the time of the accident

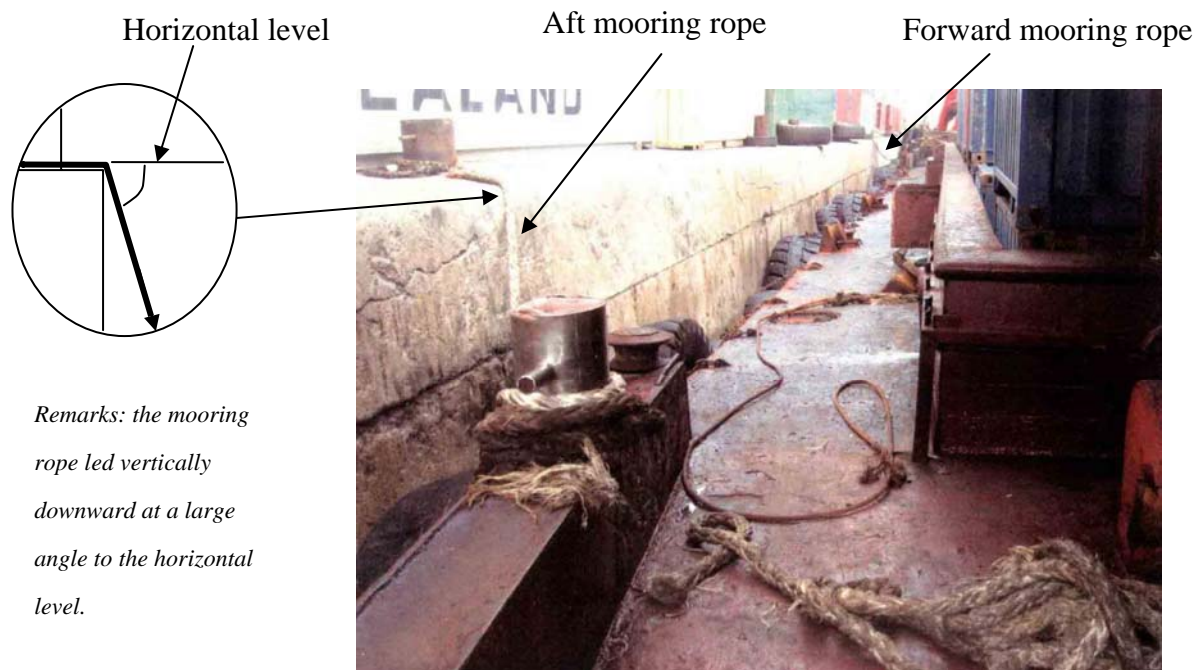
Fig. 3: The berth and the DSL

- 5.3 The *DSL* was berthed at the wharf with portside alongside. The forward and aft bollards of the *DSL* were secured to two shore bollards with two mooring ropes (see figure 3). The *DSL* was fully laden with a deadweight of about 3000 tons. The deck surface of the *DSL* was at about 2 metres lower than the land surface. Therefore the mooring ropes were led vertically downward at a large angle to the horizontal level (see remarks in figure 3). Load on the both mooring ropes was high. Movements of the *DSL* due to sea and wind effects would cause damage to the mooring ropes by rubbing the lines against the edge of the berth. Such arrangement is highly undesirable and should be avoided.

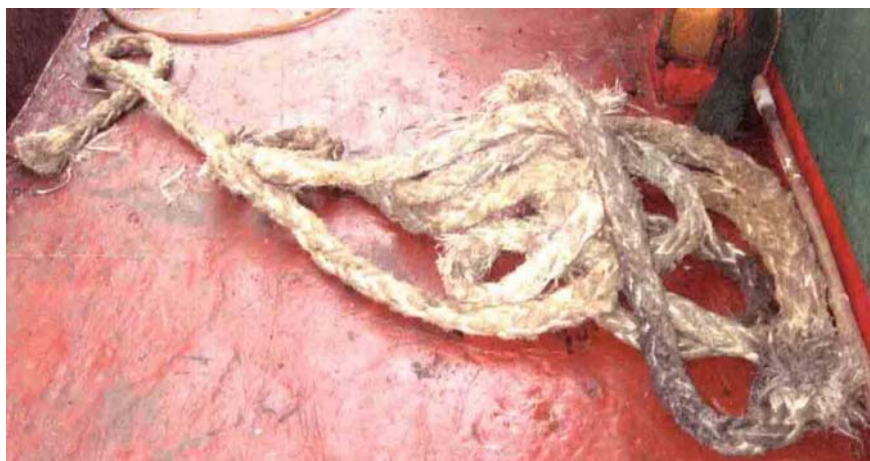
Fig. 4: The broken mooring rope

5.4 The damaged mooring rope (see fig. 4) was a multifilament synthetic rope with following particulars:

- 5.5 The length of the broken mooring rope was about 6 metres, an eye splice formed at one end of the rope and attached to the bollard of the berth. The other end of the rope was secured to the aft bollard of the *DSL*. The condition of the parted rope was poor, signs of excessive wear were found along the length and the eye of the rope. The rope failed at the midway of the eye (see figure 5).

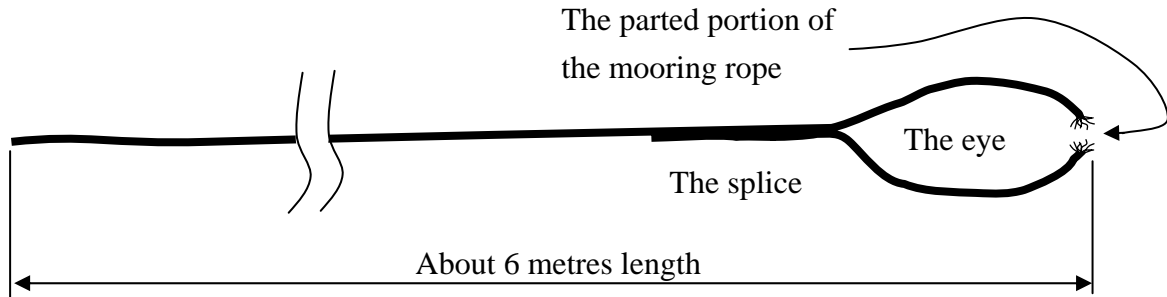
Fig. 5: Sketch of the broken mooring rope

- 5.6 The parted portion was part of the eye which was attached to a wharf bollard. The surface of the wharf bollard was rough, the eye was subjected to severe rubbing on the bollard due to the motion of *the DSL*. Heat generated due to the rubbing would melt and damage the rope fibres. Strength of the rope was reduced significantly.

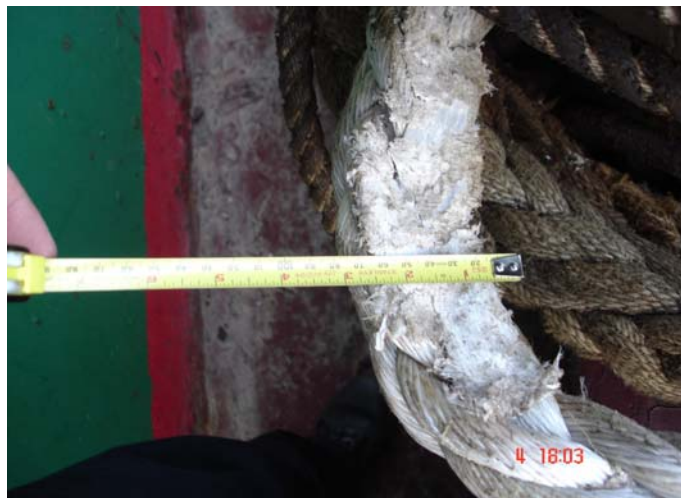
Fig. 6: Excessive wears at the eye of the other mooring rope.

5.7 Other mooring ropes of *the DSL* were inspected. Signs of excessive wear due to abrasion were also found at the eye of one of the ropes (see figure 6). The strength of the eye of the rope was seriously weakened and it would be unsafe to use the mooring rope with such excessive wear.

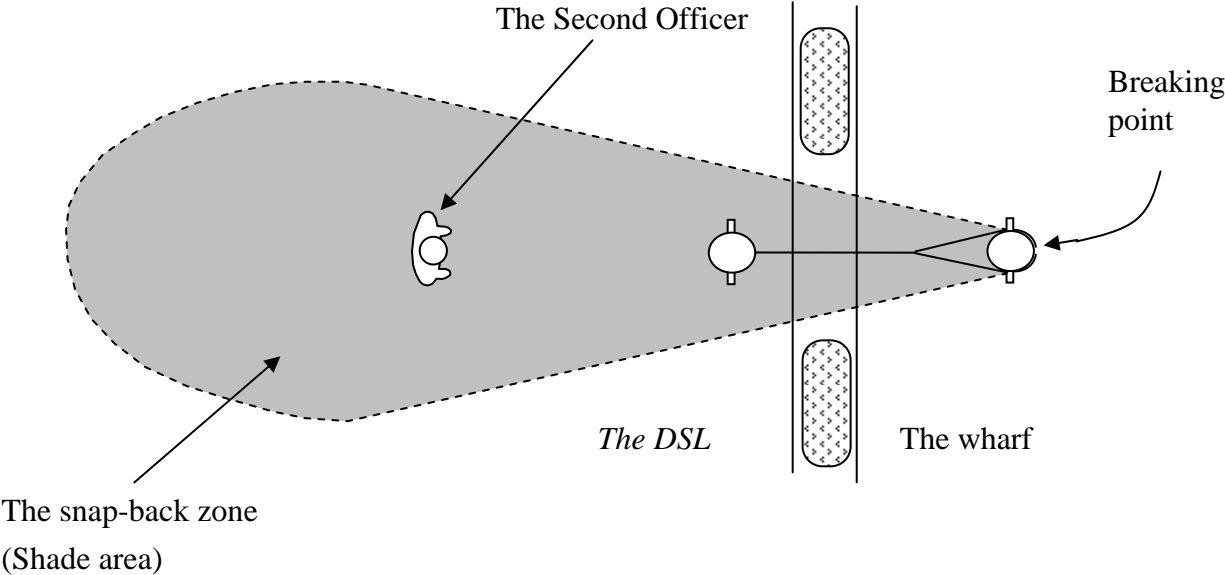
5.8 Synthetic ropes are elastic in nature, they would break without warning when under strain. All personnel should avoid remain in snap-back zones on board vessels. While the Second Officer was on his way to the shore, the mooring rope broke and sprang back to the snap-back zone (see fig. 7) in which he was passing by.

Fig. 7: The snap-back zone of the mooring rope

- 7.1 A copy of this report should be sent to the concerned parties such as the operator of the dumb steel lighter "*Millions Harvest No.2*" and the Master of the coastal vessel "*Bo Yun 278*" advising them the findings of the of this incident. In order to prevent the recurrence of the similar accident, they should observe the following safety guidelines:
- a) Mooring ropes should be properly maintained and frequently examined while in service. Excessively worn mooring rope should be replaced and discarded;
 - b) Mooring arrangements should be planned and rigged in a safe manner; and
 - c) Crewmembers should avoid to remain inside the snap-back zone of the mooring rope.
- 7.2 A Marine Department Notice (MDN) should be issued to draw the attentions to all concerned parties the lessons learnt in the incident.
