Report of investigation
into the fatal accident
involving local pleasure
vessel 93428

on 19 August 2006

The Hong Kong Special Administrative Region
Marine Department
Marine Accident Investigation Section

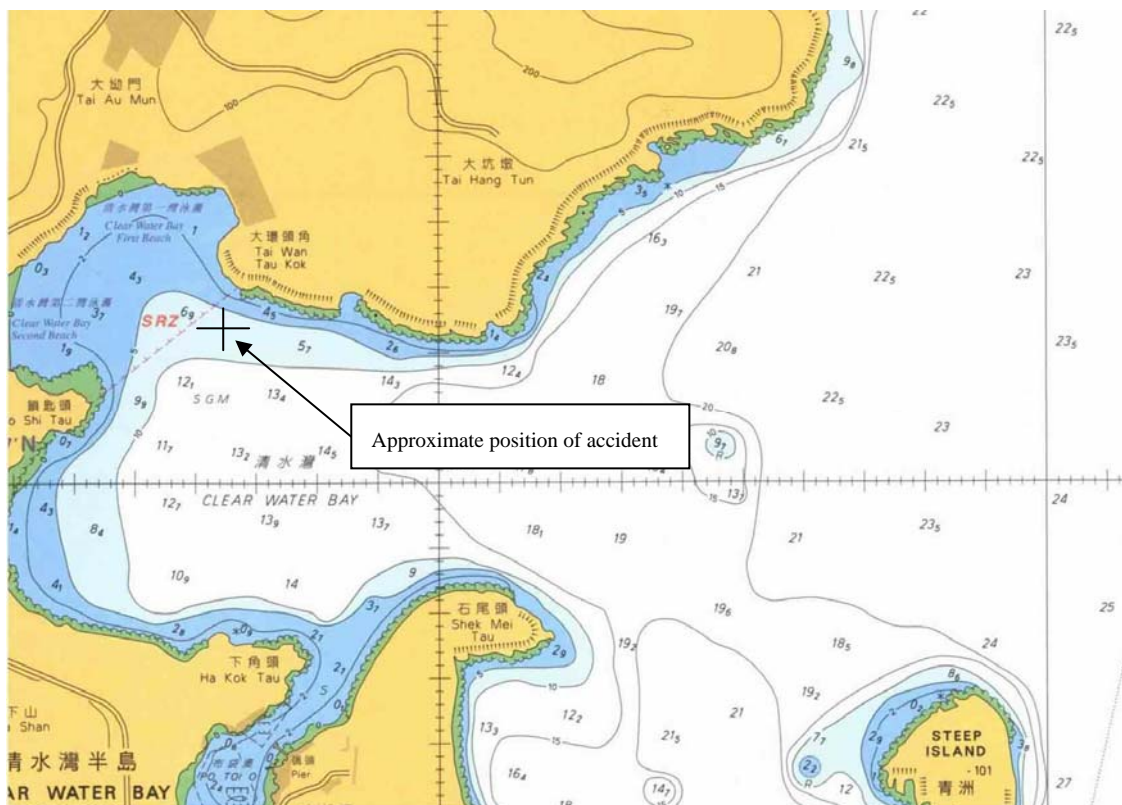
Figure 2- Diagram showing the approximate position of accident

- 5.5 The Master of PV93428 stated that the position of the incident was approximately 100 metres off Tai Wan Tau Kok in Sai Kung as depicted in Figure 2. There is insufficient evidence to establish the exact location of the accident and the area is not the authorized area for swimming. In this connection, people are risking their own lives by swimming in that area which is frequently traversed by pleasure vessels.
