Report of Investigation
into the fatal accident on board
the Hong Kong Registered ship
“Saga Spray”
on 16 November 2006

The Hong Kong Special Administrative Region
Marine Department
Marine Accident Investigation Section

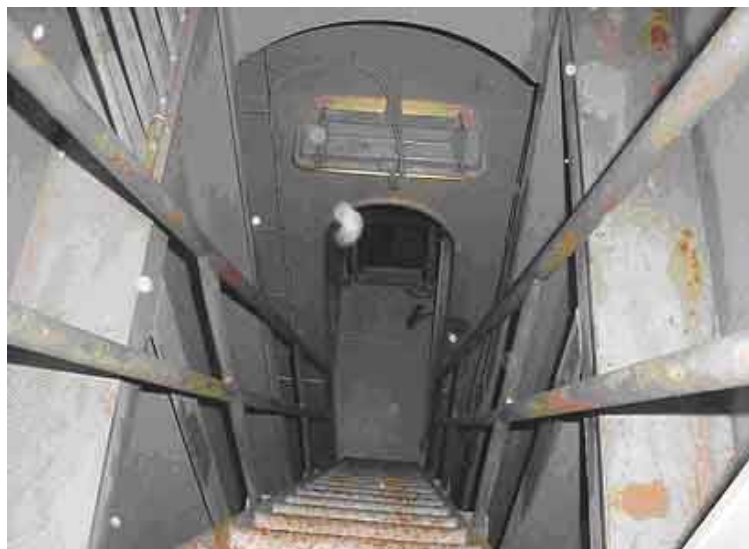
Figure 3: The enclosed stair trunk

- 4.6 When the Ordinary Seaman reached the bottom of the stairway, he collapsed and lost consciousness. The bulldozer operator immediately informed other workers via his hand held radio. Soon afterward he also collapsed inside the enclosed stair trunk. The signalman entered the enclosed stair trunk in order to help the persons inside. However, he felt breathing difficult and returned back to the deck. The stevedore foreman called 112 (the national emergency telephone number) for assistance.

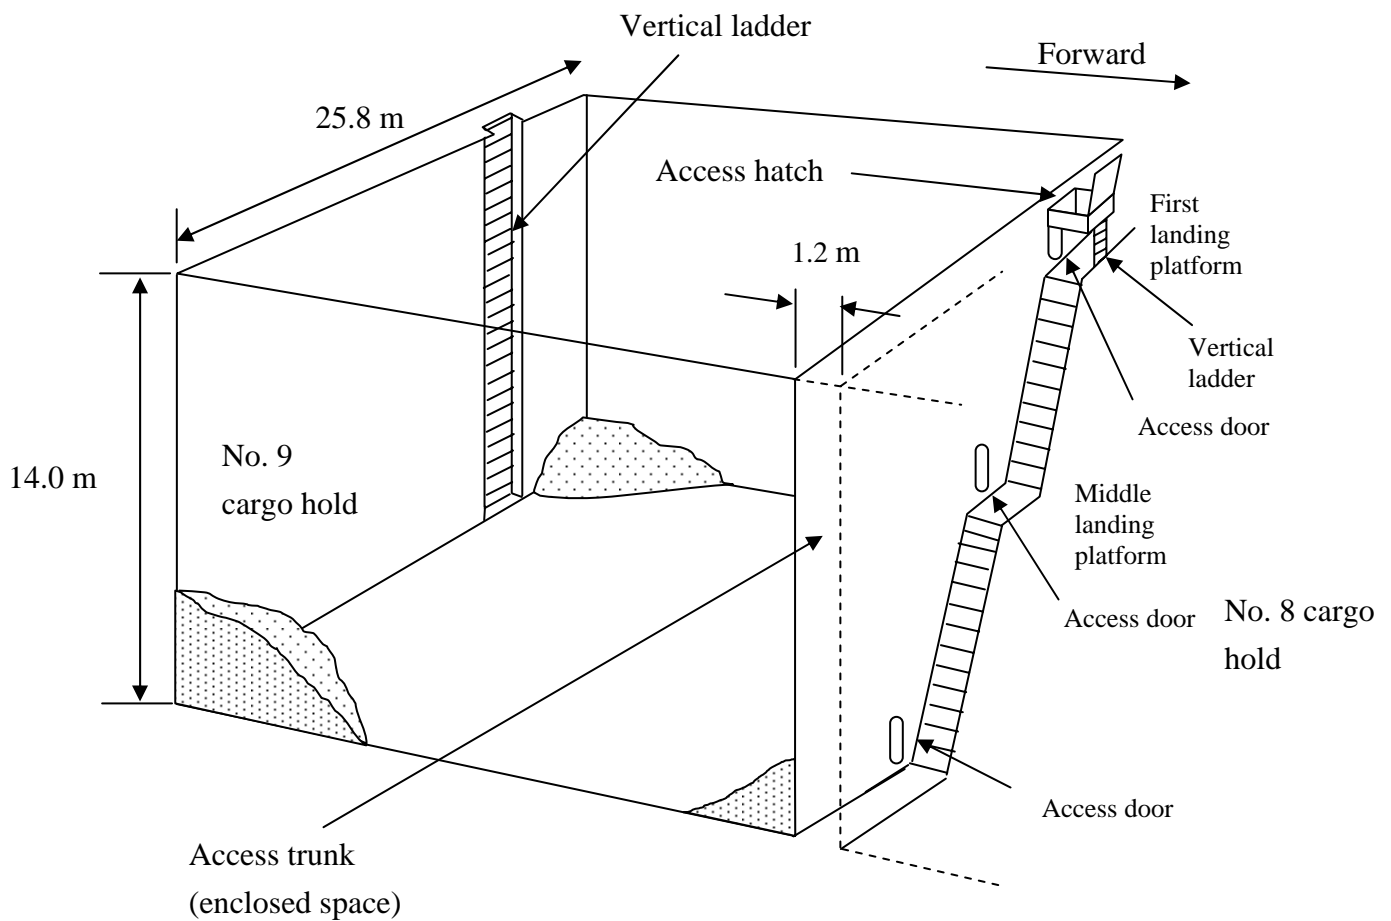
Figure 4: Sketch of the access trunk and cargo holds.

5.2 There are two means of access to No. 9 cargo hold from the main deck. The first was a vertical ladder that was mounted at the aft of the cargo hold. The second was an enclosed stair trunk located at the forward of the cargo hold (see figure 4). The enclosed stair trunk fitted with stairways and access doors for personnel to get entry into the cargo hold. To enter the cargo hold, the enclosed stair trunk would be used whenever cargo work was in progress.

- 5.3 The enclosed stair trunk was about 1.2 m width and 14 m depth. There was no means of mechanical ventilation fitted.
- 5.4 The access doors were non-watertight steel doors. The atmosphere of the cargo hold could get into the enclosed stair trunk through the gaps between the bulkhead and the doors (see figure 5). Gases could be trapped inside the trunk even the hatch was opened for a period of time.

- The enclosed stair trunks should be properly ventilated preferably by mechanical means and tested for the safety levels of oxygen and carbon monoxide prior to the entry of personnel;
- Wood pellets are classified as Group B cargoes, the Master and the Crewmembers should be well aware the safety requirements stipulated in the BC Code.
- Appropriate warning signs should be displayed at the entrances of the stair trunks.

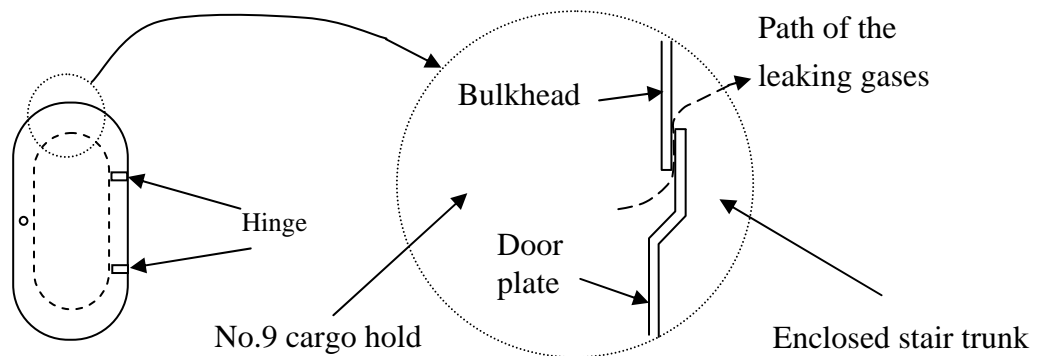
Figure 5: Sketch showing gases may leak through the gap into the enclosed stair trunk

When the cargo holds containing wood pellets had been closed for a period of time, the wood pellets would consume oxygen and emit carbon monoxide. The atmosphere inside the cargo hold could get into the enclosed stair trunk through gaps of the three access doors. Apparently, the atmosphere in the enclosed stair trunk contained a high level of carbon monoxide and depleted in oxygen.
