Crew member hit by mooring wire of a local barge and fell overboard from the PRC river-trade vessel *Hua Chang Hai 3 Hao* on 15.12.2006

1. The Incident

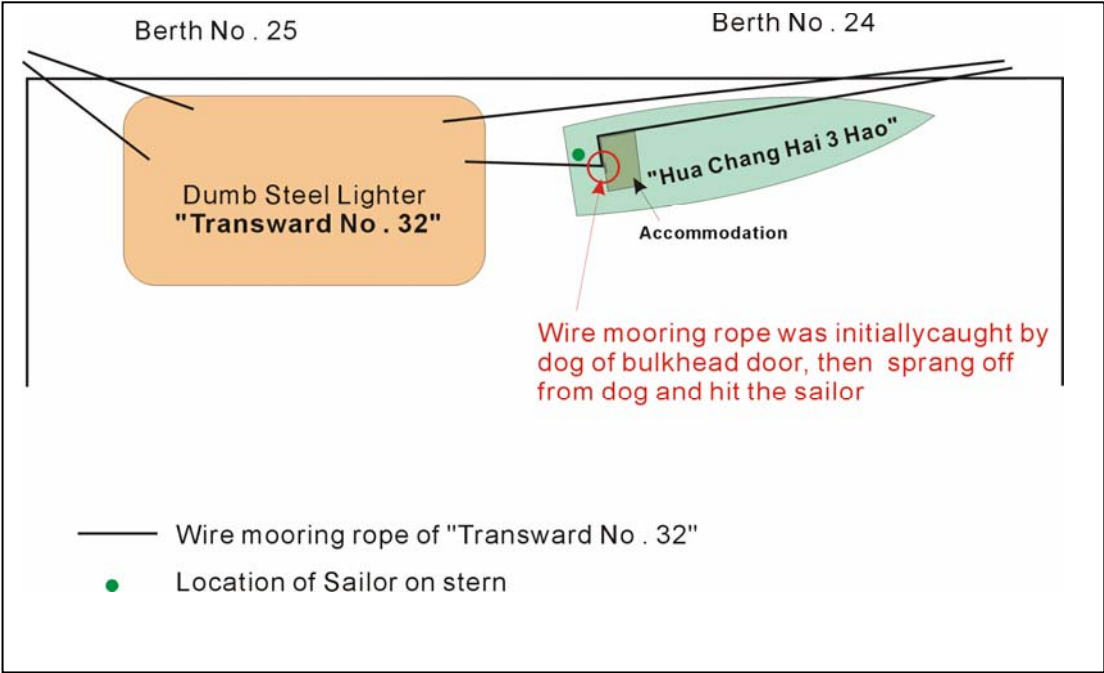
- 1.1 A fatal accident occurred on board the PRC river-trade vessel *Hua Chang Hai 3 Hao* (華昌海3號) at about 1905 on 15 December 2006. While the Vessel was berthing to the Berth No. 24 of the Tuen Mun River Trade Terminal, a sailor who was engaged in handling mooring rope at the stern was hit by the wire mooring rope of the dumb steel lighter *Transward No. 32*. He fell overboard into the sea and was drowned.
- 1.2 The accident was caused by a long wire mooring rope which sprang off under tension after being caught by the dog of bulkhead door at the stern of *Hua Chang Hai 3 Hao*. The lack of safety awareness of the deceased by locating himself in close proximity to the long wire mooring rope of the dumb steel lighter (DSL) *Transward No. 32* also contributed to the accident.

Figure 1 – Diagram showing the mooring arrangement of *Transward No. 32* which was moored to Berth No. 25 when *Hua Chang Hai 3 Hao* was approaching Berth No. 24

- 2.1 Crew members should keep themselves well clear from mooring ropes when berthing/unberthing.
- 2.2 Operators of the dumb steel lighters working within the river-trade terminal should ensure that the mooring ropes of their barges should not cause obstruction and create potential hazard to other vessels which berth/unberth from the berths of the terminal.

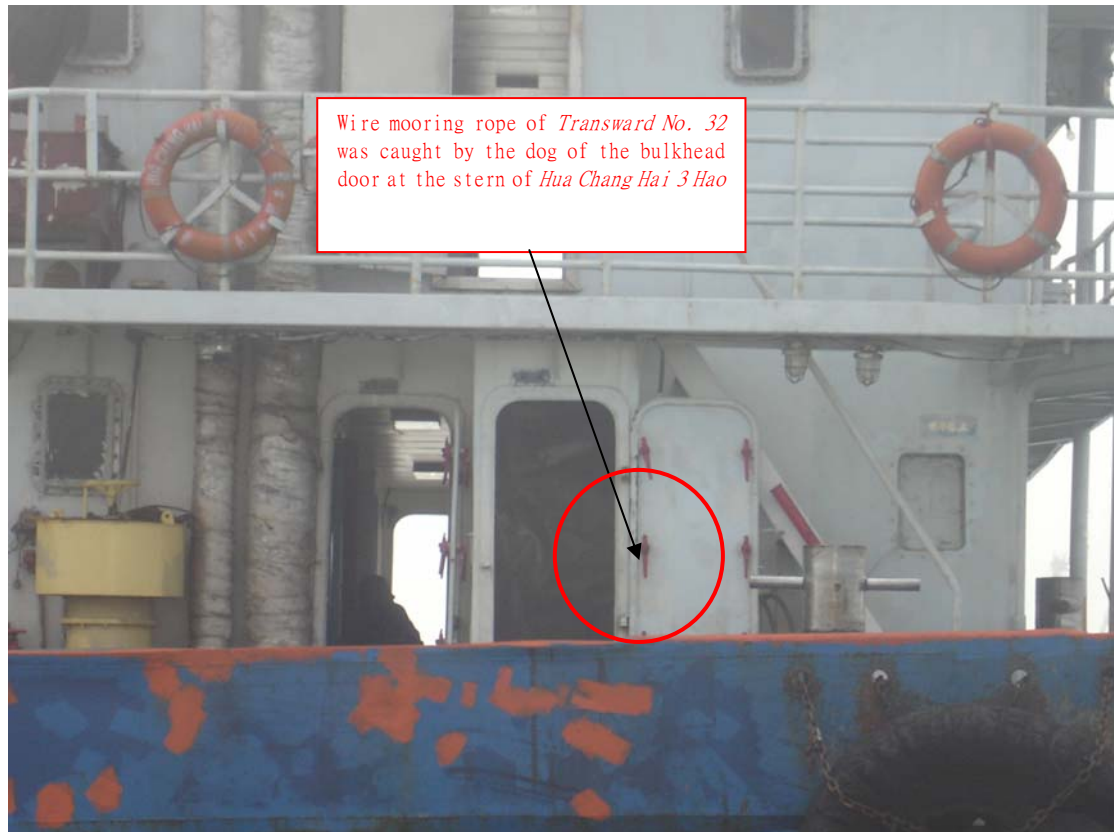
Figure 2 – Diagram showing the dog of the bulkhead door where the wire mooring rope of *Transward No. 32* was caught
