Report of Investigation  
into the fatal accident on board  
*Hua Chang Hai 3 Hao*  
at Tuen Mun River Trade  
Terminal  
at about 1905  
on 15 December 2006

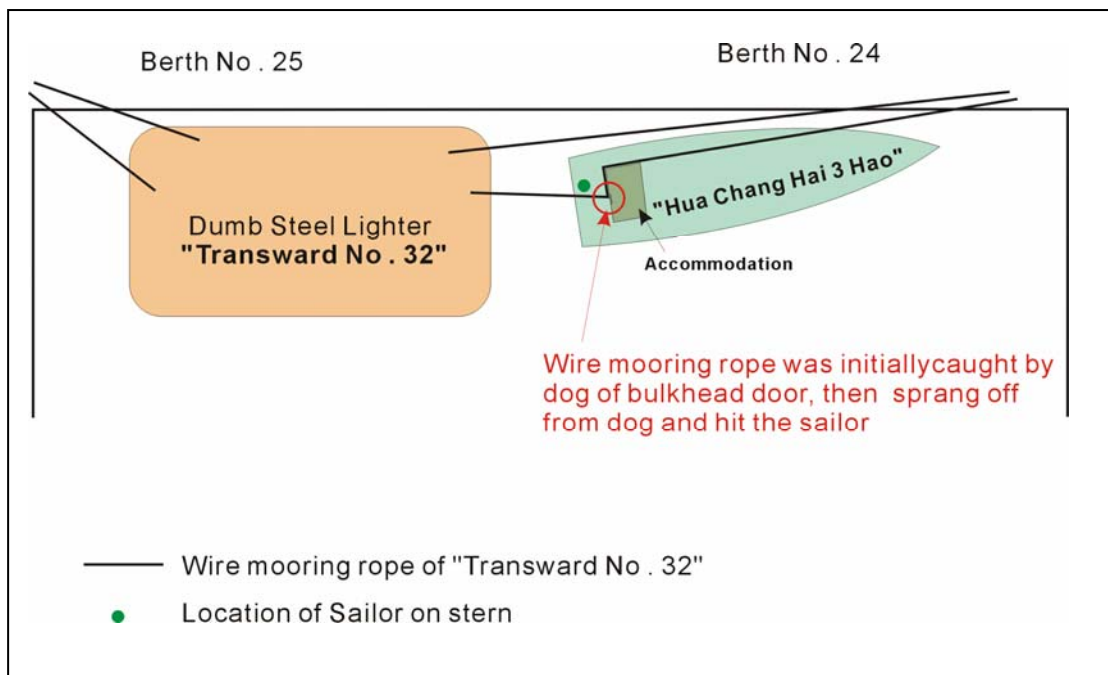
- 5.5 When the accident occurred, *Transward No. 32* was moored to Berth No. 25 with two wire mooring ropes at each end (Figure 2). The long wire mooring ropes on the forward end of *Transward No. 32* would cause obstruction to and create a potential hazard to any vessels berthing alongside Berth No. 24. In approaching to Berth No. 24, one of the bow wire mooring ropes of *Transward No. 32* was caught by the dog of the bulkhead door on the stern of *Hua Chang Hai 3 Hao* (Figure 3). The wire mooring rope sprang off from the dog and hit the Sailor who was attending at the stern. The Sailor fell overboard and was drowned.

Figure 2 – Diagram showing the mooring arrangement of *Transward No. 32* which was moored to Berth No. 25 when *Hua Chang Hai 3 Hao* was approaching Berth No. 24

- 6.1 At about 1905 on 15 December 2006, a Sailor who was on standby at the stern on board the Chinese river-trade vessel *Hua Chang Hai 3 Hao* was hit by a wire mooring rope of the dumb steel lighter *Transward No. 32*. The Sailor fell overboard and was drowned.
- 6.2 The accident was caused by a long wire mooring rope which sprang off under tension after being caught by the dog of bulkhead door at the stern of *Hua Chang Hai 3 Hao*.
- 6.3 The lack of safety awareness of the Sailor who positioned himself too close to the long wire mooring rope of the dumb steel lighter *Transward No. 32* also contributed to the accident.

- 7.1 A copy of this report should be sent to the operator and the owner of *the Vessel*, advising them the findings of the of this incident and the importance of advising their crew members to keep themselves well clear from mooring ropes when berthing/unberthing.
- 7.2 A copy of this report should be sent to the Tuen Mun River Trade Terminal advising them the findings of this incident. They should draw the attention of the operators of the dumb steel lighters working within the terminal that their mooring ropes should not cause obstruction and create potential hazard to other vessels which berth/unberth from the berths of the terminal.

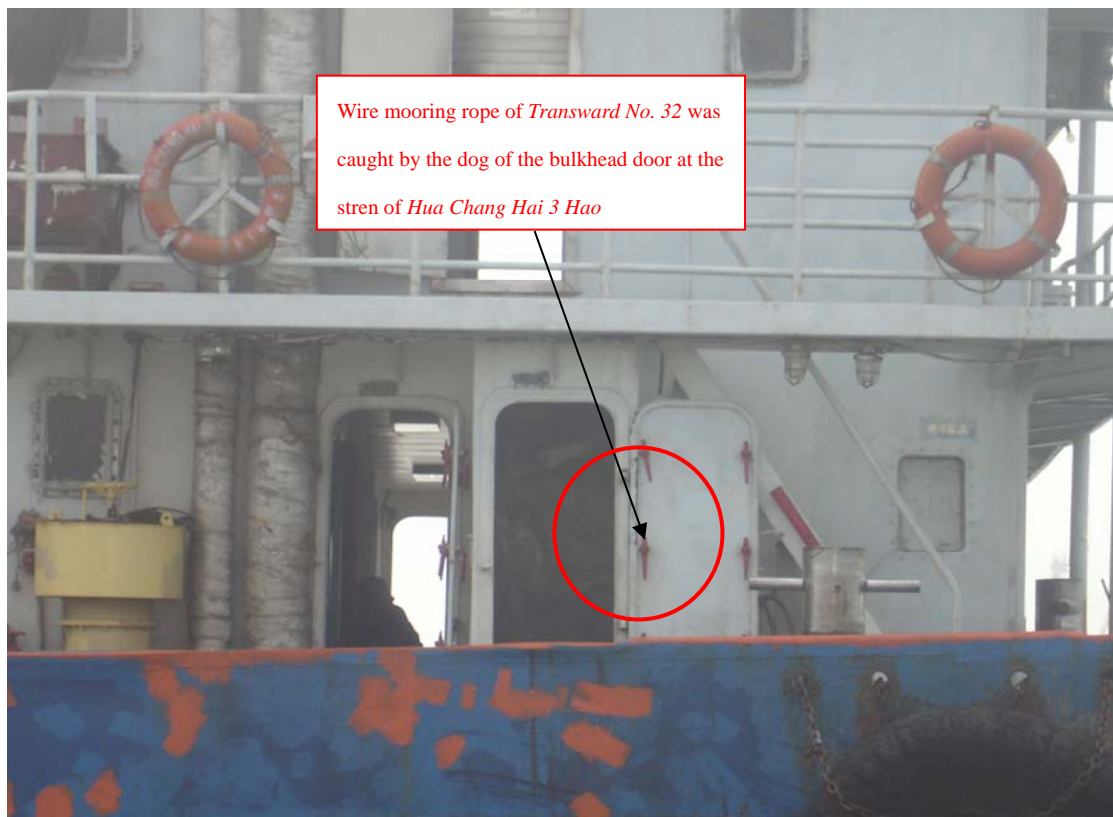
- 5.7 The Autopsy Report confirmed that the cause of death was drowning. An abrasion was found on upper forehead while bruised abrasions were discovered on outer angle of left eye, left lower front of chest and the adjoining left upper abdomen. From the autopsy report, it was deduced that the Sailor was first hit by the wire mooring rope which sprang off from the dog of the bulkhead door and then fell overboard and got drowned.

Figure 3 – Diagram showing the dog of the bulkhead door where the wire mooring rope of *Transward No. 32* was caught
