Report of Investigation

into the engine room fire on board

m.v. "Maritime Alliance"

The Hong Kong Special Administrative Region
Marine Department
Marine Accident Investigation Section

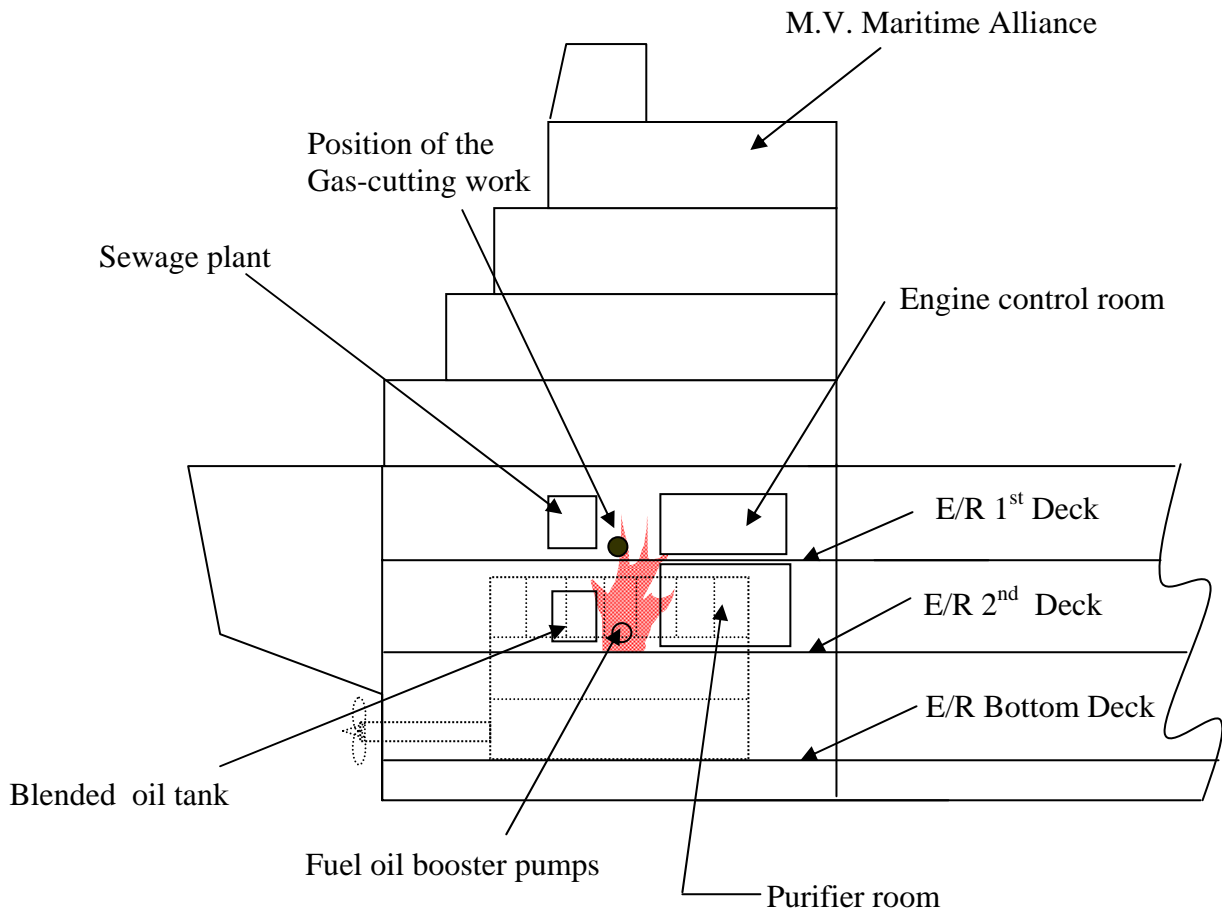
Figure 2: Location of the seat of the fire

- 5.6 The 2nd deck of the engine room was covered with heavy smoke stain. The port side area was suffered with heat damage, particularly at the aft end of the purifier room, auxiliary engines booster pumps area and blended oil tank. All areas above the blended oil tank and booster pumps were severely heat affected with electrical wiring burned and electrical fittings destroyed. The aft wall of the purifier room buckled. The side shell plating adjacent to the blended oil tank was found distorted. It appeared that the seat of the fire was located around the blended oil tank.

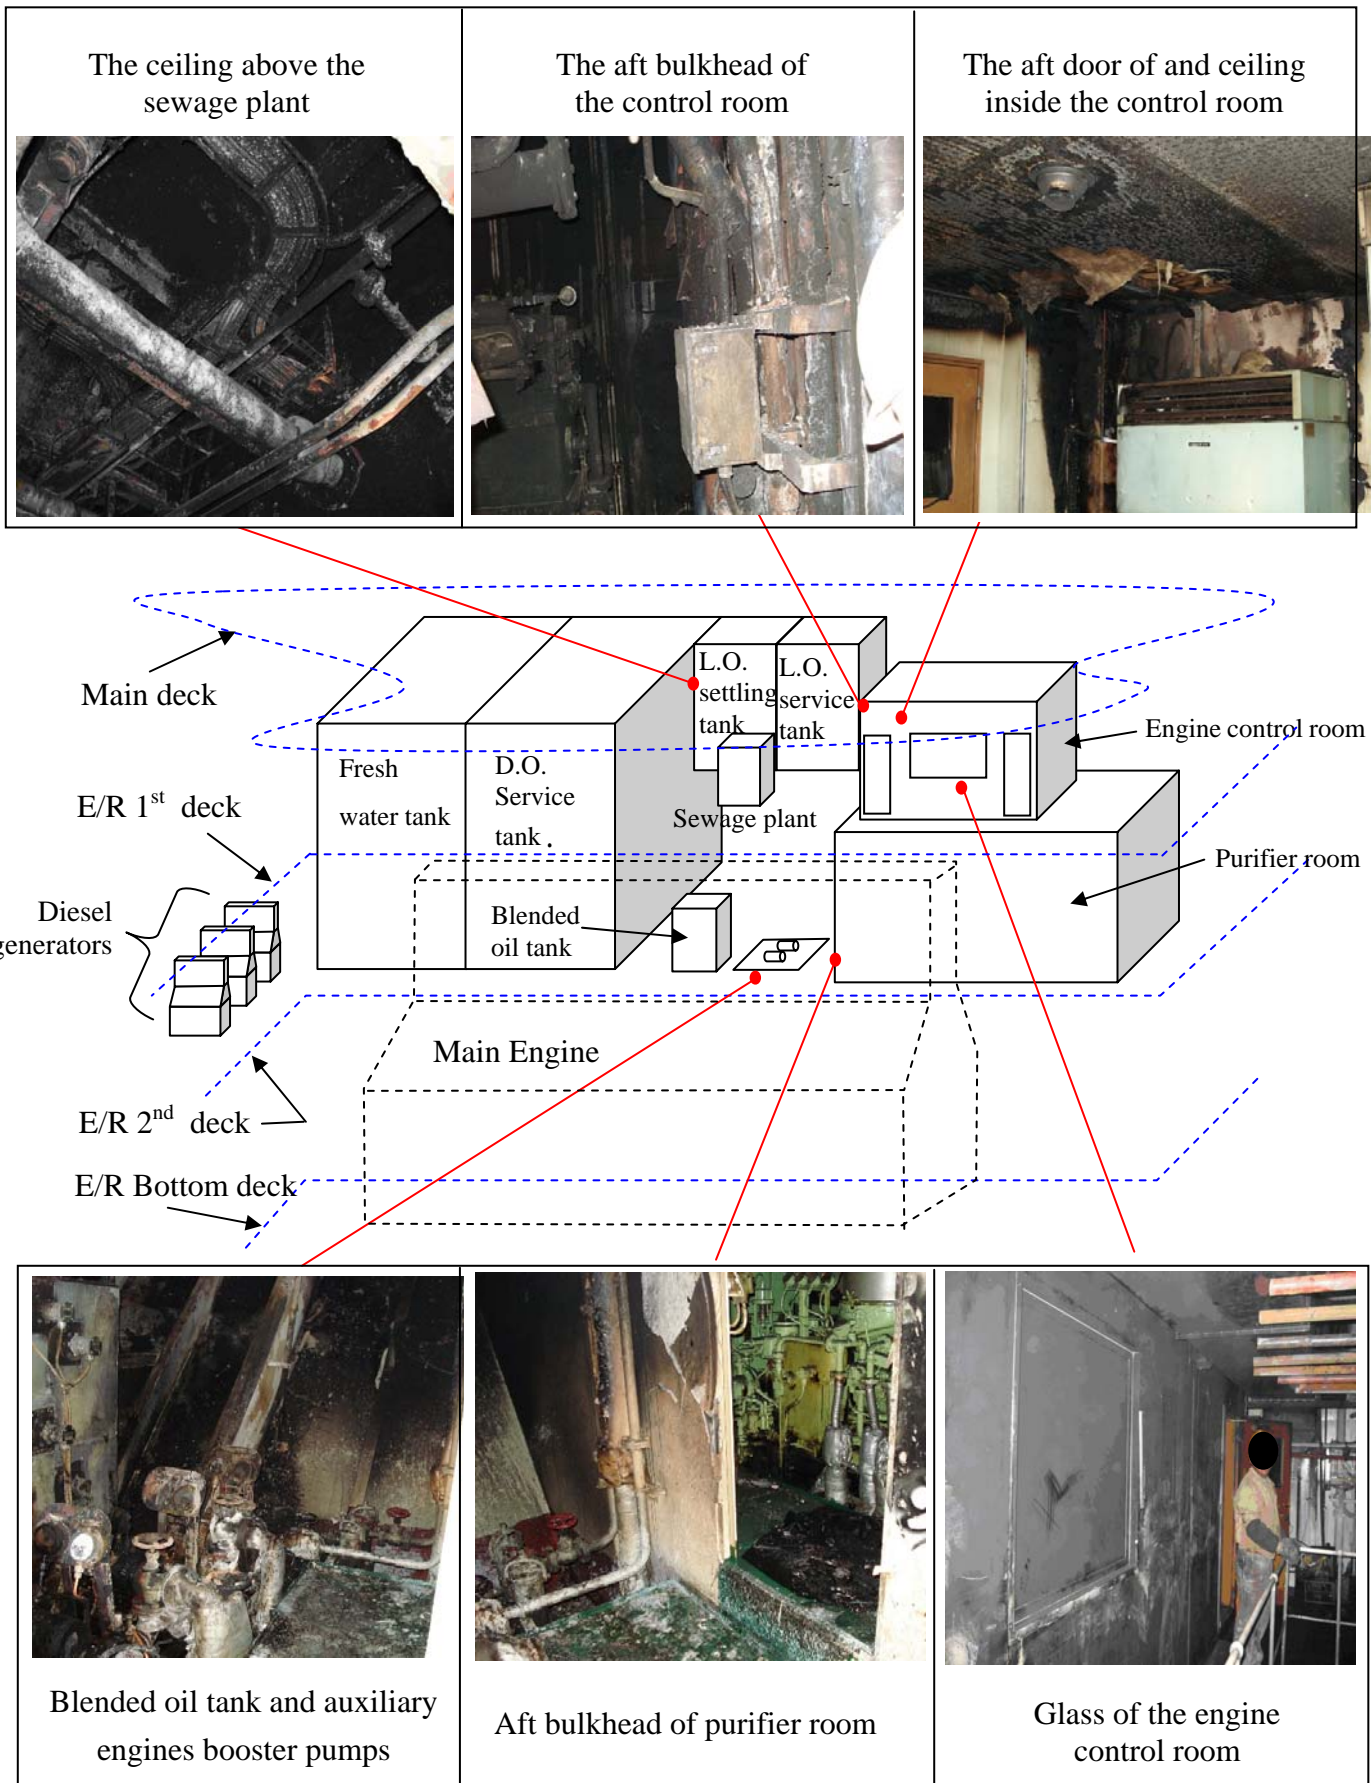
Figure 3: The fire damages

- 5.4 Figure 3 shows the extent of damages found in various locations in the engine room. Heavy soot was found covered from the upper levels. Extensive damages were found in those areas above the blended oil tank, the fuel oil booster pumps and their surroundings. A number of plastic covers for lightings at the engine room upper level above the blended oil tank were melted.

- 5.5 The 1st deck of the engine room was also coated with smoke stain. Severe heat damage was found in way of sewage treatment plant on the port side. The after bulkhead of the control room was buckled. All electric cables entering the control room from the aft and inboard sides were heat affected. The interior fittings of the control room such as ceilings and light covers were also damaged by the intense heat of the fire.

- 5.7 The bottom level of the engine room was covered with minor smoke stain, no apparent heat damage was found.

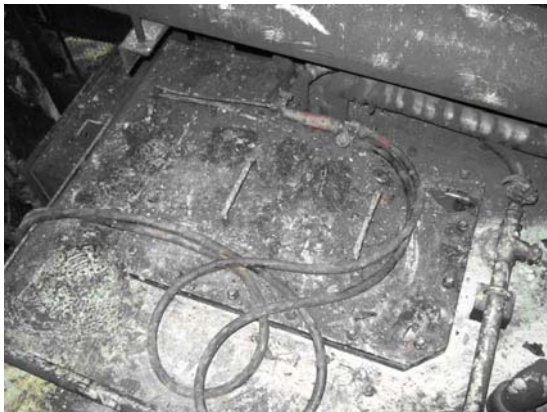
Figure 4: The gas-cutting torch

Fire origin

- 5.9 At the outbreak of the fire, hot work was being carried out by three to four workers from *the Dockyard* at the engine room 1st deck adjacent to the sewage treatment plant. They used an oxy-acetylene cutting torch to cut off the bolts on a flange of a sewage treatment plant pipe (see figures 4 and 5). Hot molten metal and sparks could fall down to 2nd deck and bottom deck of the engine room.

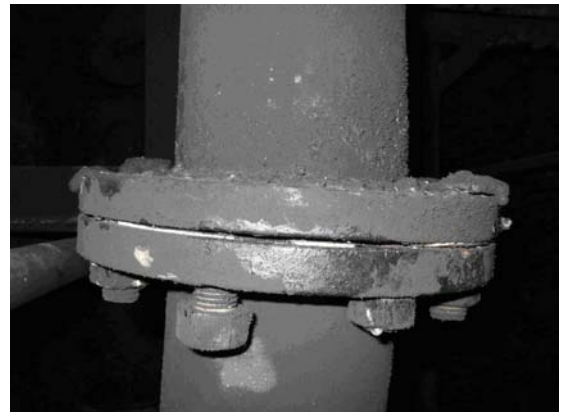
Figure 5: The cut away bolts

- 5.10 The drip tray of the booster pumps for the diesel generators was located a few metres below the position of the gas-cutting work. The gas-cutting work generated hot molten metal and sparks that ignited the fuel oil collected in the tray and consequently caused the fire.

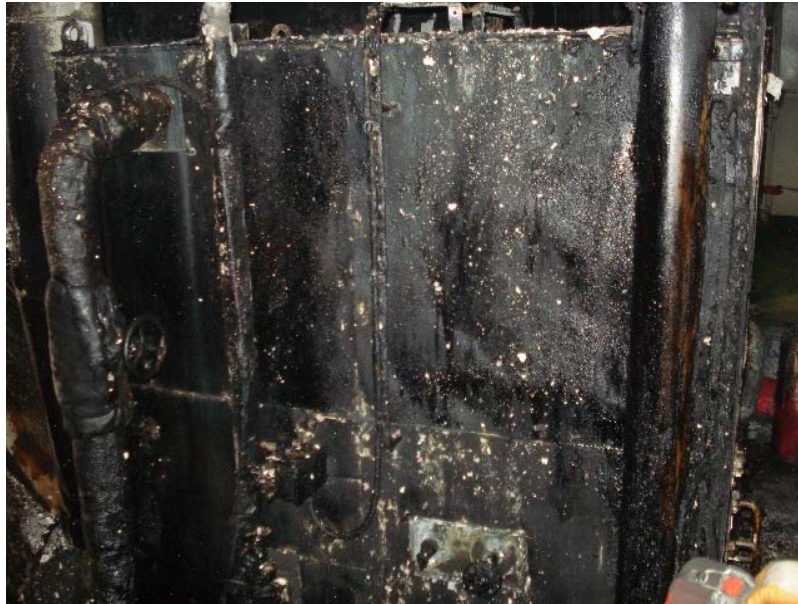
diesel oil for several days. As the booster pumps were most of the time running on viscous blended oil, oil might have leaked from the glands to the tray when the pumps were running on less viscous diesel oil. It was reasonable to believe that certain quantity of diesel oil might have collected in the drip tray if left unattended. Routine inspection on oil leakage and cleanliness on the drip trays were utmost important for prevention of fire. Whenever leakage of oil was discovered, corrective measures should be taken.

Figure 6: Sign of oil spillage from the blended oil tank.
