Report of Investigation
into the fatal accident on board
the Hong Kong registered ship
“Great Morning”
on 11 March 2007

The Hong Kong Special Administrative Region
Marine Department
Marine Accident Investigation Section

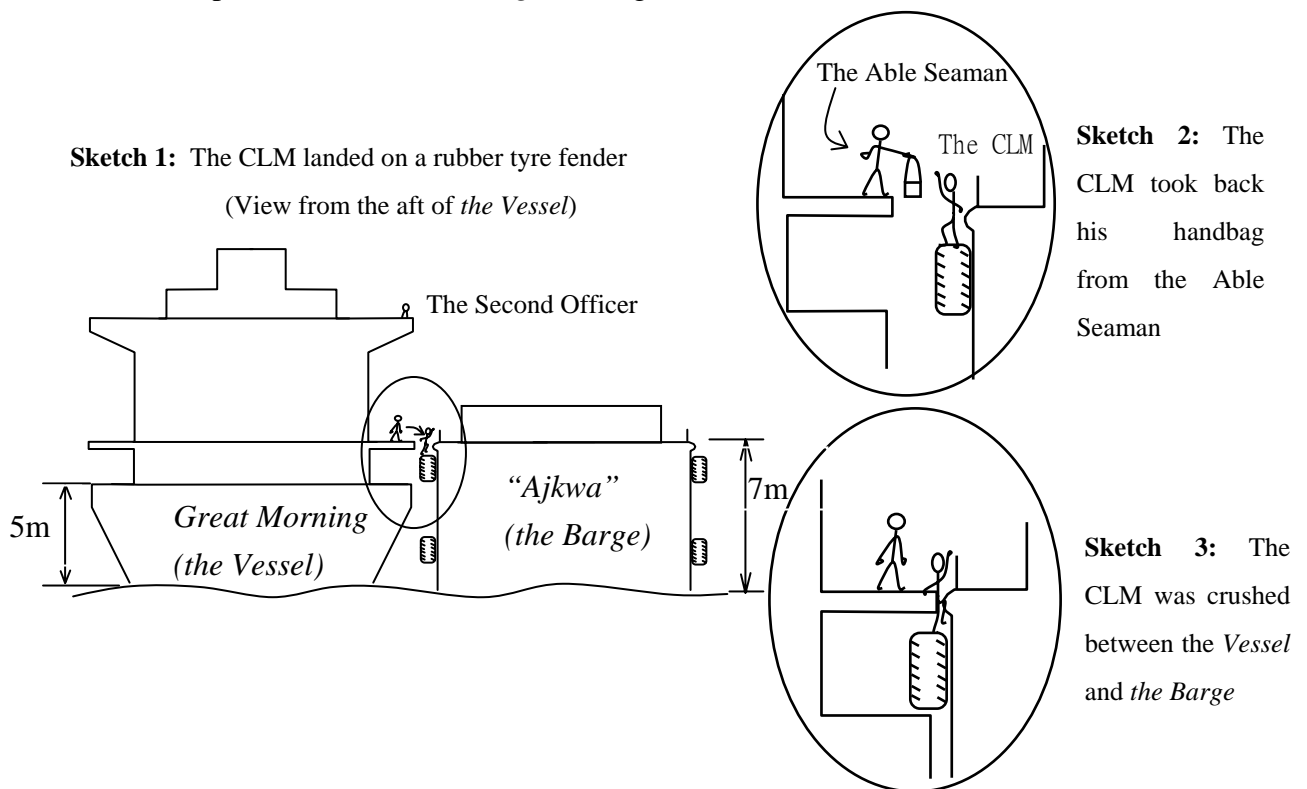
- 4.4 An Able Seaman was assigned to accompany the CLM to the boat deck for disembarking from *the Vessel* to *the Barge*. Both sides of *the Barge* were fitted with rubber fenders, the CLM landed on a rubber tyre fender at the port aft of *the Barge* from the starboard boat deck of *the Vessel*. After he had taken back his handbag from the Able Seaman, he climbed up to the deck of *the Barge* (see fig. 4).

Fig. 4: The sequence of the happening of the accident

4.5 While the CLM was climbing up *the Barge*, *the Vessel* and *the Barge* swayed and touched with each other. As a result, the CLM was crushed between *the Vessel's* boat deck structure and *the Barge's* fender.

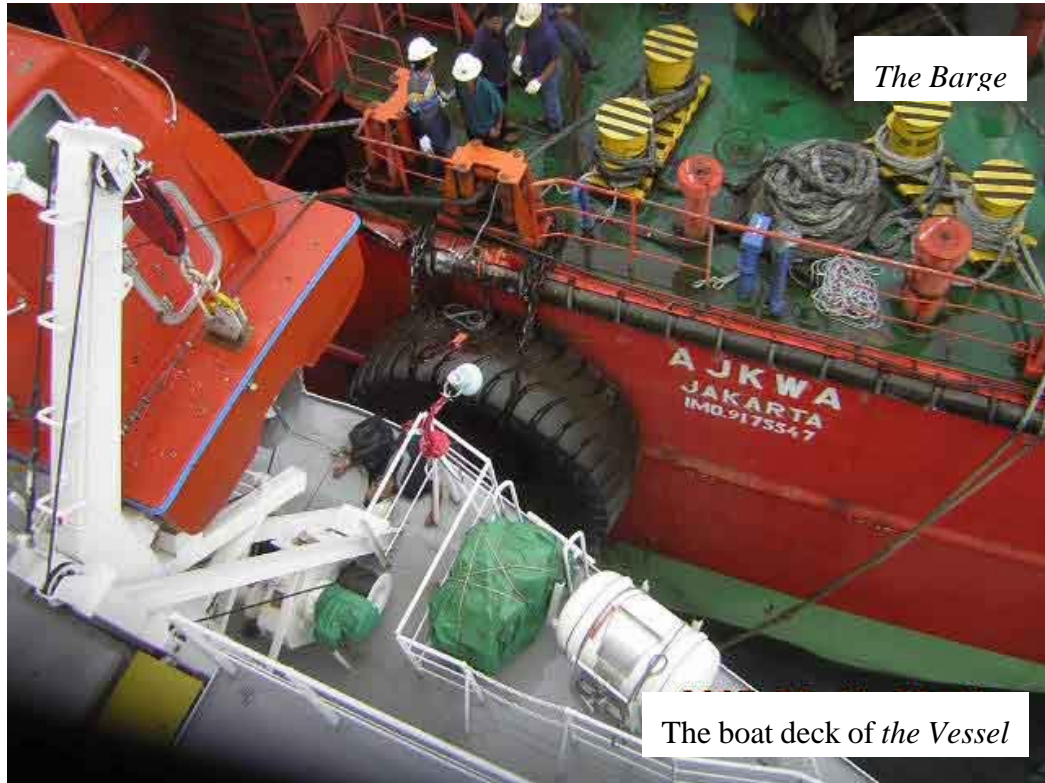
Fig 5: The scene of the accident

- 5.6 The boat deck of *the Vessel* is an extension at the side of *the Vessel's* for operation of the lifeboats. The boat deck would make contact with the fender of *the Barge* resulting from the movement of the two vessels. The boat deck was not a proper means of access for boarding *the Barge*.

- 5.7 The cause of the accident is considered to be a lack of safe means of access between the two vessels. In order to board *the Barge* from *the Vessel*, the CLM had to land on a rubber tyre fender between the two vessels. As the vessels were subject to sea movement, the structure of *the Vessel* crushed the CLM against *the Barge* while he was climbing up *the Barge* from the rubber tyre fender. Contributing to this accident was the failure to provide service boat for the CLM to get back ashore or transfer between the vessels, which may

- 7.1 A copy of this report should be sent to the management company and the Master, advising them the findings of the accident. They should ensure the crewmembers to observe the following safety guidelines:
- Safe means of access should be provided personnel to get back ashore; and
 - Personnel should be aware of the dangers of any unexpected ship movements while transferring people between vessels.
- 7.2 A Merchant Shipping Information Note should be issued to promulgate the lessons learnt from this fatal accident, drawing the industry's attention on the embarkation and disembarkation between vessels.

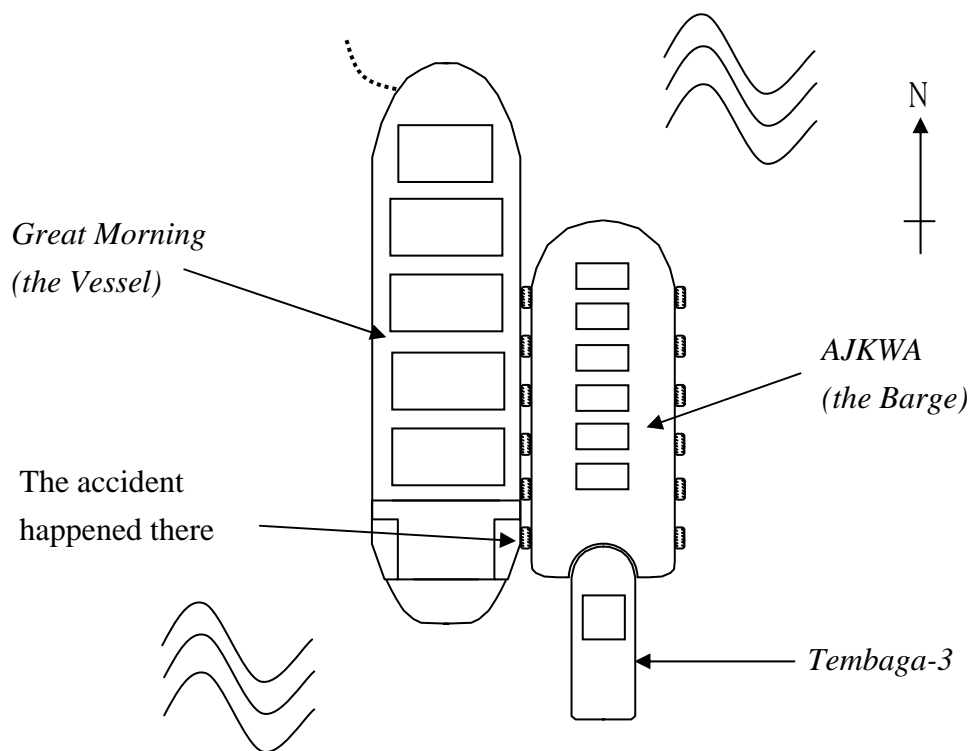
- 5.1 *The Barge* was moored to the starboard side of *the Vessel* by mooring ropes. The bow of the tugboat “*Tembaga-3*” was coupled to the stern of *the Barge* (see fig. 6). All the three vessels were at Latitude 4° 50.0’ S, Longitude 136° 40.8’ E heading to north direction. *The Barge* was fitted with a number of rubber tyres which served as fender to keep the vessel moored to its sides apart. There was a gap of about 2 metres between *the Vessel* and *the Barge*.

Fig. 6: The mooring arrangement of the vessels

The Vessel was loaded with 23,000 metric tons of cargo while *the Barge* was in lightship condition with large freeboard. *The Barge's* freeboard was about 2 metres higher than *the Vessel's* freeboard. Furthermore, a relative large gap existed between the two vessels causing it unsafe to transfer people directly between vessels.
