Report of Investigation
into the Collision between
Hong Kong Registered General
Cargo Ship “Hui Rong” and
Chinese Registered
Bulk Carrier “Peng Yan”
on 17 March 2007

The Hong Kong Special Administrative Region
Marine Department
Marine Accident Investigation Section

Preliminary Inquiry No. 1 of 2007

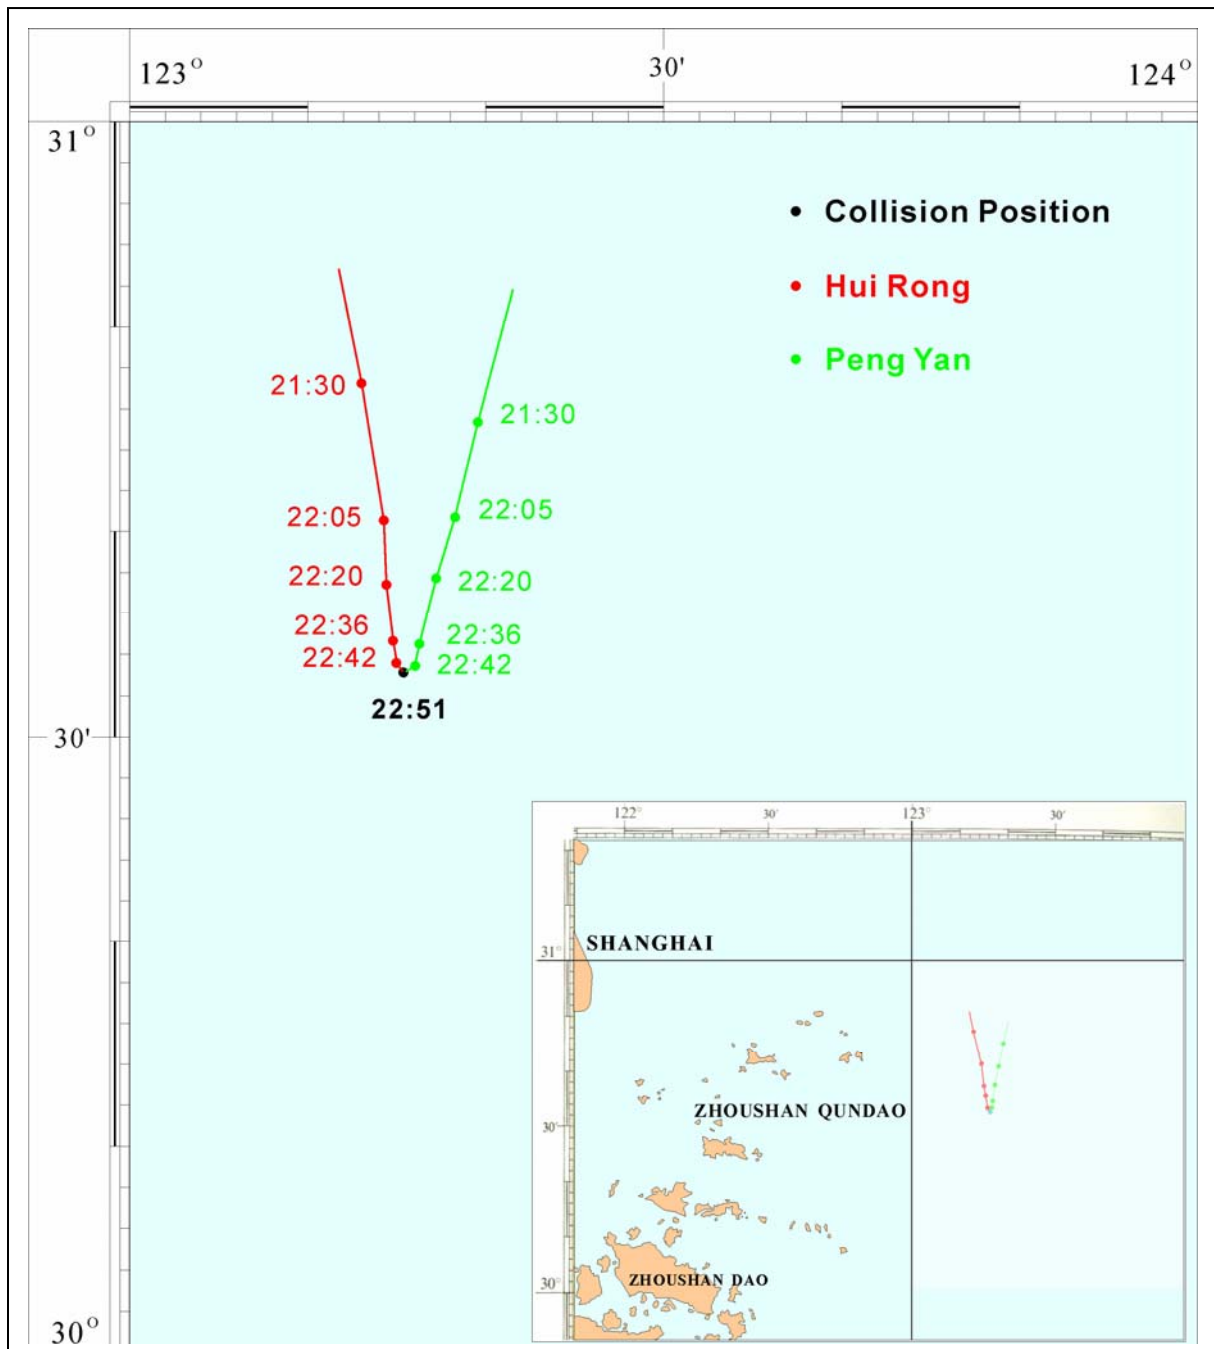
Figure 3 – Diagram showing the collision tracks of *Hui Rong* and *Peng Yan*

- 4.3.1 AIS is a ship and shore based broadcast system, operated in the VHF maritime band. It uses Self-Organising Time Division Multiple Access (SOTDMA) technology to ensure stable and reliable ship-to-ship and ship-to-shore high frequency broadcast. The system is capable of sending and receiving automatically ship information such as identity, position, course, speed, ship particulars and cargo information ship-to-ship and ship-to-shore. As the collision took place outside the VTS coverage, the AIS information from both vessels were recorded by nearby Zhoushan VTS station and was used for investigation purpose. The collision tracks of both vessels are indicated in Figure 3.

5.5.1 According to the COLREGS, in a crossing situation and being a stand-on vessel, *Hui Rong* should maintain her course and speed and should not alter course to port when taking avoiding actions. AIS information revealed that at 2205, *Hui Rong* was on a course of 171°T with a speed of 11.6 knots. At 2236 and 2242, *Hui Rong* was on a course of 178°T with speeds of 11.7 knots and 11.8 knots. *Hui Rong* took *Peng Yan*'s advice and altered course to port at 2243 and eventually collided

with *Peng Yan* at a position 30° 32.5'N 123° 15.6'E at 2251. At the time of the collision, *Hui Rong* was turning to port while *Peng Yan* was turning to starboard.

5.6.1 *Peng Yan* altered course to starboard to 196°T from 179°T at 2130 and a crossing situation developed between *Hui Rong* and *Peng Yan*. AIS information revealed that at 2205, *Peng Yan* was on a course of 196°T with a speed of 10.9 knots. At 2236 and 2242, *Peng Yan* was on a course of 194°T with a speed of 11.2 knots. At 2235 *Peng Yan* advised *Hui Rong* to alter course to port and she would alter course to starboard to keep clear of the stern of the latter vessel. *Hui Rong* took *Peng Yan's* advice and altered course to port at 2243 and *Peng Yan* made a large alteration of course to starboard at 2247. *Peng Yan* was not aware that alteration of course towards *Hui Rong* would reduce the closing distance between both vessels and subsequently the two vessels collided at 2251 while *Hui Rong* was turning to port and *Peng Yan* was turning to starboard. According to the COLREGS, *Peng Yan* being a give-way vessel should take early and substantial action to keep well clear of the other vessel. *Peng Yan* should have taken early avoiding action by either altering course to starboard to pass the stern of *Hui Rong* or slowing down, stopping or reversing her engine so that *Hui Rong* could pass ahead of it. *Peng Yan* should not advise *Hui Rong* to alter course to port to result in another close-quarters situation.
