Report of Investigation
into the fatal accident on board
the Hong Kong registered ship
“Saga Monal”
on 2 May 2007

The Hong Kong Special Administrative Region
Marine Department
Marine Accident Investigation Section

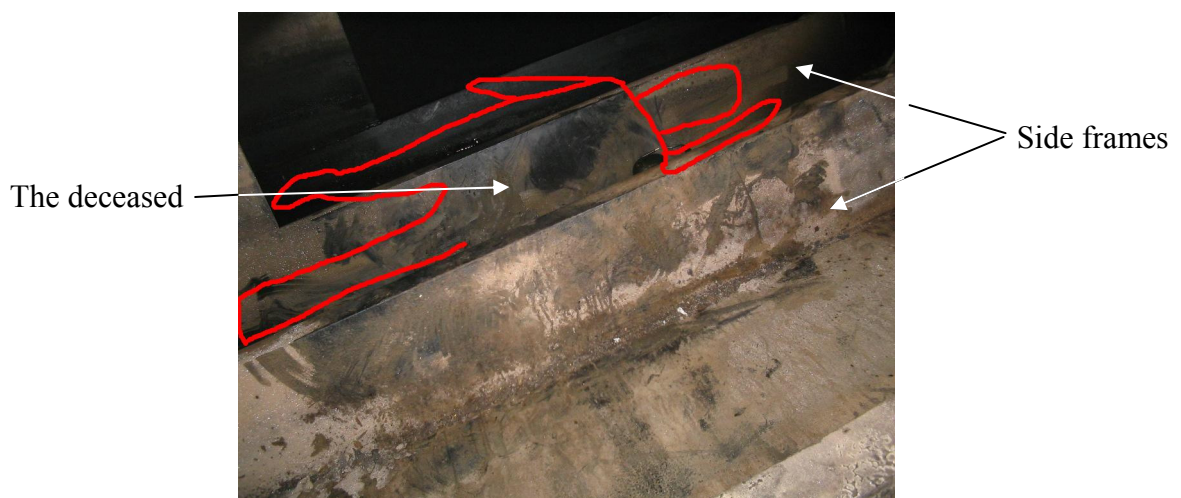
- 1.2 The investigation revealed that the enclosed oily bilge tank was not properly ventilated prior to the entry of the Chief Engineer. He was overcome by the oxygen deficient atmosphere inside the oily bilge tank.

- 4.5 At 1205, the engineers had problems with a generator and tried to inform the Chief Engineer but could not find him. At about 1210, the Wiper remembered that he had opened the manhole of the oily bilge tank for the Chief Engineer, so he proceeded to the oily bilge tank and found the Chief Engineer lying unconsciously on a side frame inside the tank.

Fig. 2: The Chief Engineer was found collapsed inside the oily bilge tank

- 7.1 A copy of this report should be sent to the Master and *the Company of the Vessel*, advising them the findings of this incident. Their attention is also drawn to the lessons learnt promulgated from the Hong Kong Merchant Shipping Information Note No. 30/2004. The Master and *the Company* should provide adequate and effective supervision to their vessels to ensure that the safety management system is effectively implemented, in particulars:
- Provide adequate training for confined space entry for all ship's staff; and
 - Ensure all the ship's staff to follow procedures of the safety management system.
- 7.2 The attention of ISM Section of the Marine Department should be drawn on the findings of the report and to consider taking appropriate measures to prevent the recurrence in future. This is the third similar case for ships managed by *the company* in 4 years.

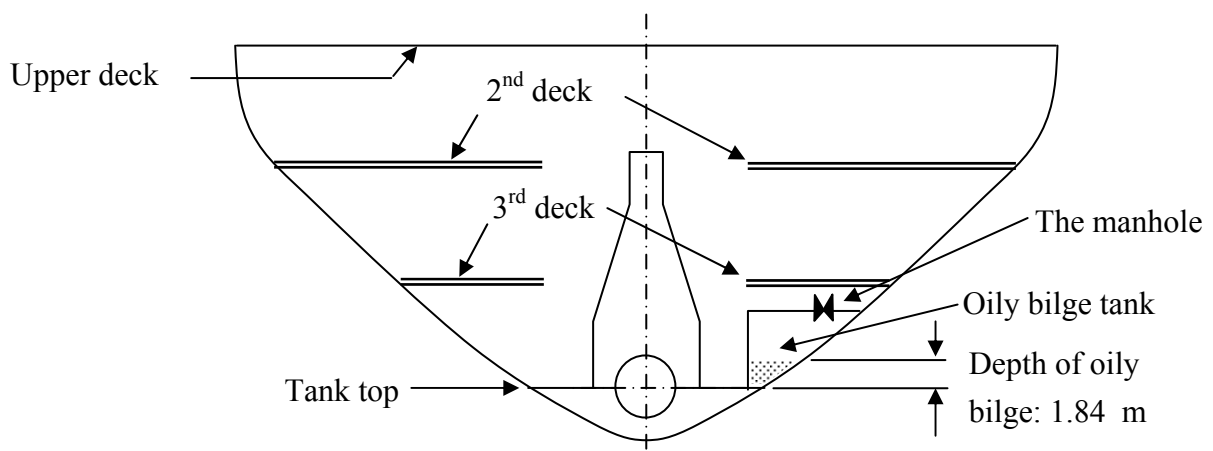
- 5.5 The oily bilge tank has a capacity of 25.90 m³, it is located at port side tank top of the engine room between frame numbers 30 and 33. A manhole is fitted on top of the tank for maintenance and inspection. A ventilation pipe is fitted on top of the tank leading up to upper deck. At the time of the accident, the oily bilge contained 8.3 m³ of oily bilge with a tank sounding of 1.84 m.

Figure 3 : Location of the oily bilge tank (Looking aft)

- 5.6 The outboard side plate of the oily bilge tank was a part of the shipside shell that fitted with a number of longitudinal side frames. The side plate flared out from bottom to top and the manhole was situated near port side shell of the ship (see figure 3). People could get into the oily bilge by stepping on the side frames. It is believed the Chief Engineer tried to get entry into the tank via the side frames to check whether the oily bilge was effectively treated there. However, he was not aware that it was risky to enter the tank without observing any safety precautions.

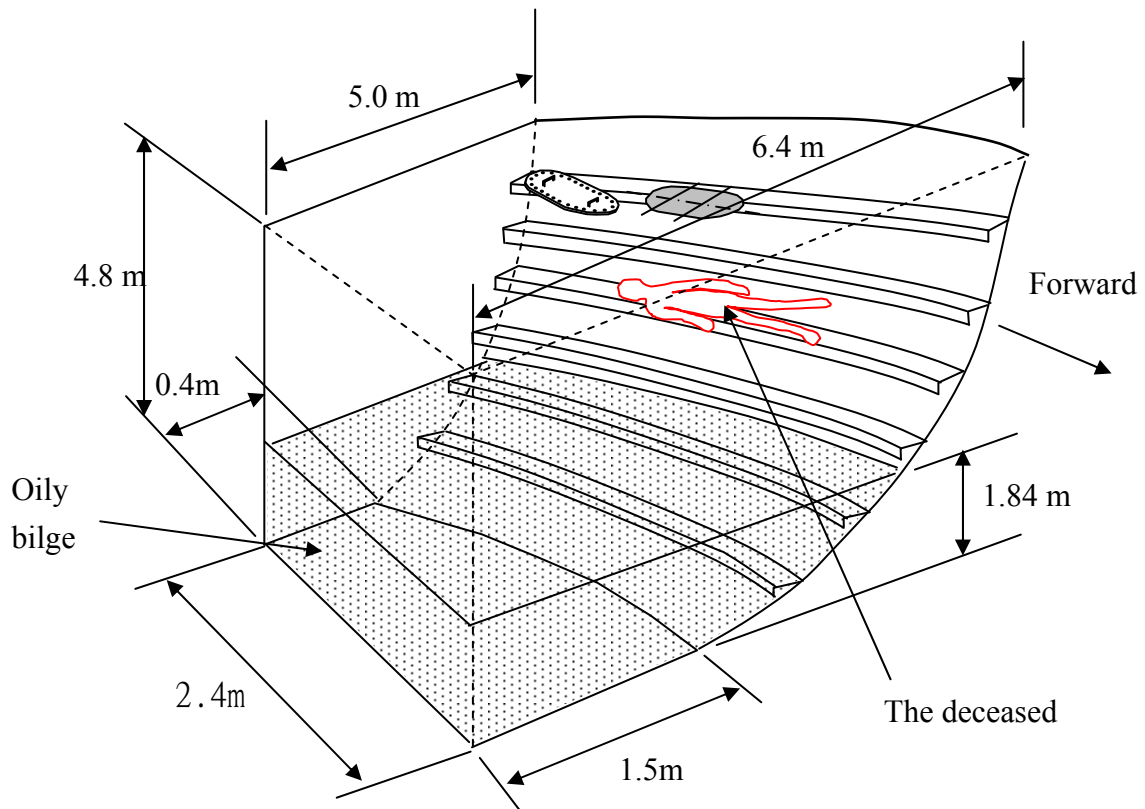
- 5.7 The oily bilge tank contained 8.3 m³ of engine room oily bilge. Signs of rusting were found at the sides. The oily bilge contained oil, seawater, pollutants and bacteria that could absorb oxygen due to chemical changes. Corrosion on steel plates could also deplete the oxygen inside the tank. The tank would have remained closed and unventilated for long periods before the accident. The tank was a confined space and the atmosphere inside

probably became deficient in oxygen. After the accident, the oxygen content at the manhole opening position was found to be 16% by volume. It is believed that the oxygen content inside the tank at the time of the accident was well below the 16% and the atmosphere inside the tank was lethal to personnel.

Fig 4: Details of the oily bilge tank
