Report of investigation
into the fatal accident of
a repairer onboard dumb
lighter
“Smart Hill No.1”
at Yau Ma Tei Anchorage
on 18 May 2007

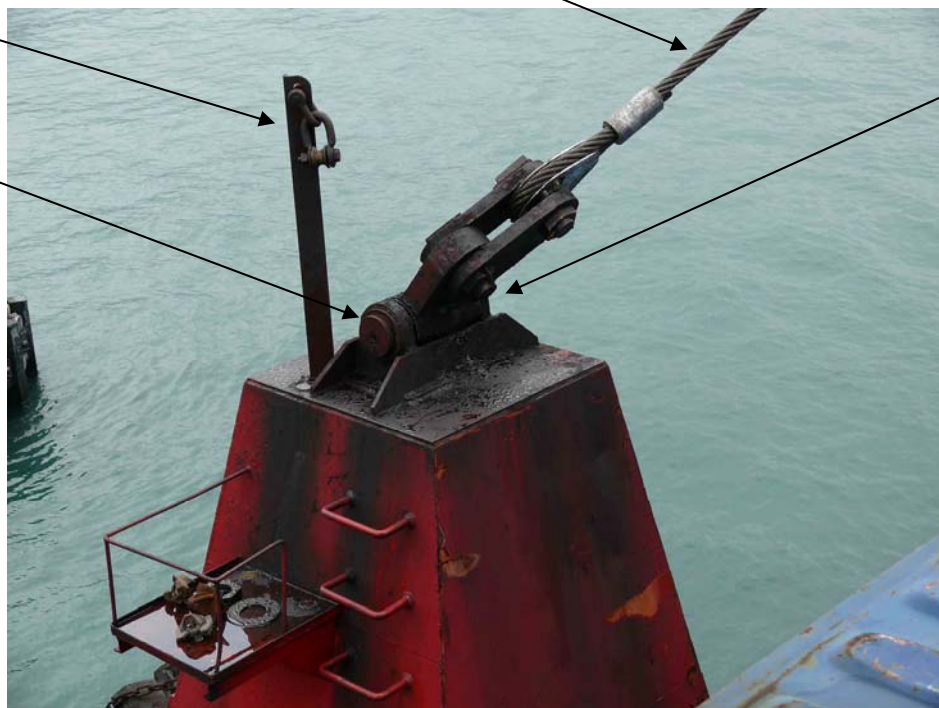
Fig. 3: Top of Anchor Block of Slewing Guy on "Smart Hill No.1"

- 5.6 A swivel block is mounted centrally on the top of the anchor block (see Fig.3). The swivel is connected to the derrick boom by means of a wire rope sling (i.e., the fixed end piece of slewing guy). The unobstructed flat area on top of anchor block at each side of the swivel providing foothold for workers is about 0.37 square metre (i.e., 0.36 metre x 1.02 metres). Oily lubricant residues could be found on those foothold surfaces that made the surfaces slippery.

- 5.7 There is no railings erected at the top of the anchor block to prevent fall of persons.
- 5.8 At the outboard side on the top of the anchor block, there is a vertically mounted angled steel bar with two steel shackles fitted at the top end of the bar. The shackles could be used as an anchor point for safety harness.

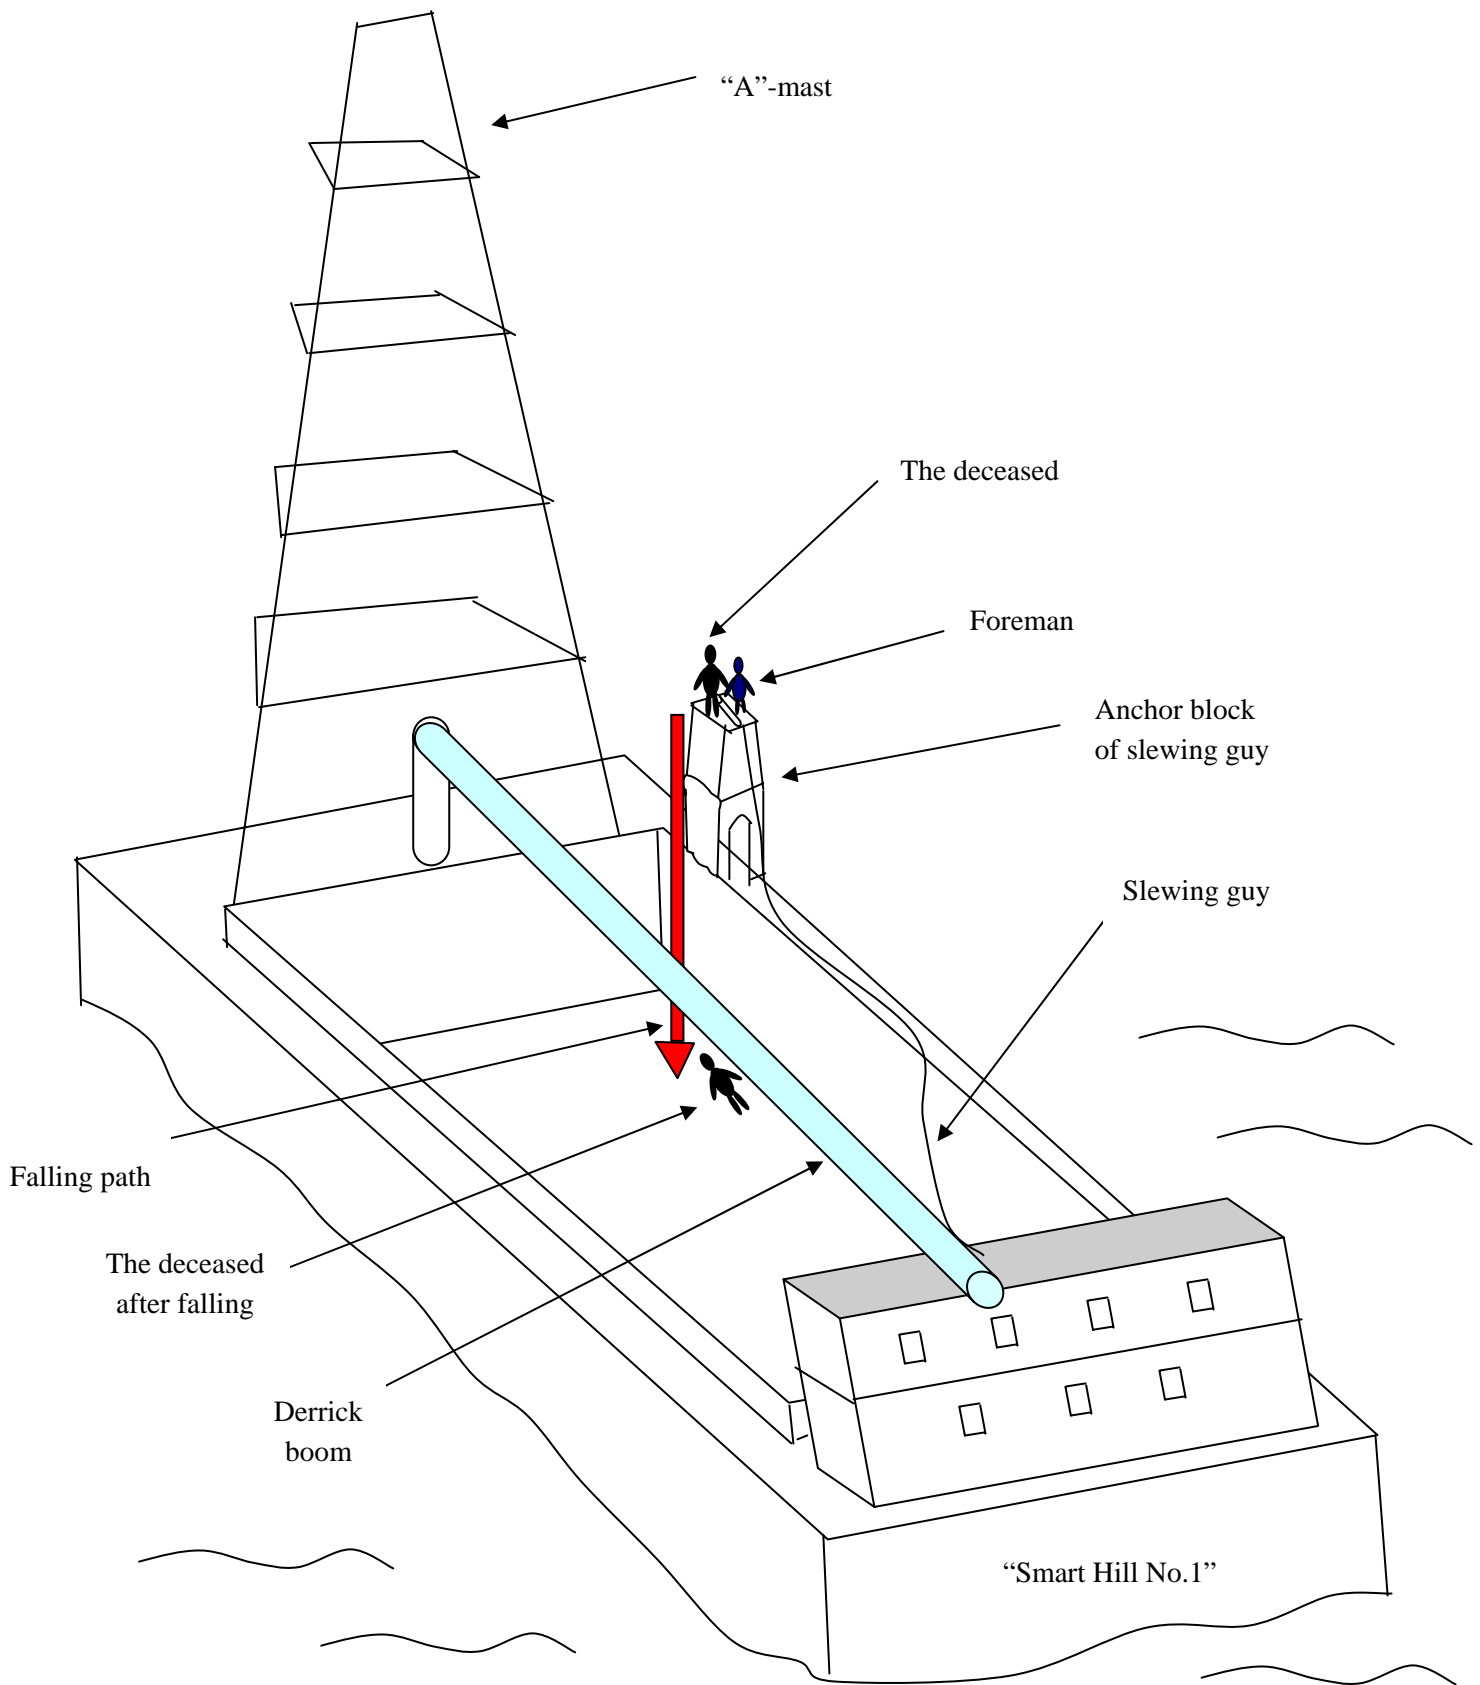
Fig. 4: The Deceased Fell from Anchor Block at the Time of Accident on "Smart Hill No.1"

- 4.6 At about 1320 hours, the Foreman was squatting on the top of the anchor block at the outboard side taking measurements of the swivel pin while the Worker was standing on the top at the inboard side. During measurements, the Worker suddenly lost his balance and fell down 10 metres to the bottom of cargo hold of *SHI* resulting in multiple injuries (see Fig.4).

- 5.12 There was foreseeable risk for the deceased and Foreman of falling more than 10 metres to the bottom of the cargo hold when working on top of the anchor block. Hence to prevent fall of persons, the use of safety harness would be necessary.

- 7.1 A copy of this report should be sent to the concerned parties such as the *Shipyard* and the person in charge of the dumb lighter, advising them the findings of this accident.
- 7.2 A Marine Department Notice should be issued to promulgate the lessons learnt from the fatal accident, drawing the industry's attention on the recommendations stipulated in the Code of Practice on Using Protective Clothing and Equipment for Works on Local Vessels and the Shipbuilding and Ship-Repairing Safety Guide.

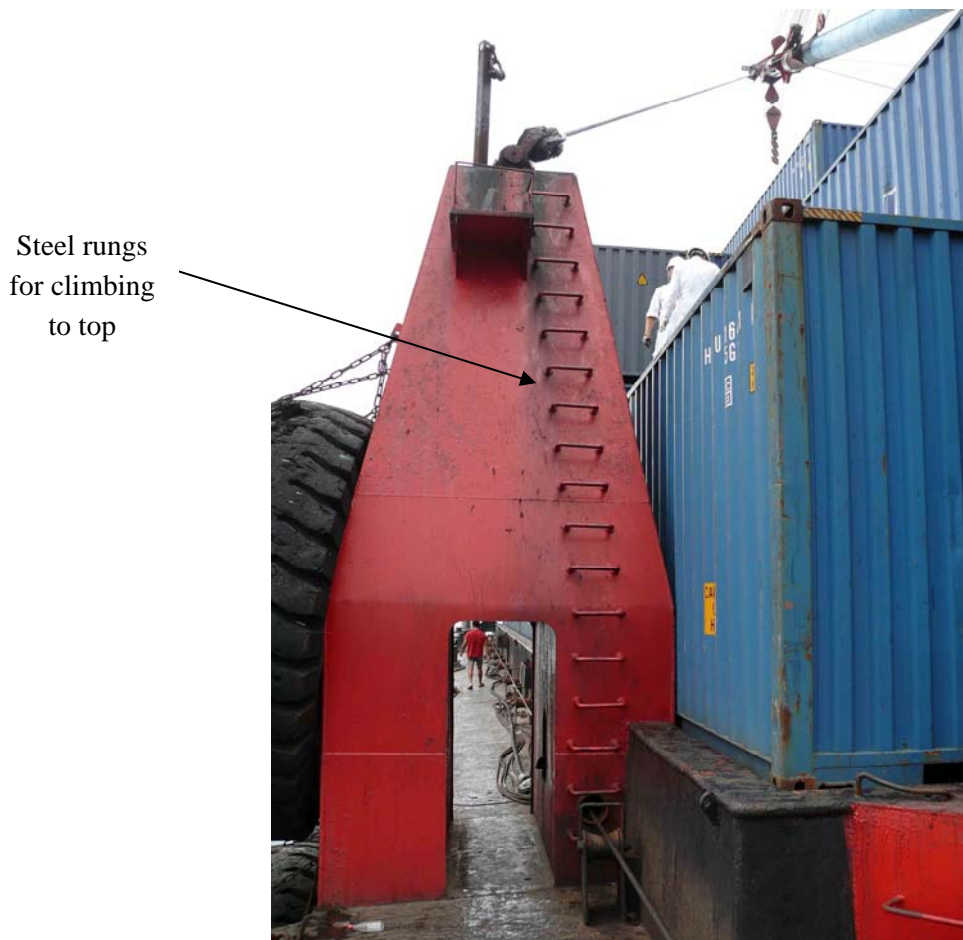
Fig. 5: Forward Side of Anchor Block of Slewing Guy on "Smart Hill No.1"

- 5.5 The height of anchor block is 5.5 metres above deck. At the forward side of the block, steel rungs are fitted to provide a safe access to the top of the block from deck (see Fig.5).
