Report of Investigation  
into the Groundings of the  
Hong Kong Registered  
High- Speed Craft

*Universal Mk 2008 &*

*Universal Mk 2010*

on 20 May 2007

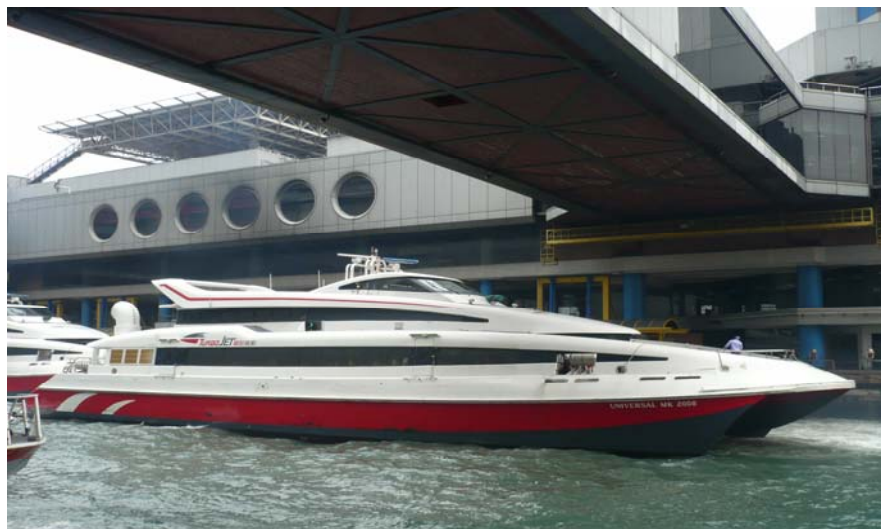
Figure 1 – Photograph of *Universal Mk 2008*

- 6.2 At the time of the accident, the weather was cloudy and squally and the visibility was poor in heavy showers.
- 6.3 *Universal Mk 2008* sustained damages on port fore peak tank and port and starboard T-foil tanks while *Universal Mk 2010* sustained damages on No. 2 and No. 4 void compartments on the port side and No. 5 void compartment (engine room) on the starboard side. There was no oil pollution and no casualty reported.
