Report of Investigation
into the injury of a sailor
on board local dumb lighter
"Shun Keung 8" (Lic. No.: 22472Y)
on 3 June 2007

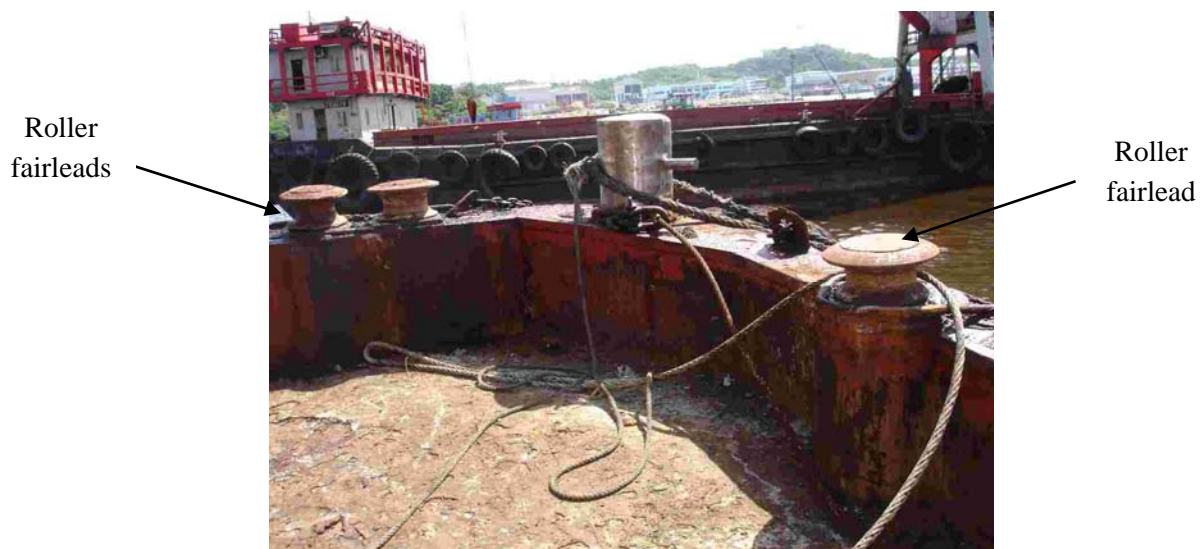
Fig. 3: The Roller Fairleads on Starboard Forward of Lighter

- 4.1 At about 1000 on 3 June 2007, the *Lighter* was alongside the berth at the seawall of sawmills at Ho Yeung Street, Tuen Mun after having finished the discharge of cargo.
- 4.2 A tug boat “*Tsui Ho 8*” (hereafter referred as the “*Tug*”) was then dispatched to Tuen Mun for towing the *Lighter* back to Kowloon.
- 4.3 The *Tug* arrived sometime before 1100. The person in charge of the *Lighter* and two sailors were preparing the tow on board the *Lighter*.
- 4.4 Two towlines were passed to the *Tug* from the *Lighter* by the two sailors. The towlines (wire ropes) were paid out slowly by the winch at the forward of the *Lighter* via roller fairleads (see Fig.3) at port and starboard sides.

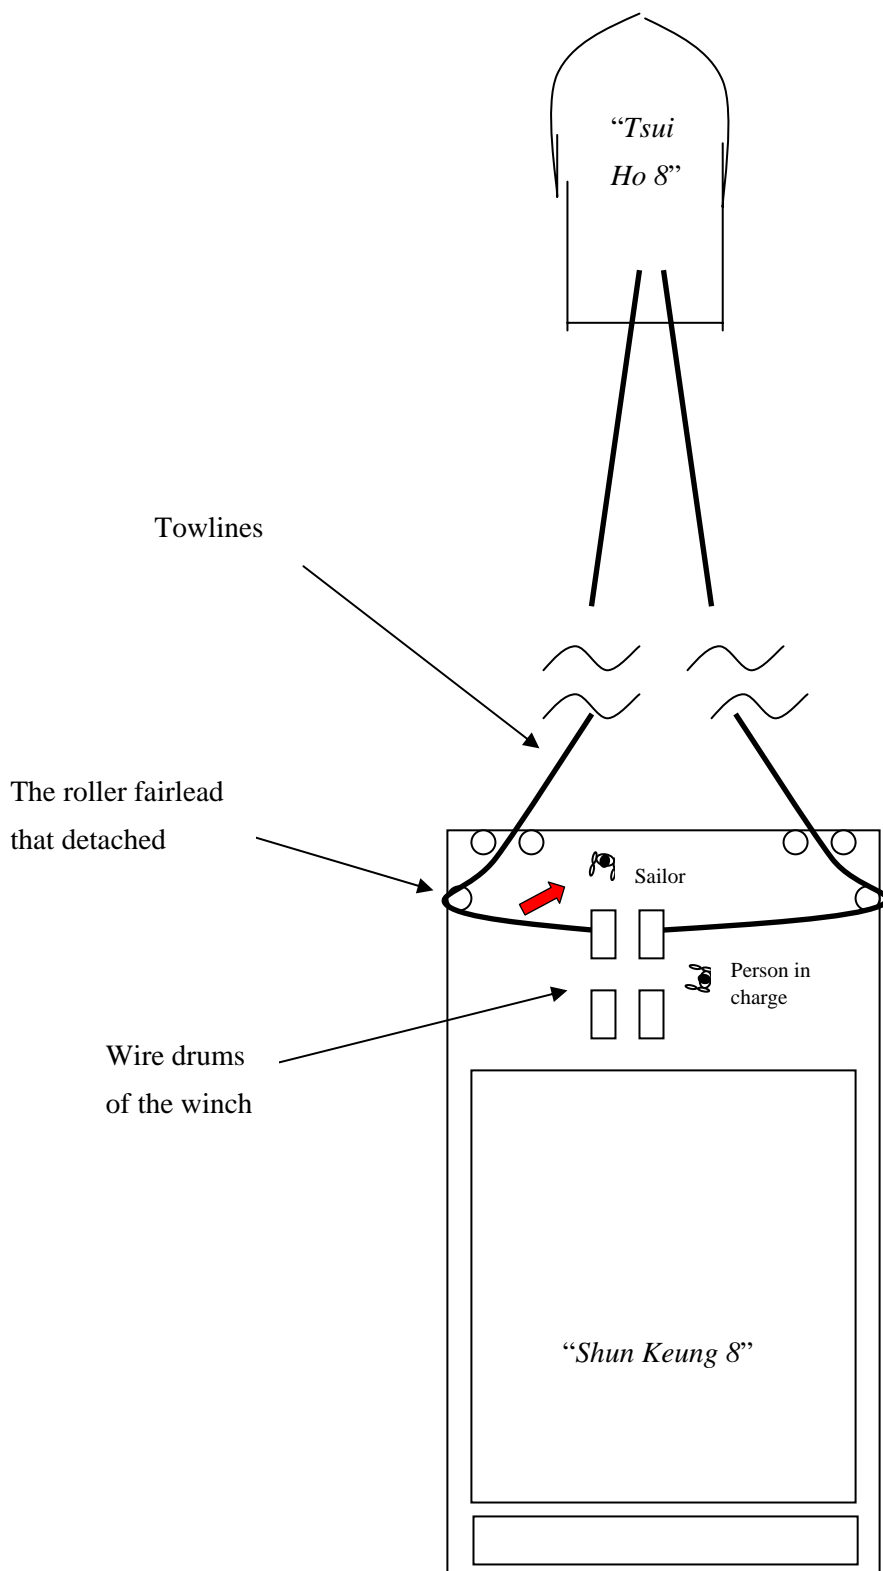
Fig. 4: The Towing Arrangement at the Time of Accident

- 4.7 At about 1100, after the towlines had been paid out about 70 metres in length, the person in charge of the *Lighter* considered that their lengths were appropriate and he applied the brake to stop the winch. One of the sailors approached the winch from port side to manually lock the wire drum of the winch.
- 4.8 Suddenly the fairlead roller at port side detached and dropped into the sea. Consequently the towline at port side sprang towards the winch and hit the sailor (see Fig.4). His right arm was amputated and sent to hospital for medical treatment.

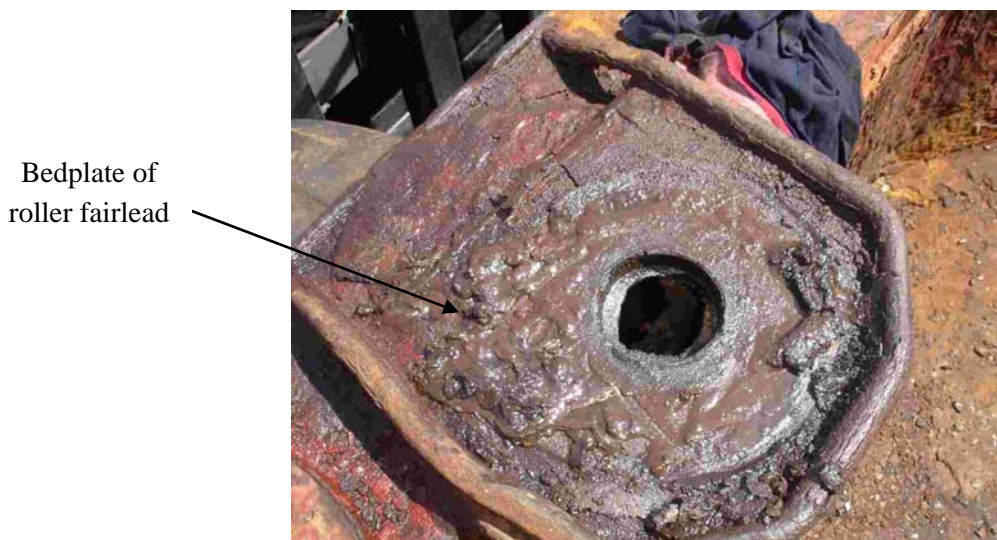
Fig. 5: The Remaining Parts of the Detached Roller Fairlead

- 5.1 After the accident, the detached fairlead roller assembly was lost in the sea. Only the bedplate, which had been welded on the *Lighter's* structure, could be examined for the failure of the fairlead (see Fig.5).
- 5.2 The roller pin was fixed to the bedplate by fusion welding. It was found that the welding did not penetrate and melt into the base metal sufficiently. This had sharply reduced the holding strength of the welds between the roller pin and bedplate and consequently the fairlead could not withstand the large pulling force of the towing rope during towing operation. The welds were sheared off in the incident.

- 5.3 The towlines on the *Lighter* had imposed large stress on the roller fairlead at port and starboard sides. The acute angle that was formed by the towing rope at the subject roller fairlead also made the rope exert greater force than it would be at a smoother leading angle.
- 5.4 The force of the towline under tow should be taken up by the bitts rather than the roller fairleads as the design of fairleads is not intended for such loading.
- 5.5 The breaking strength of the towing rope was about 50 tonnes. At the time of accident, the

tension of each towing rope was estimated to be 11 tonnes. Therefore the side force acting on the detached fairlead by the towing rope would be about 20 tonnes.

- 5.6 No safe working load markings were found on the roller fairleads of the *Lighter*. There was no document to indicate the safe working loads of roller fairleads on the *Lighter* could take on such loading (i.e., 20 tonnes).

- 7.1 The owner and person in charge of the *Lighter* should be informed of the findings of the investigation.
- 7.2 A Marine Department Notice should be issued to draw the attention of all concerned parties to the lessons learnt in this accident and advise them the need to observe the following safety practices in order to prevent the recurrence of similar accidents:
- a) roller fairleads should be properly designed and of good mechanical construction;
 - b) roller fairleads should be properly maintained and periodically inspected;
 - c) during towing, the force on towline should rest on bitts rather than on roller fairleads unless the design of fairleads is intended for such loading; and
 - d) the design of fairleads should be substantially strengthened if the fairleads are intended to take up the force of towlines under tow.
