Report of Investigation
into the Collision between
the Local Open Sampans
P41935T and *P41327K*
off Yim Tin Tsai
on 29 June 2007

The Hong Kong Special Administrative Region
Marine Department
Marine Accident Investigation Section

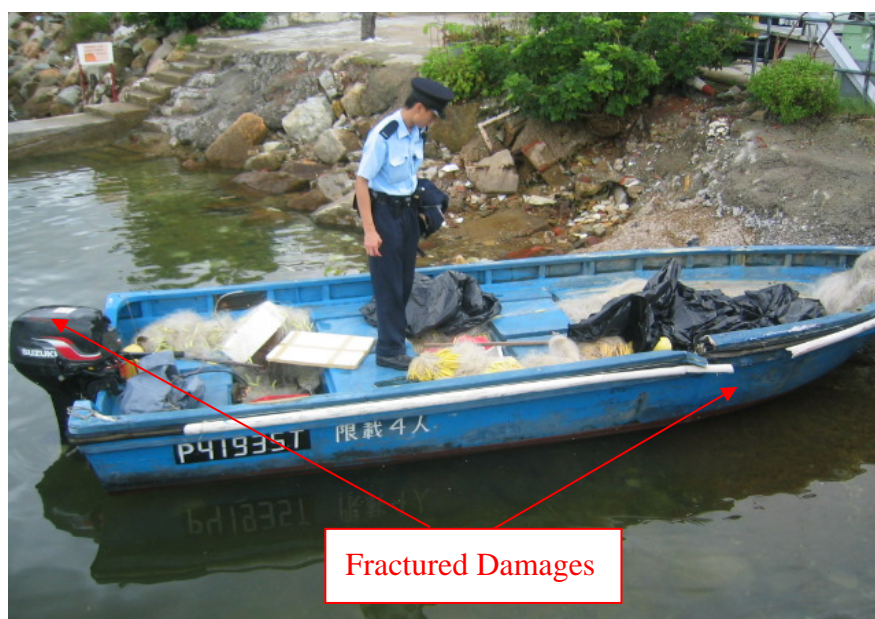
Figure 4 – Photograph showing the fractured damages on *P41935T*

P41935T

Fracture damage with length of about 30 cm on the gunwale on the starboard side at a position almost amidships of the vessel was found. Significant abrasion was found at the damaged areas of the gunwale. The outer side of the gunwale was protected by rubber trimming and white fiberglass. The portion of the rubber trimming at the damaged area of the gunwale was deformed while the white fiberglass was broken with a part missing. The black cover casing of the outboard engine was fractured.

5.7.2 Government Laboratory reported that based on the damages sustained to the gunwale on the starboard side of *P41935T*, *P41327K* could have been heading towards the bow of *P41935T* at an acute angle prior to the collision and subsequently struck the starboards side of the latter vessel.

probably caused by *P41327K* after striking the starboard gunwale of *P41935T*.

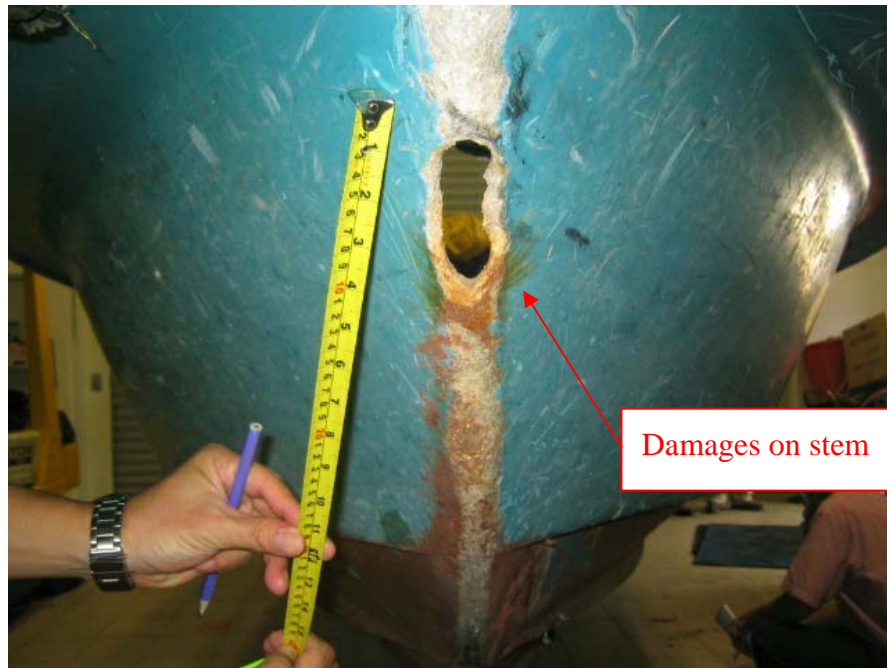
Figure 5 – Photograph showing the damages on *P41327K*

P41327K

A large abrasive damage and a hole in the shape of an irregular slot with length of about 33 cm at the bottom of the stem of the sampan were observed. Sign of abrasion damage to the hull on the port side next to the stem was observed. Physical damage to hull at the abraded area at a vertical distance about 80 cm below the top edge of the hull next to the stem was observed. Another minor physical damaged area was observed at the hull of the port side and immediately next to the bottom of the stem.
