Report of investigation
into the fatal accident of
a stevedore on board
m.v. "Aladdin Dream"
at Western Anchorage No.3
on 7 December 2007

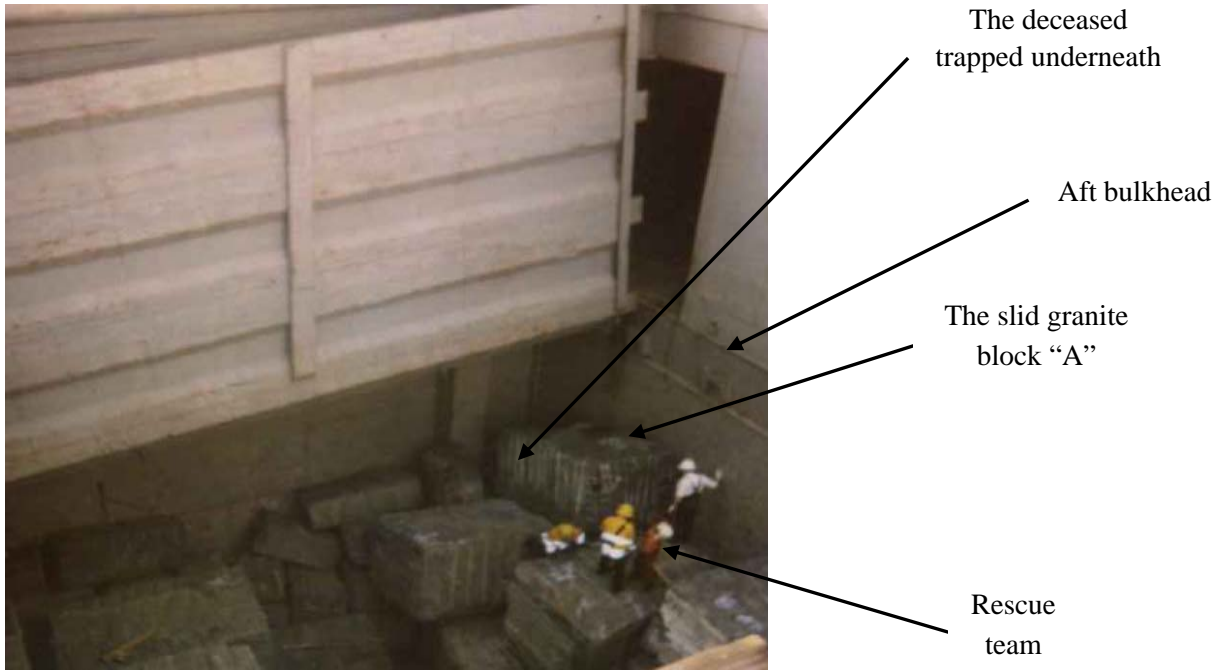
- 4.6 At about 0820, the granite block “A” suddenly started to slide towards starboard side in the hold. The stevedores shouted to escape. Within seconds the granite block crushed the ganger’s head.

- 4.7 Then a stevedore tried to reach him through the space between the granite blocks and found that he was trapped (see Figs.3, 4 & 5). He shouted for help and the Police was informed.

Fig. 3: The Slid Granite Block "A" in No.4 Cargo Hold on "Aladdin Dream"

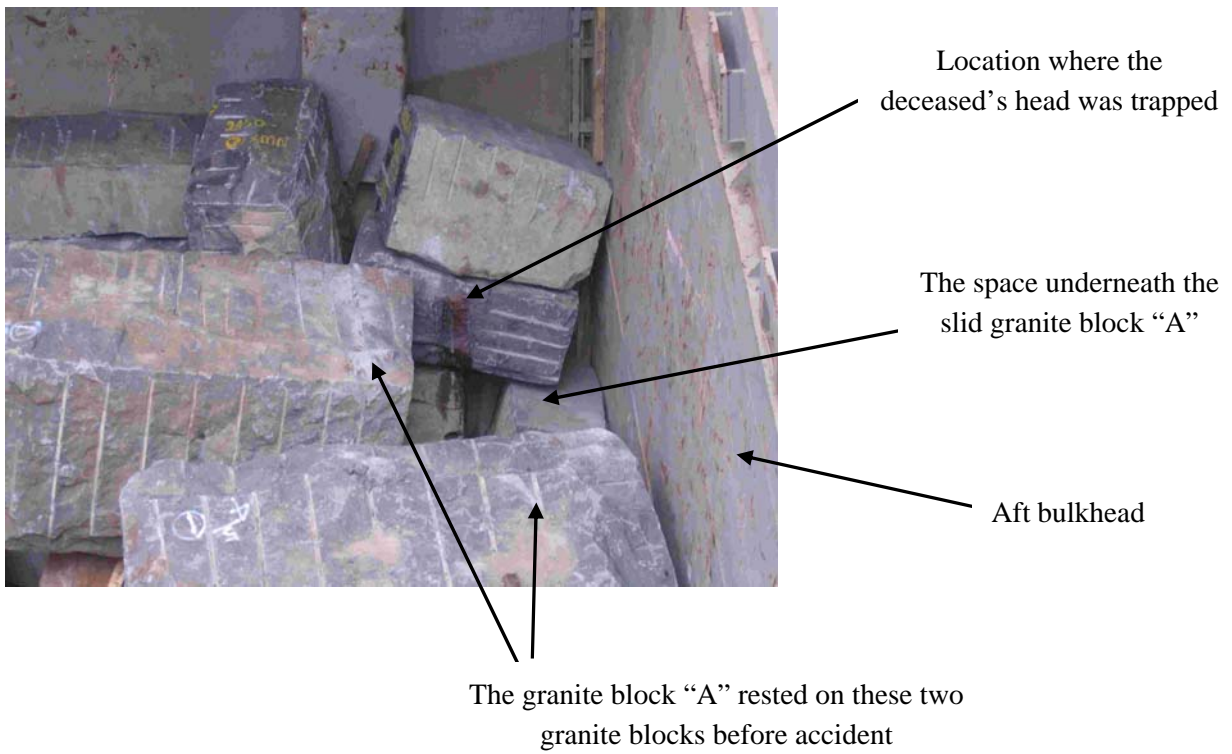
Fig. 4: In No.4 Cargo Hold on "Aladdin Dream" (the Slid Granite Block "A" removed)

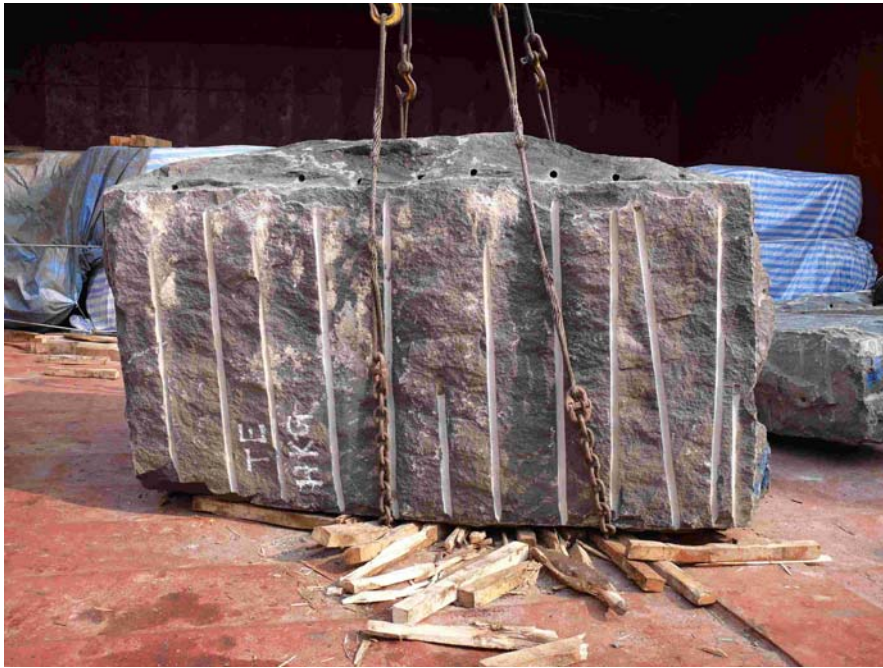
Fig. 5: The Granite Block “A” which Slid in No.4 Cargo Hold on "Aladdin Dream"

- 5.6 The granite blocks in the No.4 cargo hold were not properly stowed in the loading port in India. The blocks were of varying dimensions. Some blocks were not leveled and many were not properly dunnaged and chocked. To facilitate the slinging of granite blocks during unloading, it is a normal practice to provide dunnage during loading cargo at the loading port. To prevent the collapse or shift of stacked granite blocks, it is also a normal practice that the small gaps between the blocks are properly chocked and wedged with timber at the loading port.
- 5.7 The granite block “A” that shifted at the time of accident was rectangular in shape with dimensions of about 3.1 m in length, 1.9 m in width and of height 1.57 m. The weight of the granite block was about 25 tons.

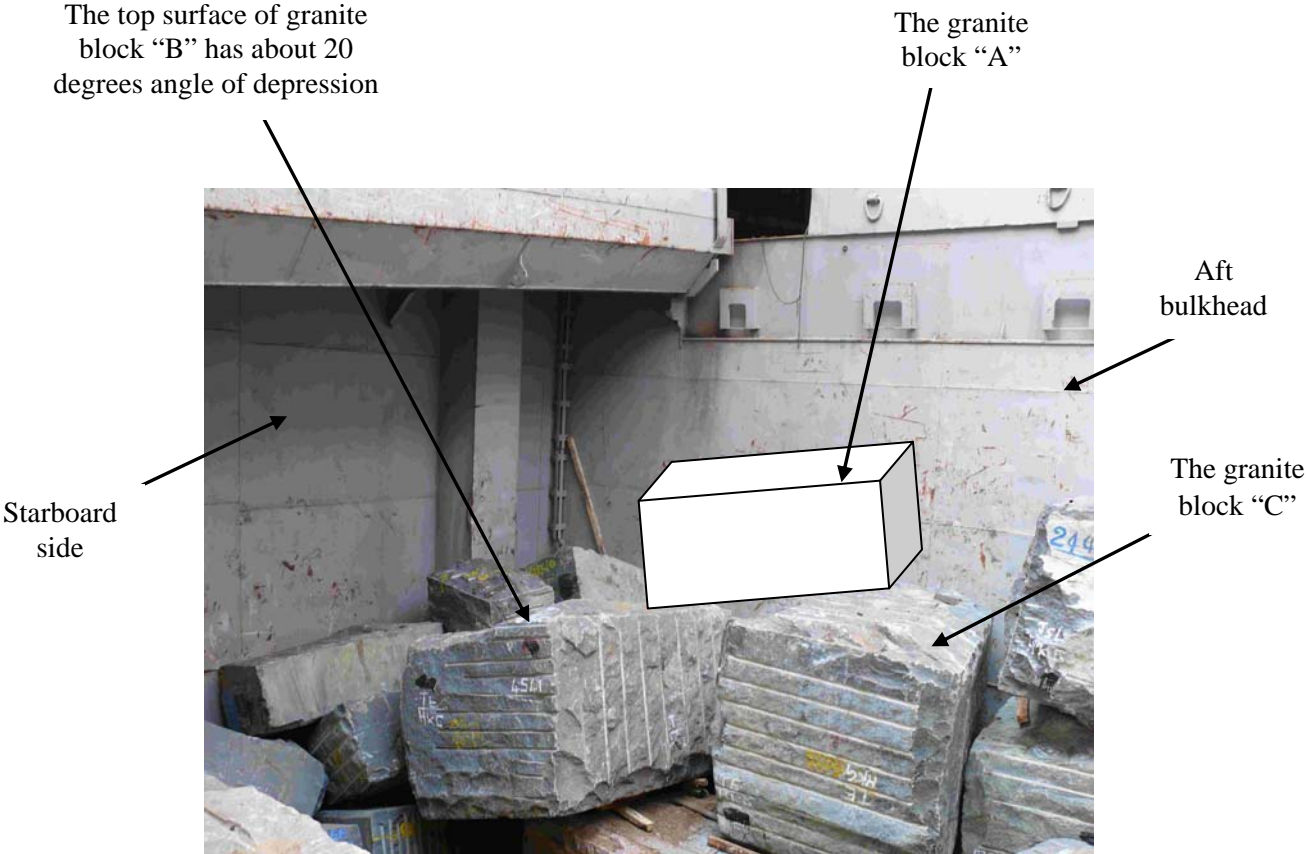
- 5.8 The surfaces of the granite block “A” were rough. There was no dunnage placed underneath the block and it just sat on two other granite blocks (granite block “B” and granite block “C”) near the aft bulkhead (see Fig.6).
- 5.9 The top surface of the granite block “B” was not leveled, with a depression angle of about 20 degrees towards starboard side. Hence before occurrence of the accident, the slid granite block “A” would have probably sat at an angle close to 20 degrees towards starboard side (see Fig.7).

Fig. 6: The Granite Blocks in No.4 Cargo Hold on "Aladdin Dream" (Before Sliding Occurred)

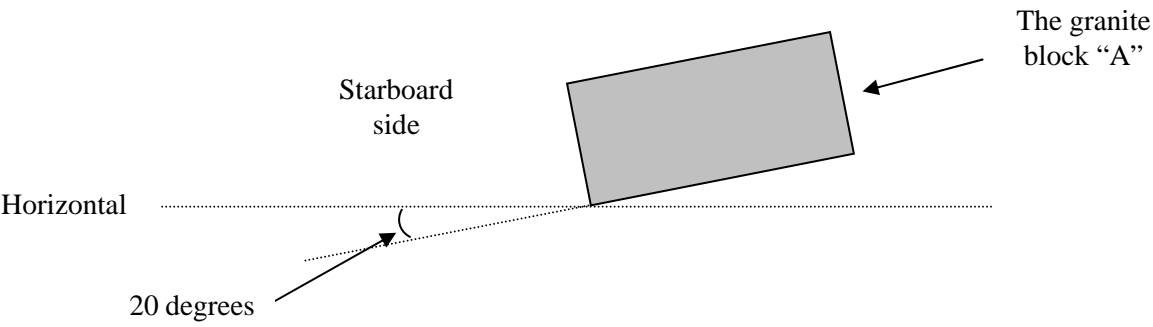
Fig. 7: The Granite Block “A” Sat at a Depression Angle Before Sliding Occurred

5.10 The coefficient of static friction between granite surfaces is about 0.43 and hence the angle of inclination (depression) for a granite block just before sliding occurred would be about 23 degrees. Evidence suggested that the granite block “A” was close to start shifting just before the accident.

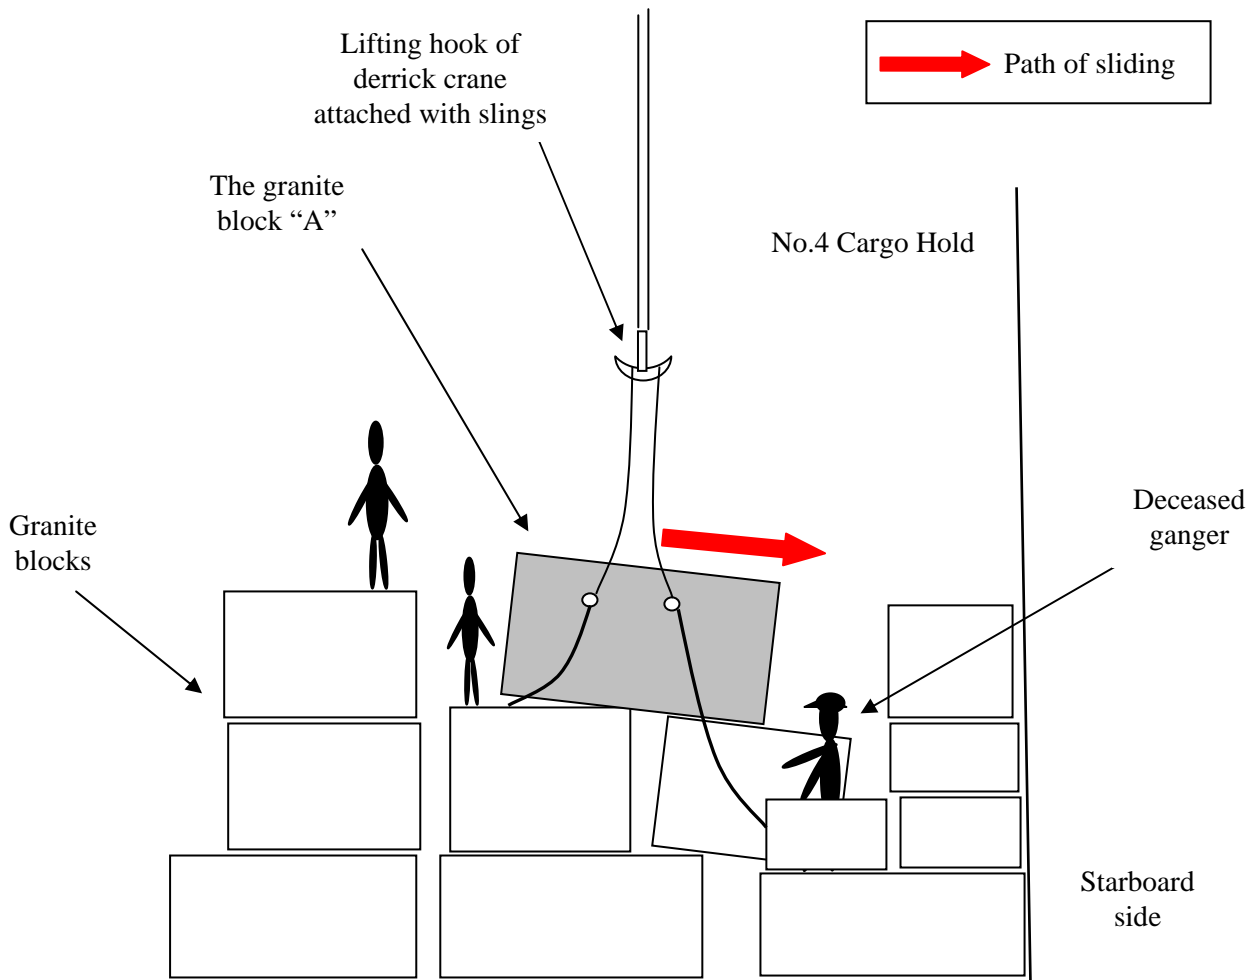
5.11 At the time of accident there was gentle breeze, hence there should be some waves at the sea of Western Anchorage. The *OGV* could be swaying slightly due to the actions of the waves. The swaying motion of *OGV* might trigger the sliding movement (see Fig.8).

Fig. 8: The Granite Block “A” Commenced to Slide in No.4 Cargo Hold on "Aladdin Dream"

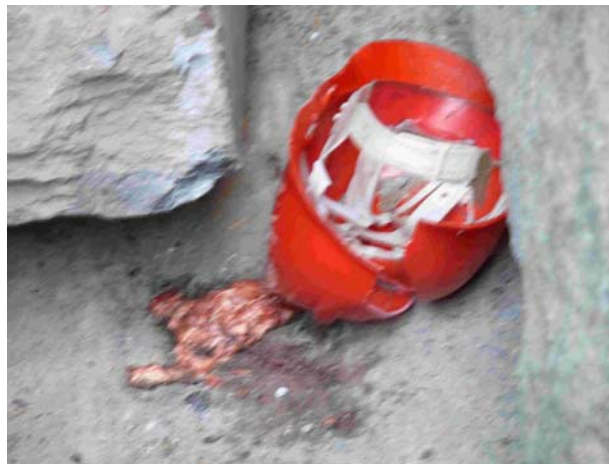
5.13 The deceased had worn a safety helmet at work. The impact force of the granite block “A” was so large that his safety helmet was broken and could not protect his head from injury (see Fig.9).

5.14 According to the autopsy report of the deceased furnished by the Department of Health, the cause of death was head injury.

Fig. 9: The broken safety helmet of the deceased
