Report of Investigation
into the Fatal Accident onboard
“APOLLO LYNUX” in
PYONGTAEK, REPUBLIC OF
KOREA
on 4 March 2008

The Hong Kong Special Administrative Region
Marine Department
Marine Accident Investigation Section

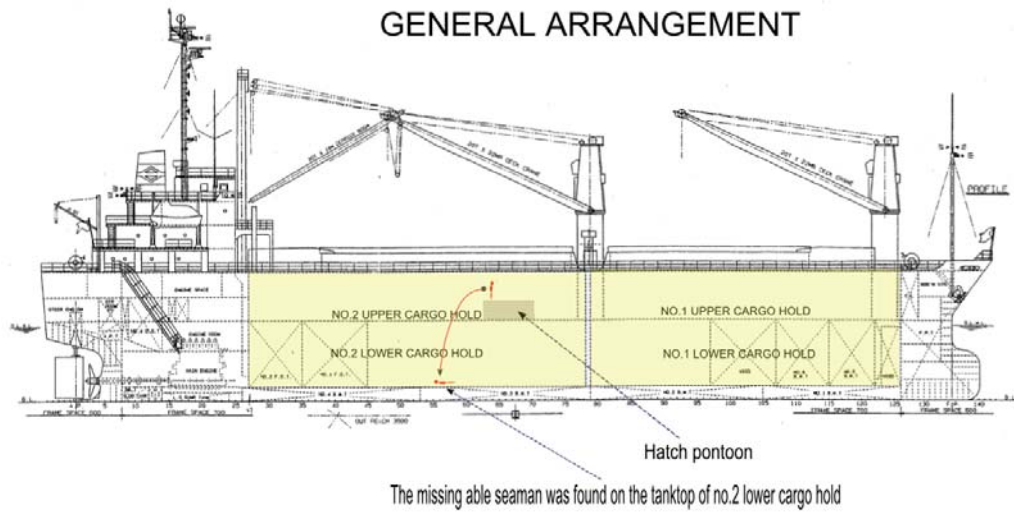
M.V. APOLLO LYNUX GENERAL ARRANGEMENT

- 4.7 At 0325, the body of the missing AB was found on the tank top inside No. 2 cargo hold (see Fig. 3). He suffered multiple injuries with a pool of blood around his head, and there was no sign of breathing and pulse. His body was lifted onto the main deck waiting for rescue.

Fig 3 - The able seaman was found seriously injured on the tank top of No. 2 hold

- 4.9 The cause of death of the AB as stated in his body examination certificate issued by the Korean Hospital was due to serious brain injury resulted from falling down from height.

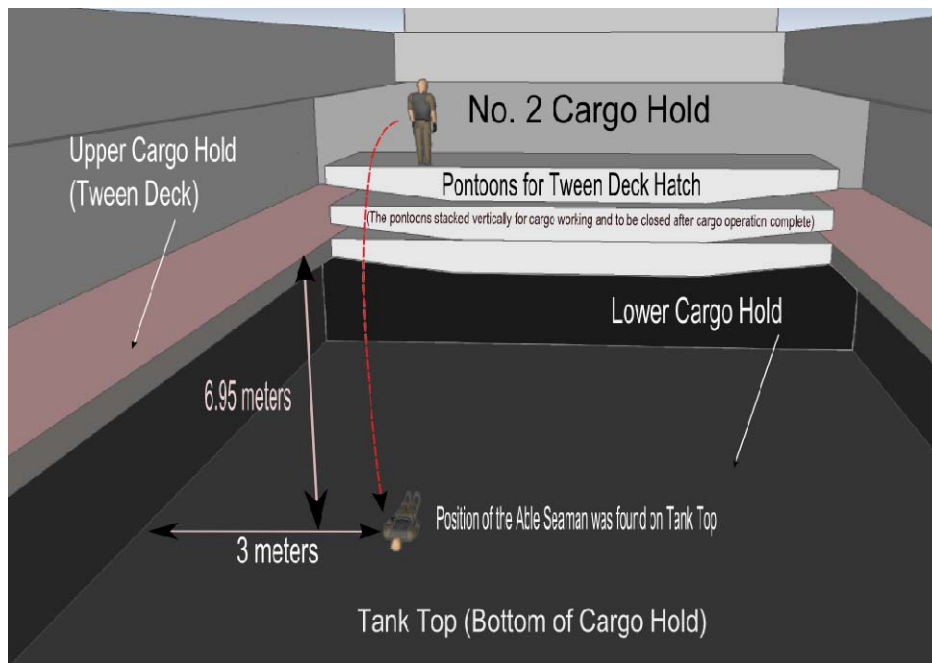
the lighting from tween deck and main deck could not reach the lower part of the hold. After the ship departed from berth, the AB was later found in location about 3 metres from port side vertical plating and midway between forward and after transverse bulkhead of No. 2 hold.

Fig 4 - The location of the Able Seaman was found on the tank top of No. 2 lower cargo hold

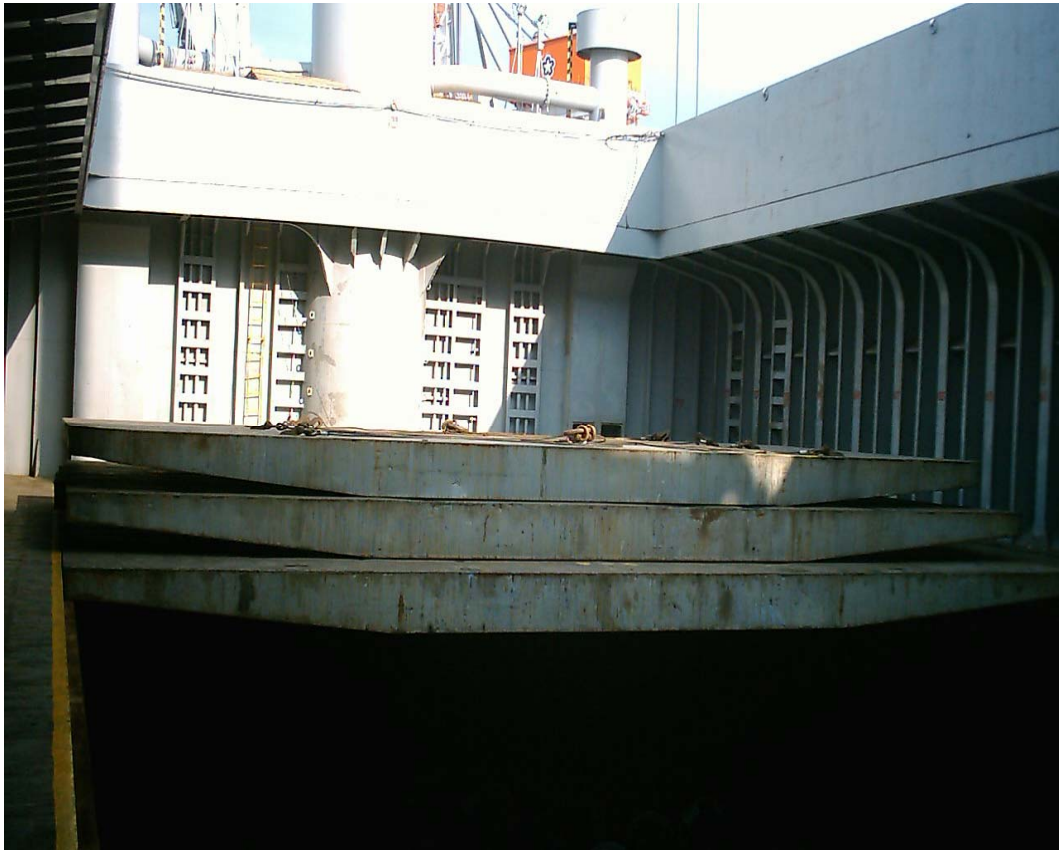
- .4 The pontoon hatch covers for tween deck inside cargo hold were handled by cargo cranes using sling wires (Fig 5). The AB might have gone down into the hold No. 2 alone to prepare the sling wires on top of the stacked pontoon without the knowledge of other crewmembers. No witness saw how the AB had fallen from the tween deck onto the tank top of No. 2 hold.

Fig 5 – The picture shows the stacked pontoons on tween deck of No. 2 cargo hold with the lifting sling wires for lifting by cargo crane

- 6.4 The investigation into the accident revealed the main contributory factors to the accident as follows:
- due to insufficient lightings inside the No.2 cargo hold at night, the AB was unable to see clearly any obstacles, such as the slings, wire rope, etc., lying on top of the pontoon. He might have lost his balance and fallen from the top of the stacked pontoon hatch cover on the tween deck onto the tank top of No. 2 cargo hold while he was preparing the sling wire for closing the hatch cover alone;

- precautionary measures and protection to prevent crew falling from the top of the pontoon are taken when securing the sling wires for hatch opening / closing operation;
