Report of Investigation  
into the fatal accident of  
a grit-blasting & painting worker  
on board floating dock “*United*”  
at West Tsing Yi  
on 13 March 2008

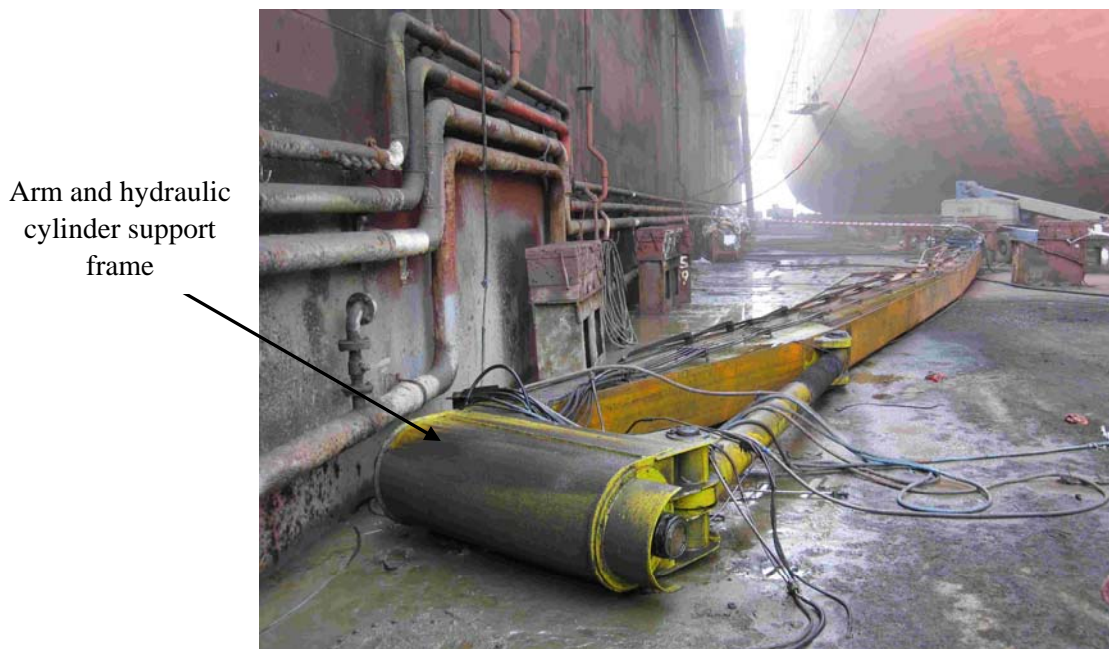
Fig.8: Broken Dock Arm Lying at the Bottom of Floating Dock “United”

- 4.6 The worker on the platform fell together with the arm to the bottom of the *FD* (see Figs.8, 9, 10 & 11).

- 5.1 The fallen arm was found slightly bent and the work platform was distorted (see Figs.8 & 9). The upper coupling of the arm and hydraulic support frame was deformed with both keyways being torn apart (see Figs.12, 13 & 14).

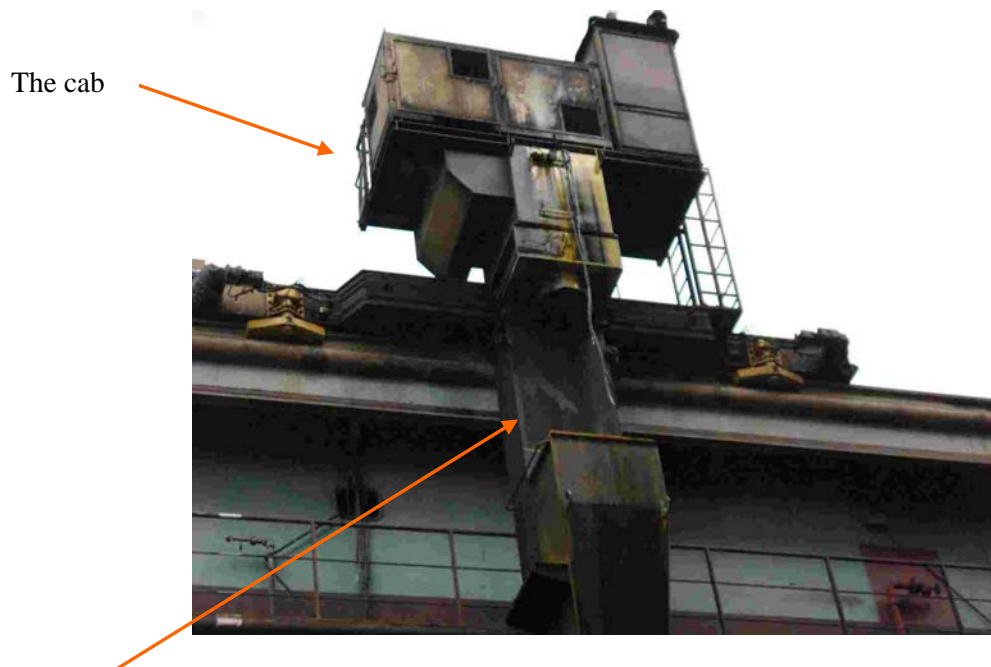
Fig. 10: The Cab of No.2 Dock Arm on board Floating Dock "United"

The cab

The arm had detached from the lower structure

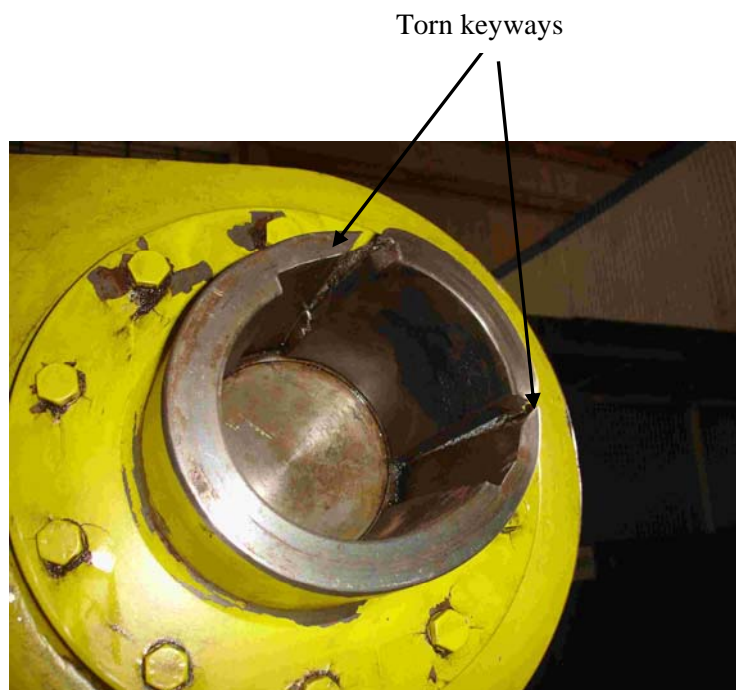
Fig.13: Deformed Upper Coupling with Both Keyways being Torn Apart

- 5.4 The nominal outside diameter of the cylindrical section of the steel upper coupling is about 250 mm. After the accident, it is found that it has been enlarged to a maximum of 285 mm (see Fig.13).
- 5.5 The thickness of metal of the cylindrical section of the coupling is about 35 mm. The depth of each keyway at the coupling is about 12.5 mm. Hence the thickness of metal in way of each keyway is 22.5 mm. The keyway located at the tangent line parallel to the arm (tangent to the cylindrical section of the coupling) (see Fig.20). The keyways would be the stress concentrated areas at the upper coupling and would easily be torn apart when the coupling was under excessive stress.

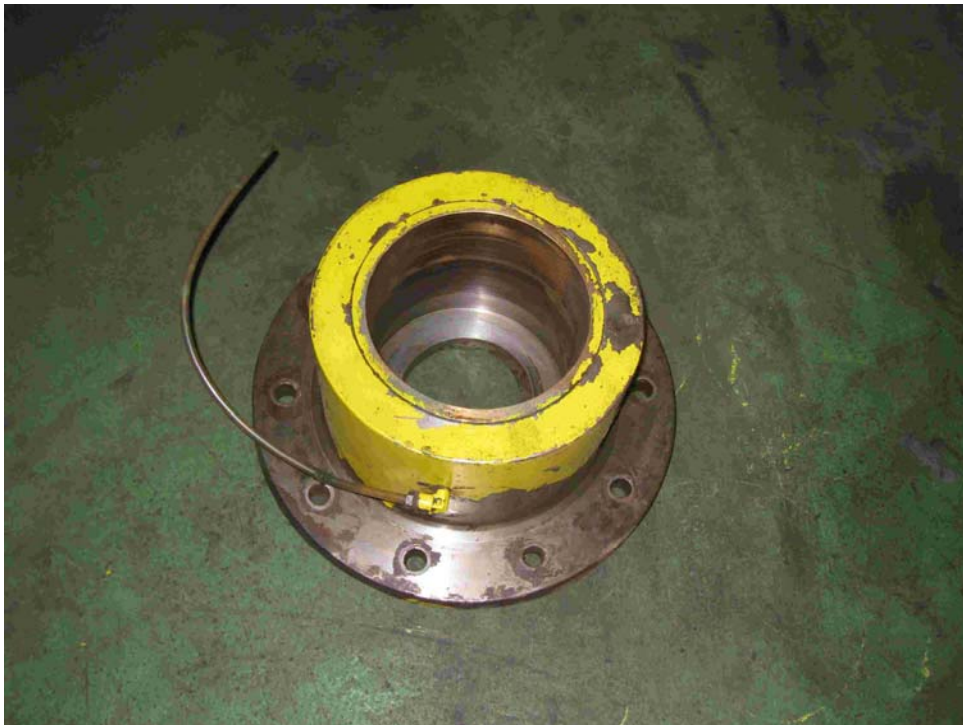
Fig.15: Lower Support Bush for the Arm and Hydraulic Support Frame of No.2 Dock Arm

5.2 The lower support bush for the arm and hydraulic support frame was deformed and detached from the lower structure during the accident. All 10 pieces of M20 steel bolts (diameter of bolts is 20 mm) which fixed the bush onto the lower structure were broken (see Figs.15, 16, 17 & 18).

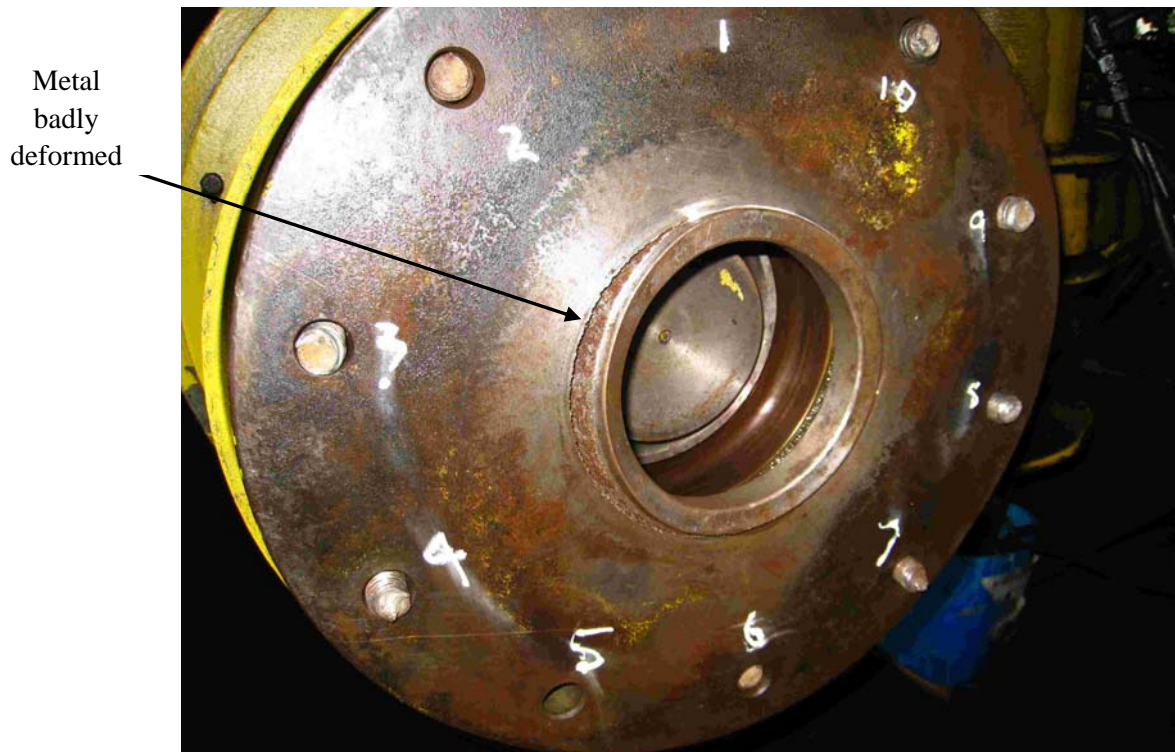
Fig.16: The Bottom Side of the Deformed Flange of Lower Support Bush

- 5.9 The outside diameter of the steel flange of the lower support bush was about 450 mm. Its surface was found bent by about 11 mm. Such deformation might occur before or during the accident. There were no lock washers fitted to the M20 bolts.
- 5.10 On the other hand, it is also probable that at the time of service before the accident, some of the M20 bolts became loosened and the lower support bush shifted aside. The arm and hydraulic support frame would then become misaligned as well as the flange became bent. Such misalignment would impose excessive stress on the flawless upper coupling resulting the failure of the keyways.
- 5.11 After the accident, the upper couplings and lower support bushes of the remaining three dock arms of the *Vessel* were opened up for inspection. No defect had been found.

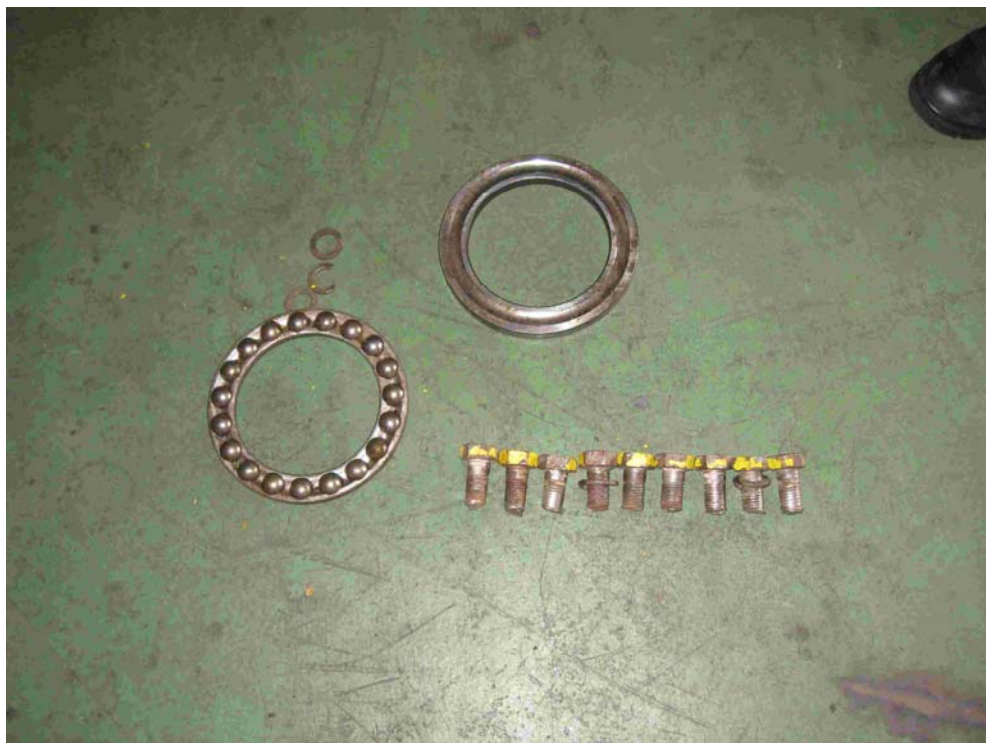
Fig.17: Nine Broken M20 Bolts of the Lower Support Bush and Parts of Thrust Bearing

The lower support bush had been detached from the lower structure

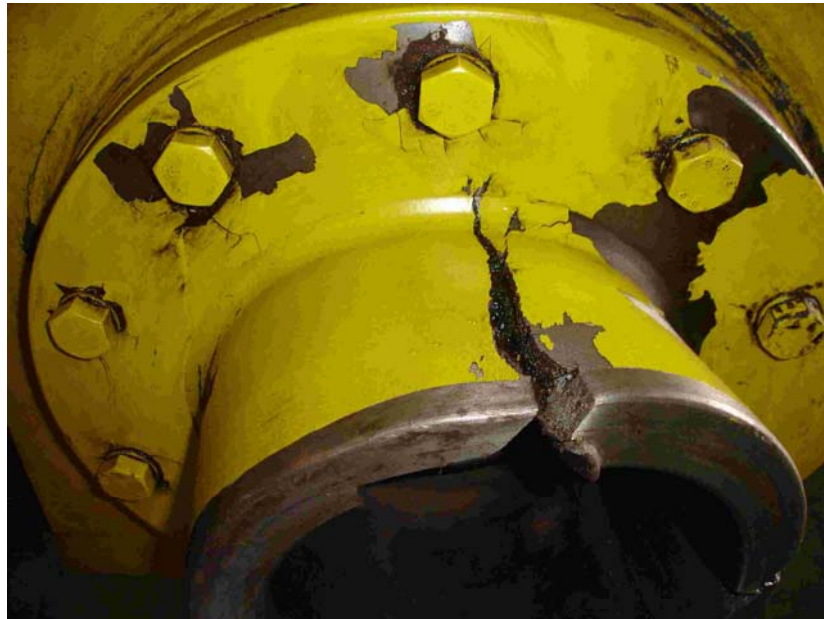
Fig.21: Deformed Upper Coupling with Keyway being Torn Apart

- 5.6 The maximum outreach of the dock arm is 25 metres. At the time of accident the outreach the dock arm was about 22.5 metres, i.e., it was at a position close to maximum stress sustained.
- 5.7 It is probable that tiny cracks had been developed and propagated in the keyway of the upper coupling which in line with the arm at the time of service before the accident. The

cracks developed rapidly at the time of accident leading to the failure of the coupling at the keyways (see Figs. 21 & 22).

- 5.17 Had the upper coupling and lower support bush of the dock arm been thoroughly examined (i.e., open-up inspected) before the accident, any cracks developed in the keyways or any loosened bolts could have been found and remedied, and thus the accident could have been prevented.

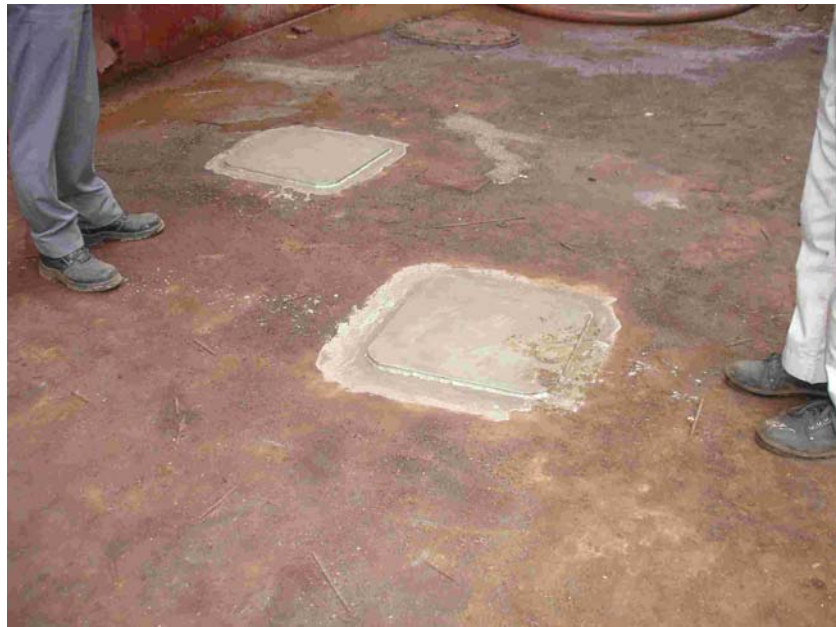
- 5.12 The falling of the No.2 dock arm had also caused two small holes on the bottom steel plates of *FD* (see Fig.23).

Fig.23: Two Holes were Repaired by Doublers on the Bottom Plate of Floating Dock “*United*”
