Report of Investigation
into the fatal accident
caused by turning propeller of
a local pleasure vessel
Crescent Island
at Port Island
on 27 July 2008

The Hong Kong Special Administrative Region
Marine Department
Marine Accident Investigation Section

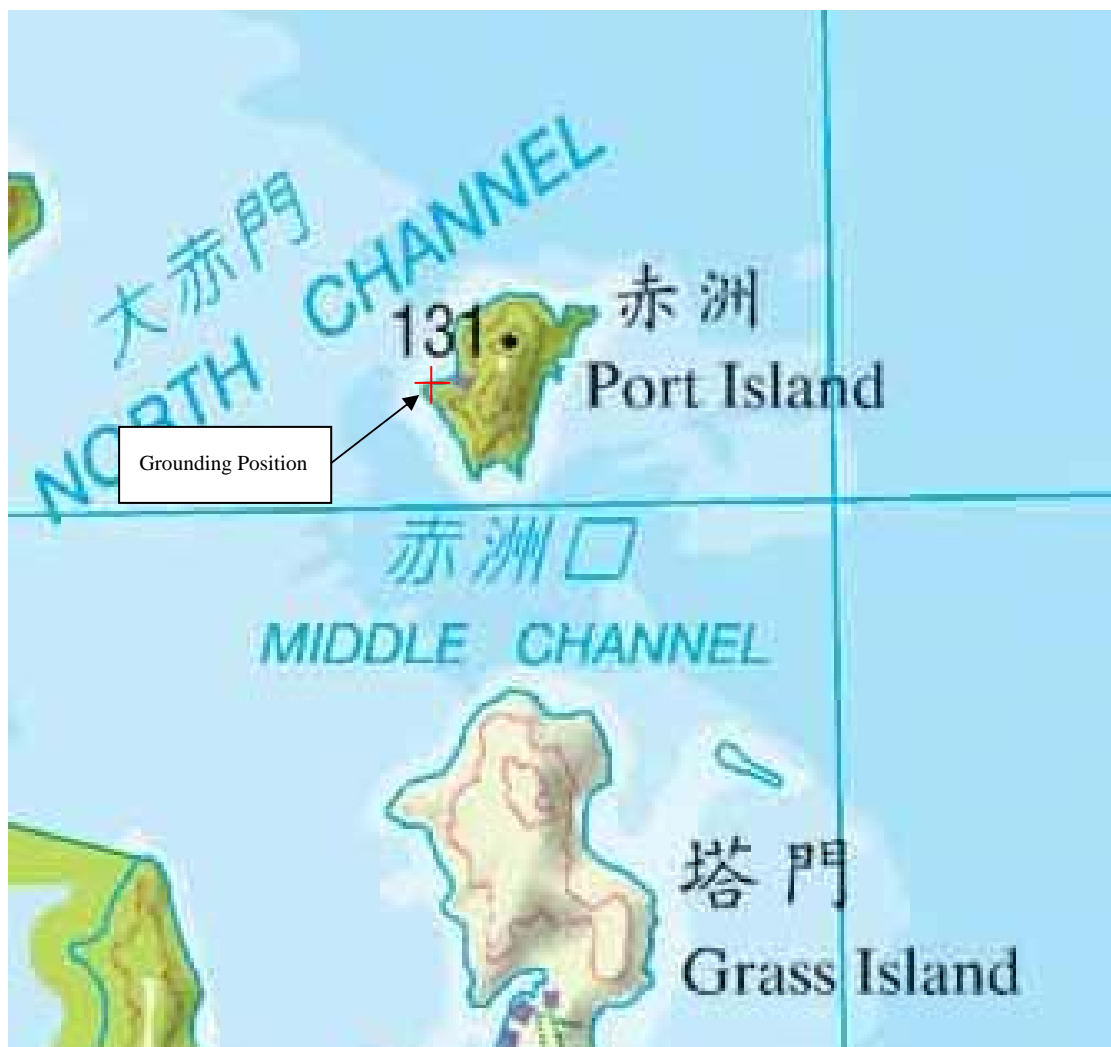
Figure 1 – Grounding position of *Crescent Island*

- 4.4 At about 1430 *Crescent Island* had dragged anchor under the action of strong wind and grounded on a rocky beach at Port Island. Fearing that the Vessel might capsize due to grounding, the Master engaged the astern engine for 5 minutes trying to clear the Vessel from grounding. The Master stopped the engine after failing to clear the Vessel and then used the rubber dinghy on the port side trying to push the Vessel to clear from the beach but in vain. Later he re-engaged the astern engine again trying to clear the Vessel from grounding.

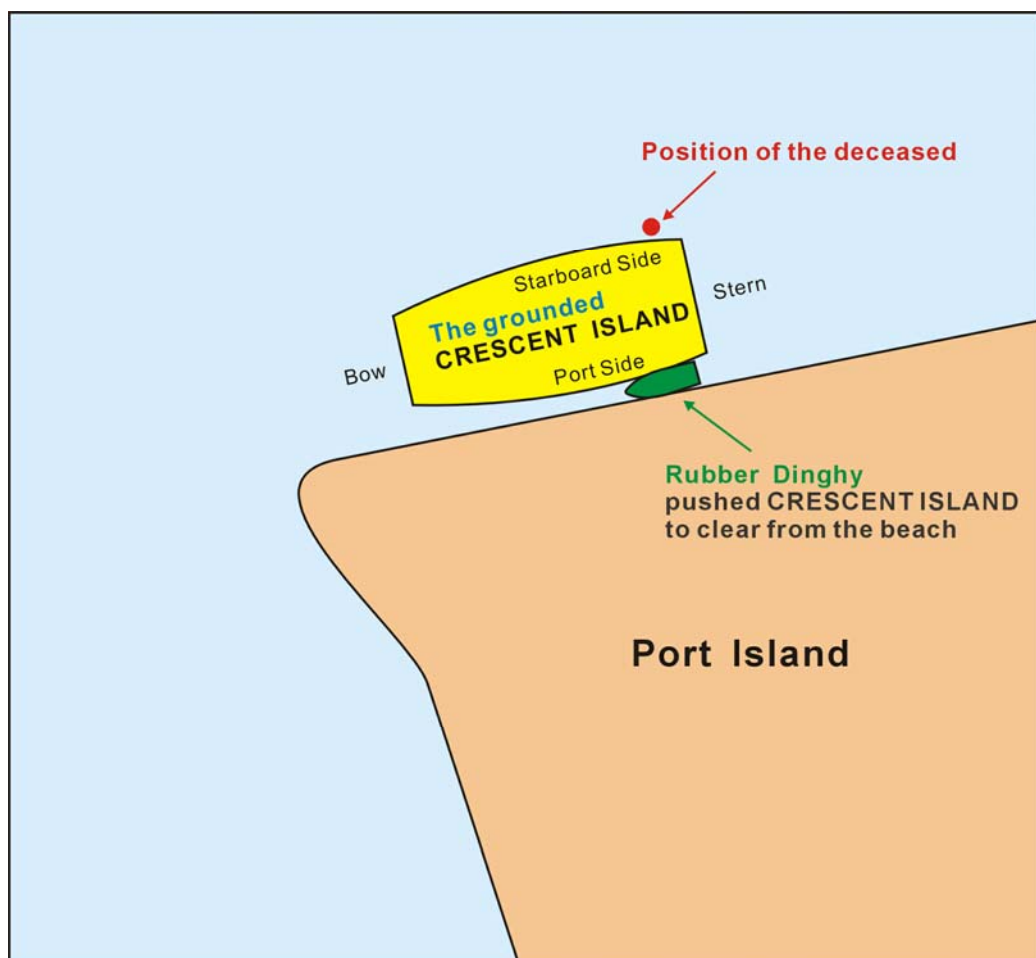
Figure 3 – Diagram showing the position of the deceased before accident

5.4.1 The direct cause of death as given in the Autopsy Report was due to multiple injuries. It is believed that the multiple injuries were caused by the turning propeller of *Crescent Island*. Before boarding *Crescent Island*, some divers saw that the deceased was pushed by the waves towards the stern of the Vessel and then disappeared. Figure 3 indicates the approximate location of the deceased in the water before she was dragged towards the propeller. The rags of the diving suit of the deceased and a piece of rope were found entangled with the propeller after the vessel was docked in a small shipyard (Figure 4).

- 6.1 The accident occurred at about 1500 on 27 July 2008 on a rocky beach of Port Island.
- 6.2 At the time of the accident, the weather was squally with strong wind and heavy rain and a rough sea.
- 6.3 A diver was drawn towards and killed instantly by the turning propeller of *Crescent Island* which had grounded on a rocky beach of Port Island when the accident occurred.
- 6.4 The cause of this fatal accident was due to engagement of astern engine by the Master of *Crescent Island* who tried to clear the Vessel from grounding. However, in manoeuvring the engines, he did not realize that the deceased was in the water waiting to board the Vessel near the stern. As a result the deceased was drawn towards the propeller and killed.

- 7.1 A copy of this report is to be sent to the Master and company of *Crescent Island* drawing their attention on the findings of the investigation. The Company should issue guidelines to the masters warning them not to operate the engine unless they are absolutely sure after checking by himself or by a lookout that there are no divers in close proximity to their vessels. A good communication must be established between the Master and the lookout if posted.
- 7.2 A Marine Department Notice should be issued to advise the public of taking all necessary safety precautions when engaged in diving activities.
