Report of investigation
into the suspected falling
overboard of Deck Cadet from the
Hong Kong Registered Bulk Carrier
"Federal Rideau" in positions
between $40^{\circ} 37.8' N$ $019^{\circ} 01.9' W$
and $40^{\circ} 33.3' N$ $019^{\circ} 08.8' W$
on 5 August 2008

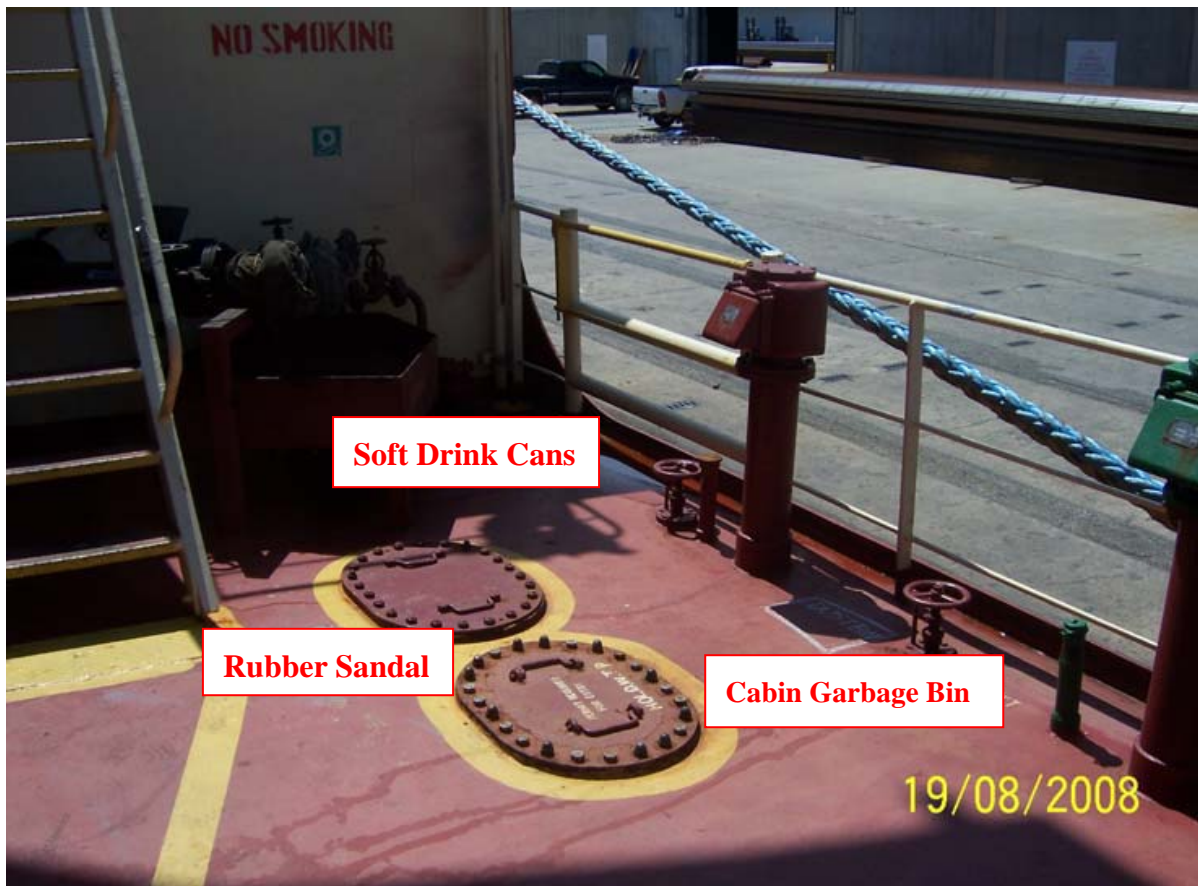
Figure 2 – Diagram showing the locations of soft drink cans, rubber sandal and cabin garbage bin on the main deck

4.7 The crew members took the tea break from 1500 to 1530 and after returning from tea break at 1530, the Bosun found that the weathertight door leading to the main deck on the port side was opened. He saw some soft drink cans littered on the main deck just outside the weathertight door and he instructed one AB to clean it up. While the AB was cleaning up the soft drink cans, he observed a rubber sandal and a cabin's garbage bin were also at the location (Figure 2). He threw the rubber sandal overboard and brought the garbage bin inside the accommodation and informed the Bosun. The weathertight door was closed afterward. However, they had not reported to the navigational watchkeeping officer on the bridge or to any other crewmembers on board about that matter.

- 4.9 At 1840, the Second Officer reported to the Master that he and the deck crew were unable to find the Deck Cadet. At 1845, the Master ordered all crew to muster in the deck office where he instructed search parties to look for the Deck Cadet. At this stage, the Master was informed by the Bosun that he had earlier found the weathertight door leading to the main deck on the port side was opened and soft drink cans, a sandal and a garbage bin were found on the main deck outside the weathertight door.

- 5.5 Although the Bosun and the AB had found that the weathertight door leading to the main deck on the port side was open and that soft drink cans, a rubber sandal and a garbage bin were in the area, they were not alerted by the unusual scene. Therefore,

they had not reported to the navigational watchkeeping officer on the bridge nor talked about it among crewmembers.
