Report of investigation  
into the falling overboard of  
Seaman I from the Hong Kong  
Registered Car Carrier  
*“Hua Xing”* off Ulsan  
on 4 September 2008

The Hong Kong Special Administrative Region  
Marine Department  
Marine Accident Investigation Section

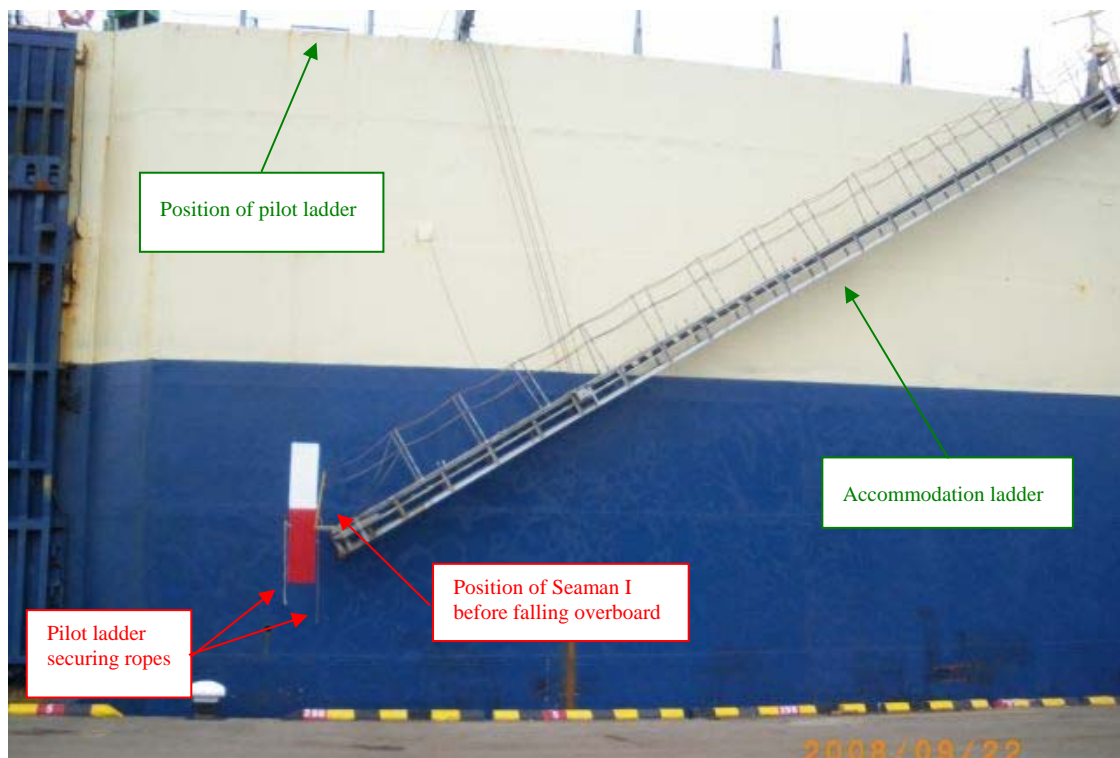
Figure 2 – Diagram showing the position of the Seaman I

4.1 At about 1806 on 4 September 2008, the Hong Kong registered car carrier *HUA XING (the Vessel)* departed from Ulsan, Korea to Senboku, Japan. After the Pilot disembarked at 1836, three crew members including the Bosun, a Seaman I and a Seaman II were ordered to recover the pilot ladder at 1846. Seaman I was arranged to take off the pilot ladder securing rope at the bottom platform of the accommodation ladder (Figure 2).

- 6.1 At about 1849 on 4 September 2008, while the vessel *HUA XING (the Vessel)* was leaving Ulsan in approximate position at 35° 26.5' N 129° 24.0' E, the Seaman I fell overboard while he was engaged in recovering the pilot ladder at the bottom platform of the accommodation ladder on the starboard side of the vessel.

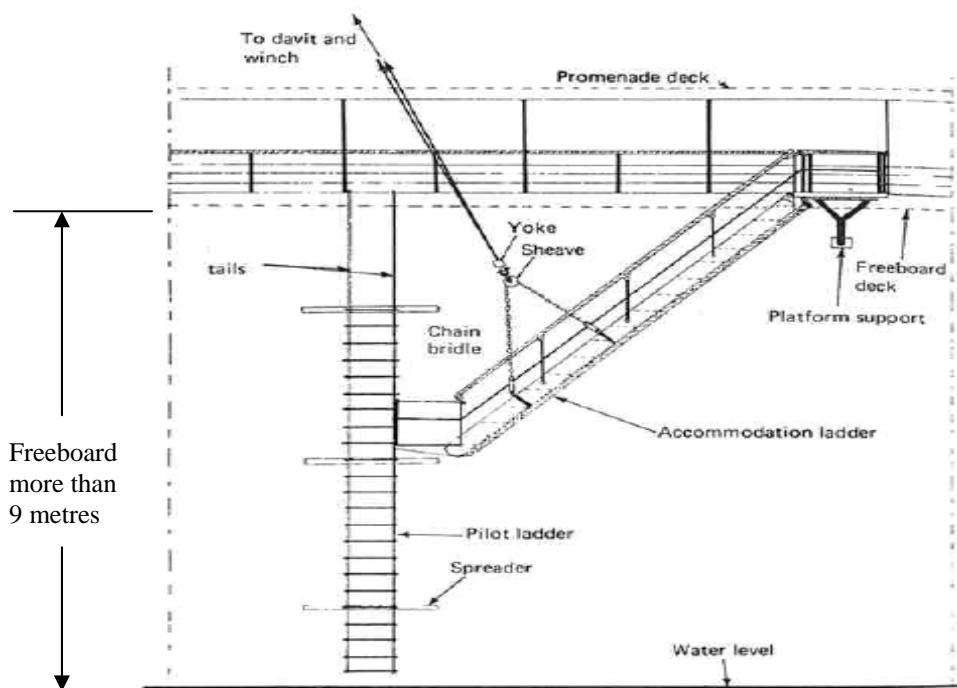
Figure 3 – Combination ladder arrangement for pilot transfer

- 5.3 Under Regulation 23 of Chapter V of the International Convention on Safety of Life at Sea, if the freeboard of a vessel is more than 9 metres, an accommodation ladder in conjunction with the pilot ladder shall be provided for safe and convenient access to and egress from the ship for the pilot. At the time of accident, the freeboard of the *Vessel* was 19.95 metres and the above pilot transfer arrangement was required. Figure 3 illustrates the required rigging arrangement.
