Report of Investigation
into the fatal accident of
a lighterman on board
local dumb steel lighter “*Pak Lee*”
at Stonecutters Island
Public Cargo Working Area
on 13 January 2009

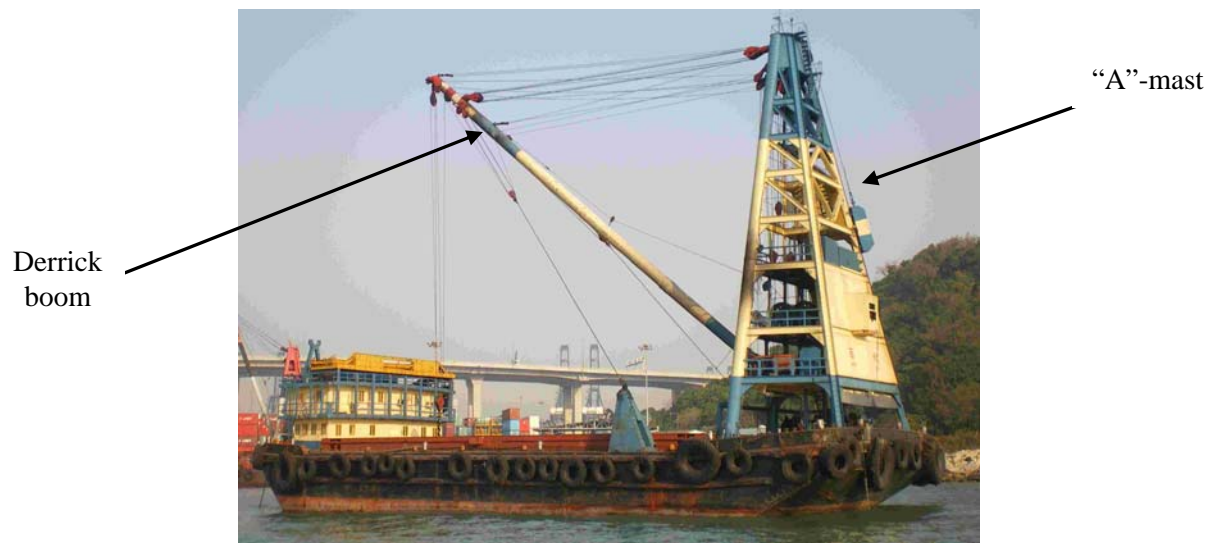
Fig. 1: Dumb Steel Lighter “*Pak Lee*”

2.2 “*Pak Lee*” (the “*DSL*”) (see Fig.1), is a locally licensed dumb steel lighter. The *DSL* is fitted with a derrick crane with safe working load ranging from 10 to 60 tons to facilitate cargo handling operations. The derrick crane is rigged to the “*A*”-mast located at the forward of the *DSL*.

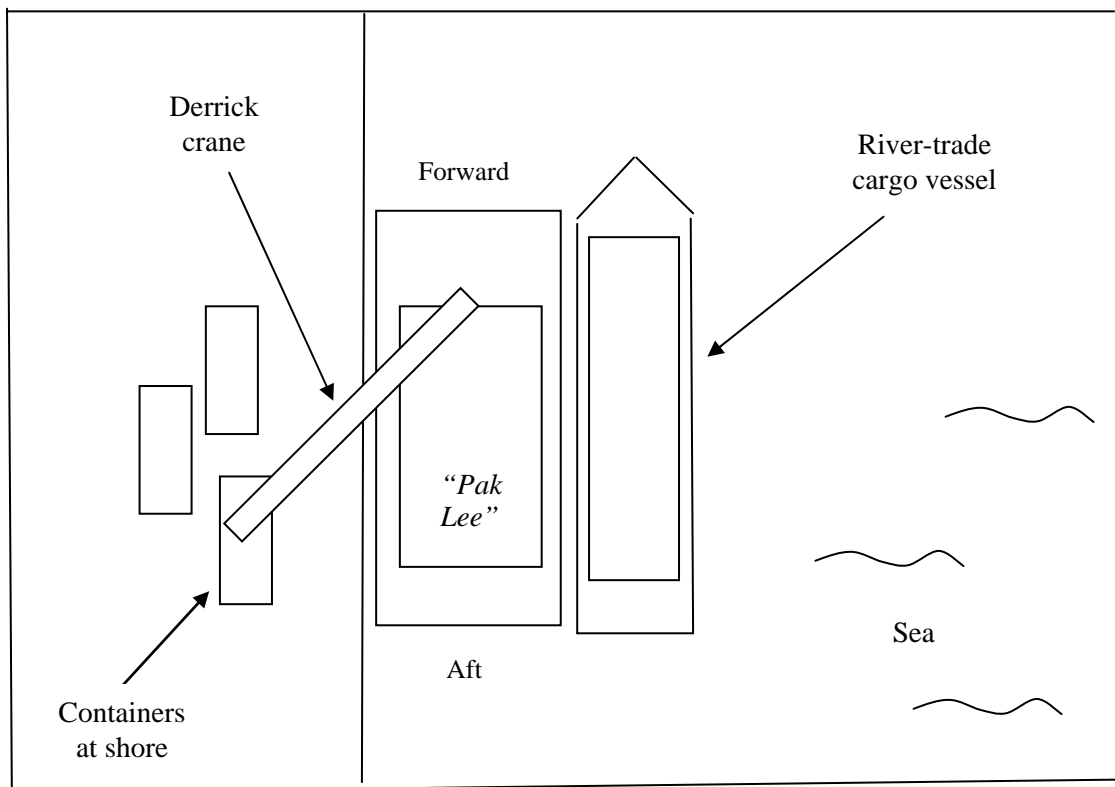
Fig. 2: "Pak Lee" at berth

- 4.1 On the evening of 13 January 2009, the *DSL* was towed by a tugboat from Yau Ma Tei Typhoon Shelter to Stonecutters Island and at about 2000, she was berthed at the Stonecutters Island Public Cargo Working Area.
- 4.2 After that, a Chinese-registered river-trade cargo vessel was moored to the starboard side of the *DSL*. Containers were loaded to the cargo vessel from shore by using the derrick crane of the *DSL* (see Fig.2).

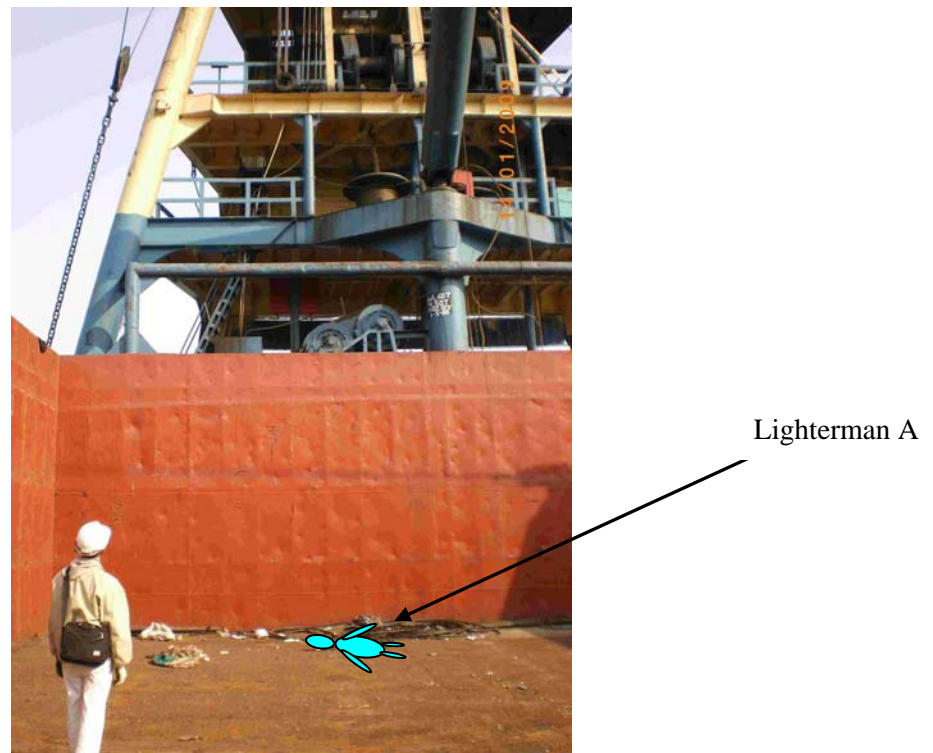
Fig. 4: Lighterman A lying on the cargo hold of “Pak Lee”

- 4.3 There were three crewmembers working on board the *DSL*. One of them was the person in charge (PIC) who was also the crane operator and operating the derrick crane in the control station on the 5th level of the "A"-mast. The other two were the Lighterman A and Lighterman B who were making splices to wire ropes on the main deck at the forward of the *DSL* (see Fig.3).
- 4.4 At about 2110, while a 40-foot laden container was transferred from the shore across the cargo hold of the *DSL*, the PIC heard a pounding noise from the cargo hold of the *DSL*. He saw Lighterman A lying on the tank top of the empty cargo hold (see Fig. 4).

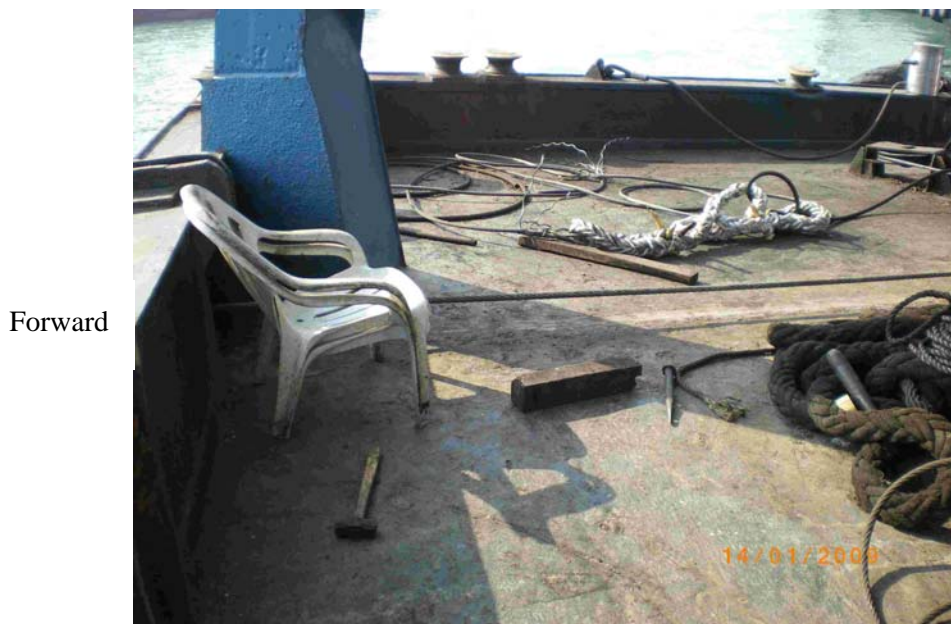
Fig. 5: Location of the deceased working on board “*Pak Lee*” before the accident

- 5.6 Prior to the accident, the PIC was operating the derrick crane in the control station on the 5th level of the “A”-mast. The deceased and Lighterman B were making splices to wire ropes on the main deck at the forward of the *DSL* (i.e., on the 1st level of the “A”-mast, see Fig.5). As the three of them worked separately, neither the PIC nor Lighterman B knew where the deceased was and what he was doing. Also, neither the crewmembers onboard the Chinese-registered cargo vessel nor the staff working ashore saw the deceased at the time of the accident.

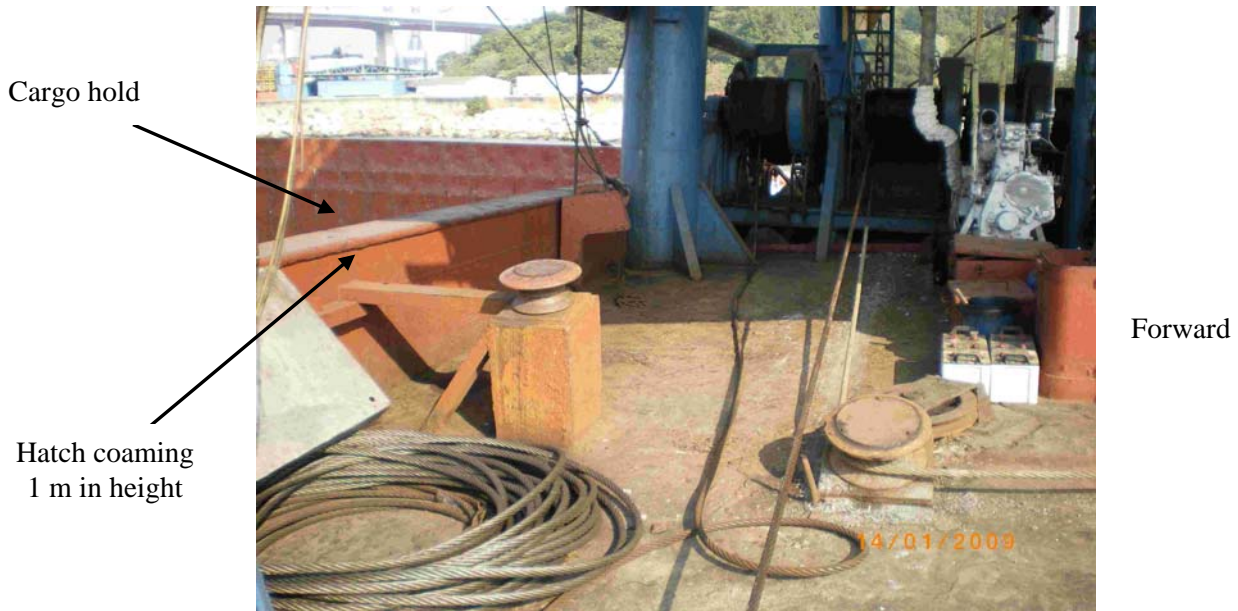
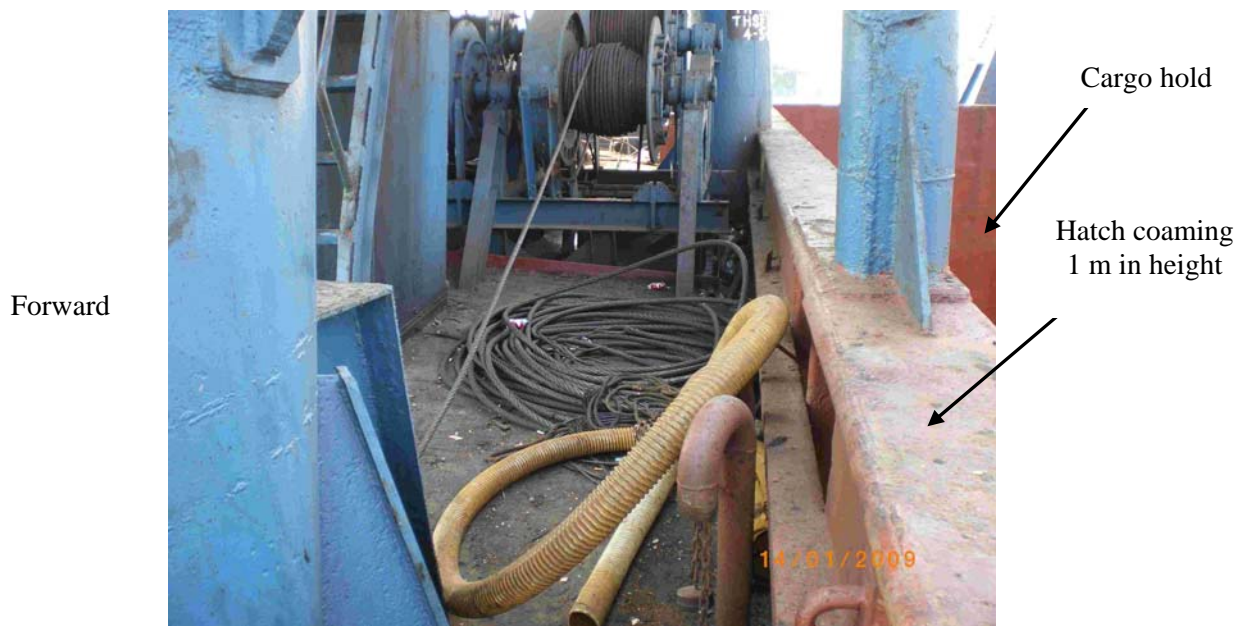
- 5.7 The height of the hatch coaming for the cargo hold of the *DSL* was about 1 metre (see Fig. 6 and Fig. 7).
- 5.8 On the 2nd level of the “A”-mast, there was an opening facing the cargo hold (see Fig. 8). The height from the tank top of the cargo hold to the 2nd level was about 7 metres. There was a reel of new wire ropes placed close to that opening. Two steel chains were provided as guard to the opening. However, the chains were unlashed at the time of the

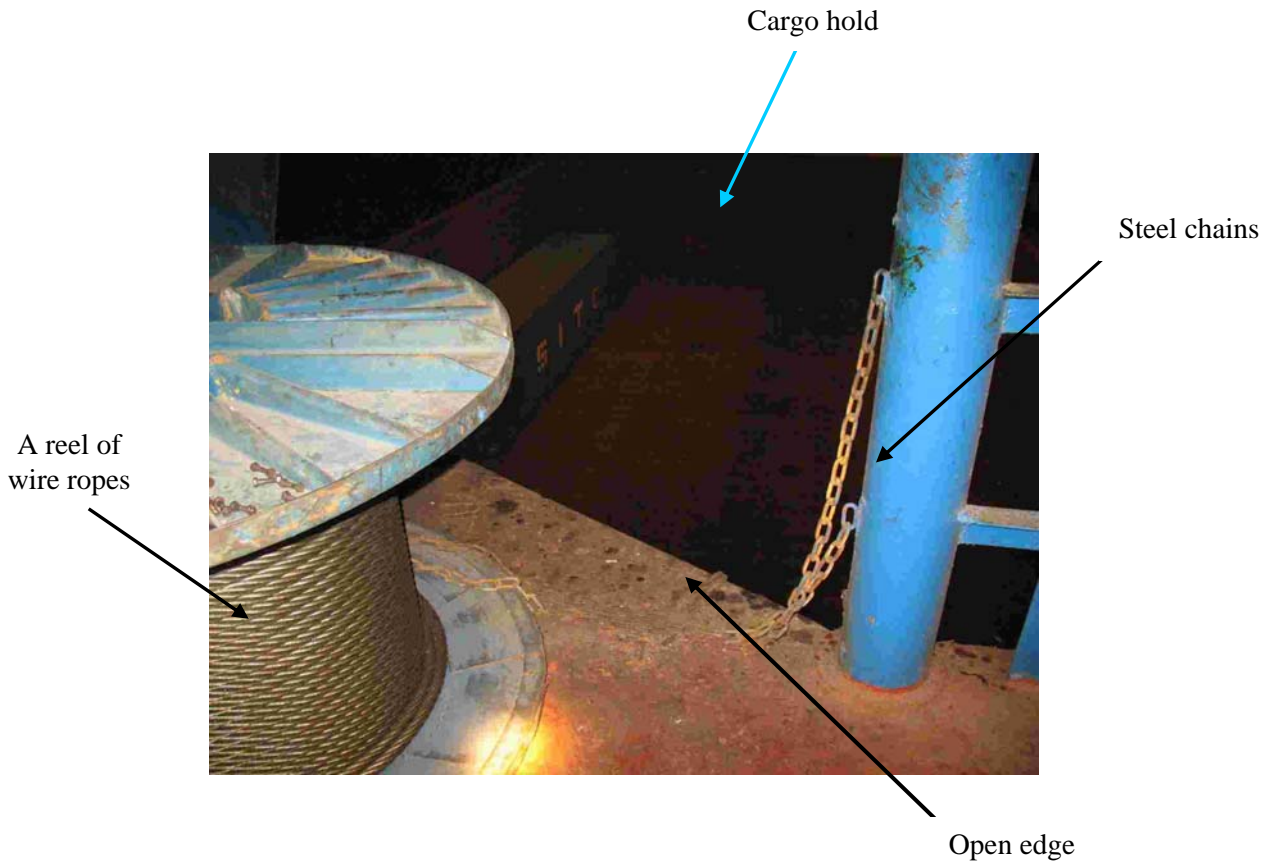
Fig. 8: Open edge on the 2nd level of the “A”-mast on “Pak Lee”

accident.

- 5.11 The deceased was wearing a pair of sport shoes at work. Oil stains were found on the soles. Oil stains were also found on the floors of the 2nd level to the 5th level of the “A”-mast.

- 5.19 The open edge on the 2nd level of the “A”-mast should be securely fenced and the fence should be maintained in good condition. The steel chains provided to fence the open edge should not be unlashed without valid reason.

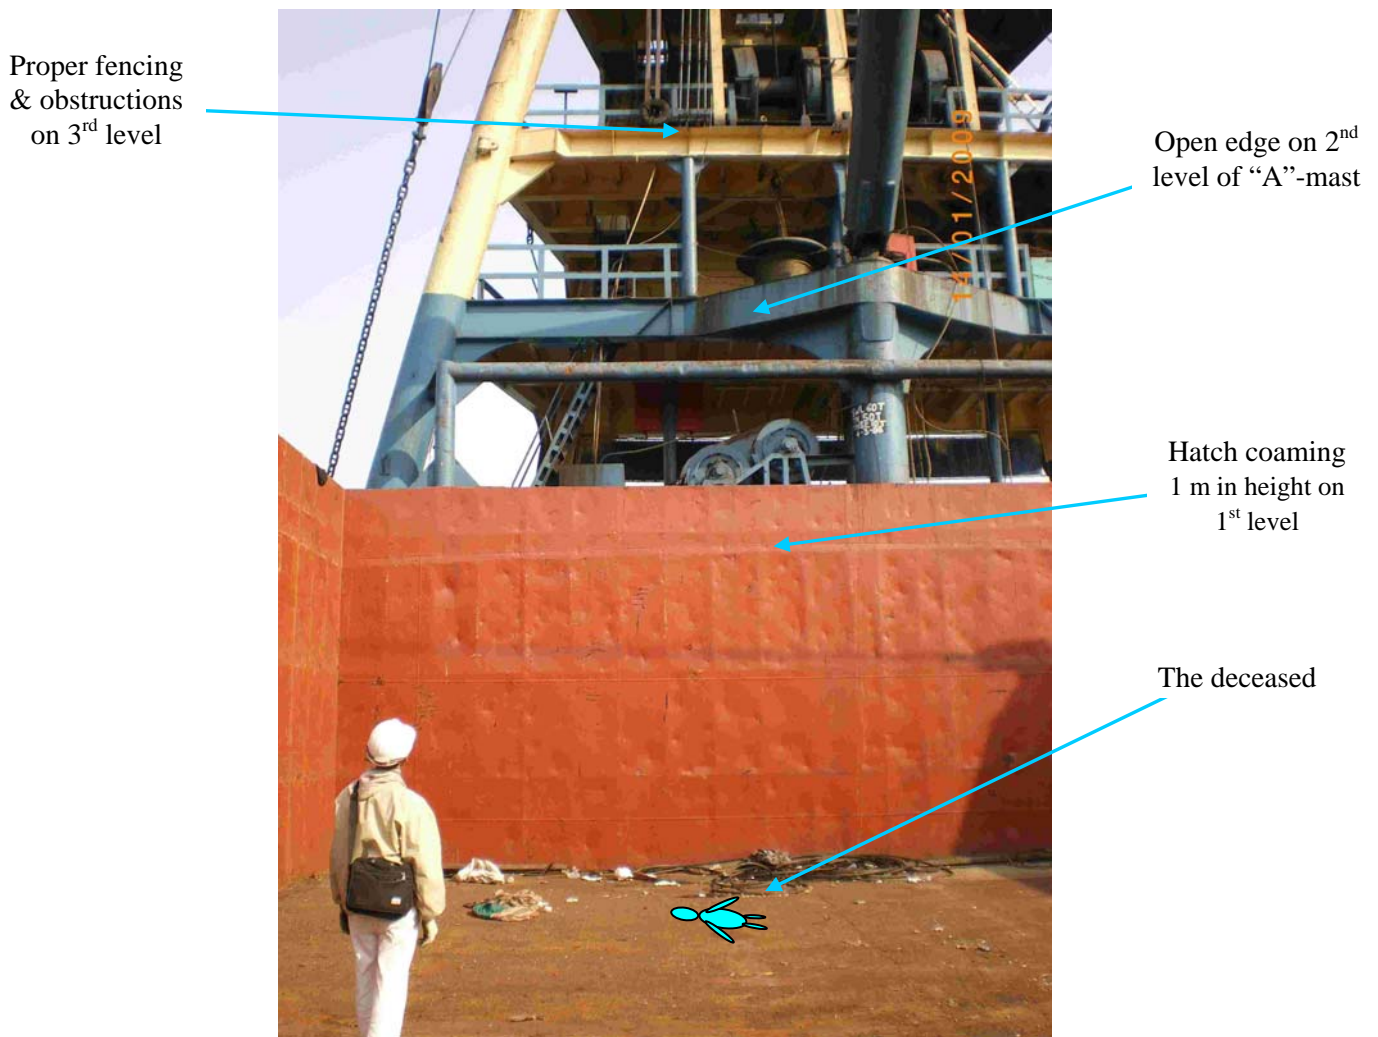
Fig. 9: Probable falling path of the deceased on “*Pak Lee*”

- 5.10 The deceased was found lying inside the cargo hold right under the unfenced opening on the 2nd level of the “A”-mast (see Fig.9). Similar locations on other levels were either fenced or obstructed by machinery. Therefore it could be deduced that the deceased fell from the 2nd level.

- 5.13 It is probable that at the time of accident, the deceased went to the 2nd level of the “A”-mast to get new wire ropes for making splices. The *DSL* was swaying due to the action of waves and movements of the derrick boom with the lifted container, he slipped and lost his balance and fell down into the cargo hold.
