Report of Investigation into the
Man-Overboard Accident
onboard a Chinese registered
river- trade container vessel
Shi Tai 818 on 14 May 2009

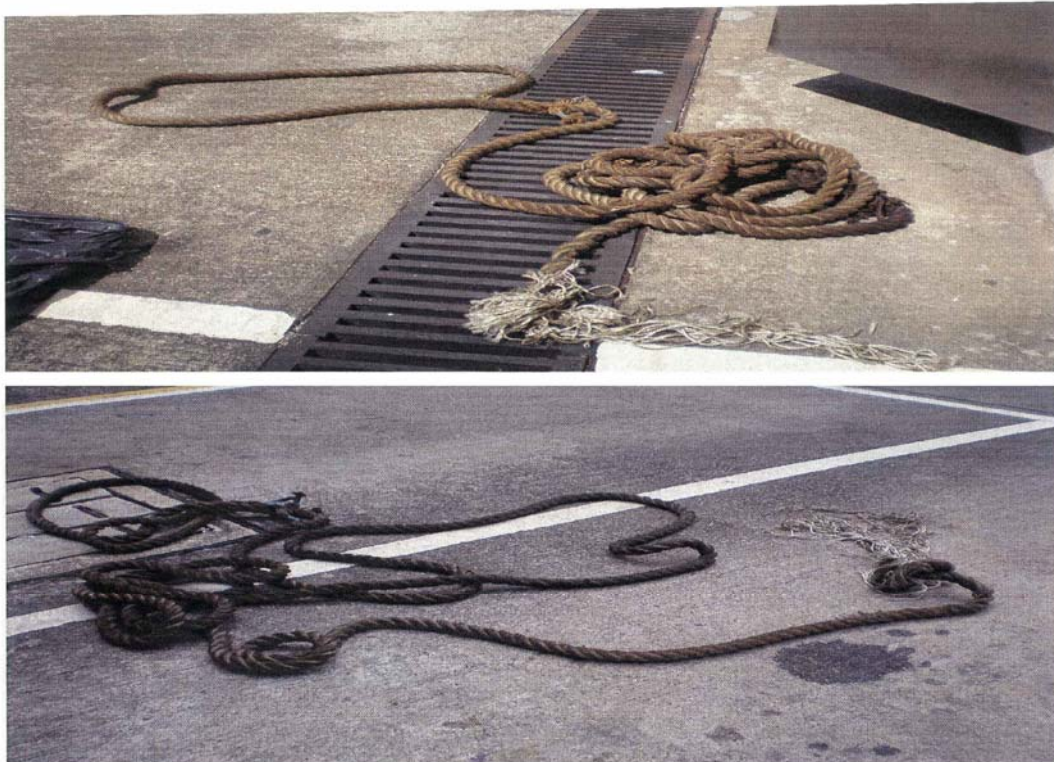
Fig. 2 Parted Stern Mooring Ropes

- 5.6 The mooring rope used at stern was a synthetic fibre rope of diameter about 32cm and appropriately 25 metres in length. After the accident, the mooring rope was found parted at about half-length. The rope was contaminated with oil but there were no signs of severe wear and abrasion on the rope (see Fig. 2).

- 5.11 The stern mooring rope was immediately under tension while the *Vessel* started to depart with the rope unfastened. Although Mechanic-A might not have heard the instructions from Sailor-A to unfasten the mooring rope, he would have noticed the *Vessel* was departing. It was probable that, at that moment, Mechanic-A was still attempting to ease the tension of the mooring rope so as to unfasten them. Unfortunately, the rope yielded and parted suddenly due to over-tension. The ends of the parted rope snapped and hit Mechanic-A with tremendous force that threw him overboard. He might have become unconscious while falling into the water.

- 7.1 A copy of the report should be sent to owners and the Master of *Shi Tai 818* advising them the findings of the investigation into this accident.
- 7.2 The owners are required to:-
- issue instructions to ensure safe and prudent mooring operation onboard their vessels by ship Masters, particularly all ropes must be unfastened before manoeuvring the vessel for departure; and
 - review the onboard communication arrangement between crew members during mooring operations.
- 7.2 A Marine Department Notice should be issued to promulgate the lessons learnt from this accident.
