Report of investigation  
into the falling overboard of  
Assistant Third Officer from the  
Singaporean Registered  
Container Carrier “*WAN HAI 205*”  
at Western Anchorage No. 2  
in Hong Kong  
on 25 August 2009

The Hong Kong Special Administrative Region  
Marine Department  
Marine Accident Investigation Section

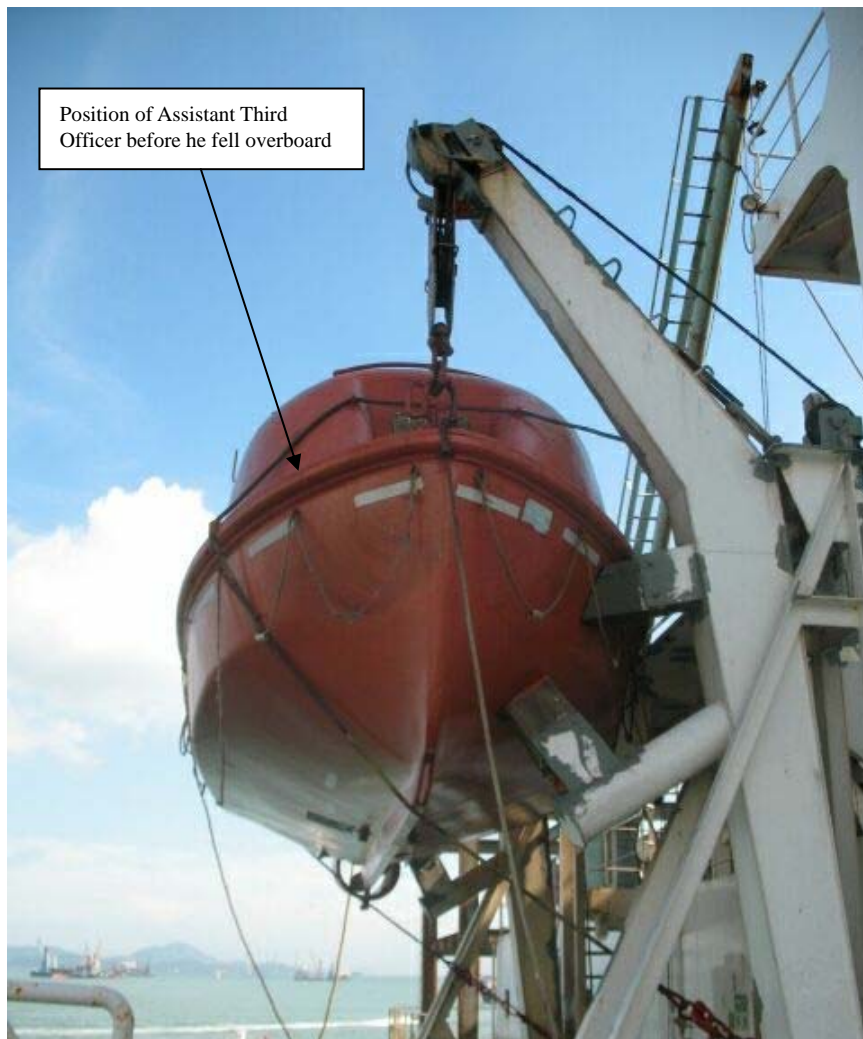
2.2 A totally enclosed motor lifeboat was stowed on the davit installed on each side i.e. port and starboard side of the accommodation of the vessel. Each lifeboat can accommodate a total number of 24 persons. There was an opening on each side of the lifeboat for access of crew members. Figure 2 shows the position of the Assistant Third Officer before he fell overboard.

Figure 2 – Position of the Assistant Third Officer before he fell overboard

- 4.2 At 1045 while the Chief Officer was working on the platform of the starboard lifeboat, the Bosun and Assistant Third Officer were inside the lifeboat. In order to carry out maintenance work i.e. to change the grablines on the starboard bow of the lifeboat, the Assistant Third Officer went outside of the lifeboat from the door on the outboard i.e. starboard side of the lifeboat. When the Bosun came out from the port side of the lifeboat, he could not see the Assistant Third Officer but found that he had fallen overboard into the water.

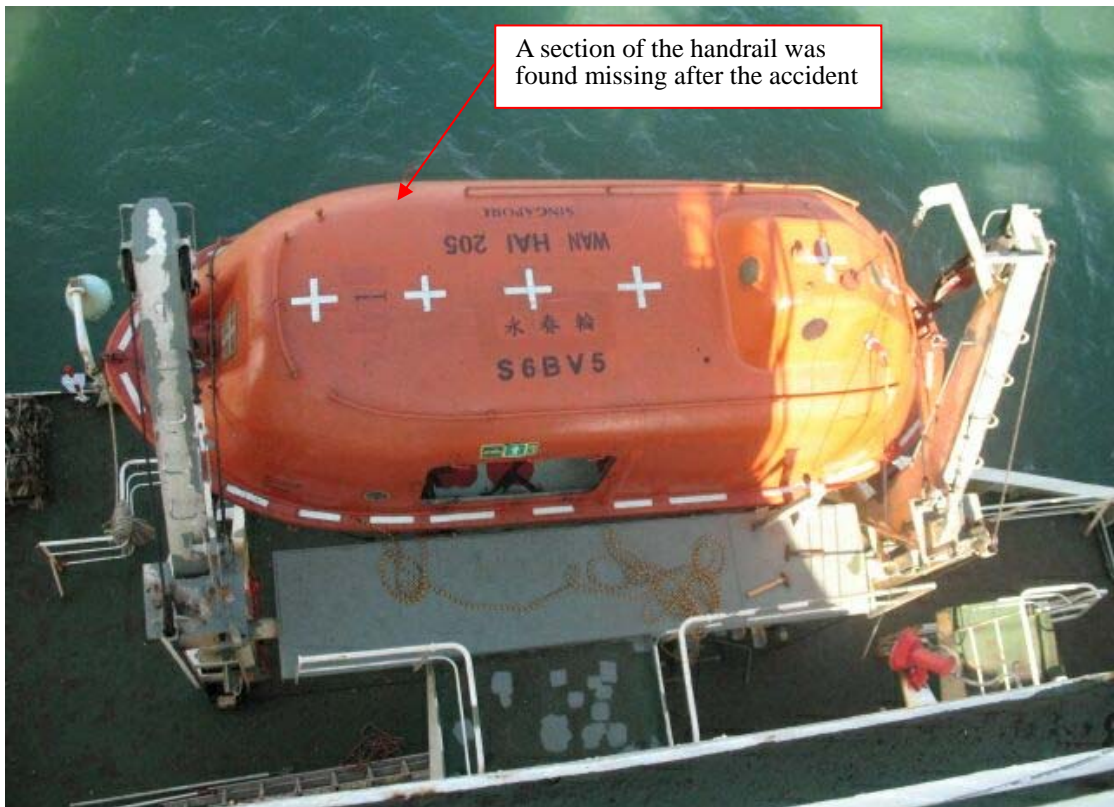
- 5.7 Neither the Chief Officer nor the Bosun witnessed how the Assistant Third Officer had fallen overboard from the lifeboat. However, it was discovered that a section of the handrail on the top of the lifeboat at the starboard side forward was missing after the accident (Figure 3). It was deduced that when the Assistant Third Officer came out from the starboard side of the lifeboat and moved forward on the narrow gunwale, he grabbed the handrail to balance his body or he anchored the lanyard of his safety belt to that section of handrail. A section of the handrail detached from the mounting on the roof and parted by the body weight of or the force exerted by the Assistant Third Officer. He might have lost his balance and fell overboard into the sea. The Chief Officer confirmed that prior to the accident, the handrail was intact but the section was found missing after the accident.

Figure 3 – A section of handrail was found missing after the accident

- 6.3 It is believed that while the Assistant Third Officer was trying to carry out maintenance work on the starboard bow of the lifeboat, he was standing on the starboard gunwale and used his hand to grab or anchored the lanyard of his safety belt on the handrail on top of the lifeboat. The handrail parted and the Assistant Third Officer lost his balance and fell overboard into the water.

- 7.1 A copy of the report should be sent to the ship management company of *WAN HAI 205* who should issue a notice to draw the attention of their masters and officers to the findings of this report. The Company should instruct their masters and senior officers on board ships to follow company procedures when requesting newly joined and/or inexperienced junior officers/ratings to work aloft and over the shipside.
- 7.2 A copy of the report should be sent to Maritime and Port Authority of Singapore, as Flag State Administration of the vessel, for their information and follow-up actions if deemed necessary.
