Report of Investigation
into Electrocution of a Fitter
while Performing Electric Arc
Welding Repair on board
Hong Kong Registered Vessel
Pacific Explorer
on 20 November 2009

The Hong Kong Special Administrative Region
Marine Department
Marine Accident Investigation Section

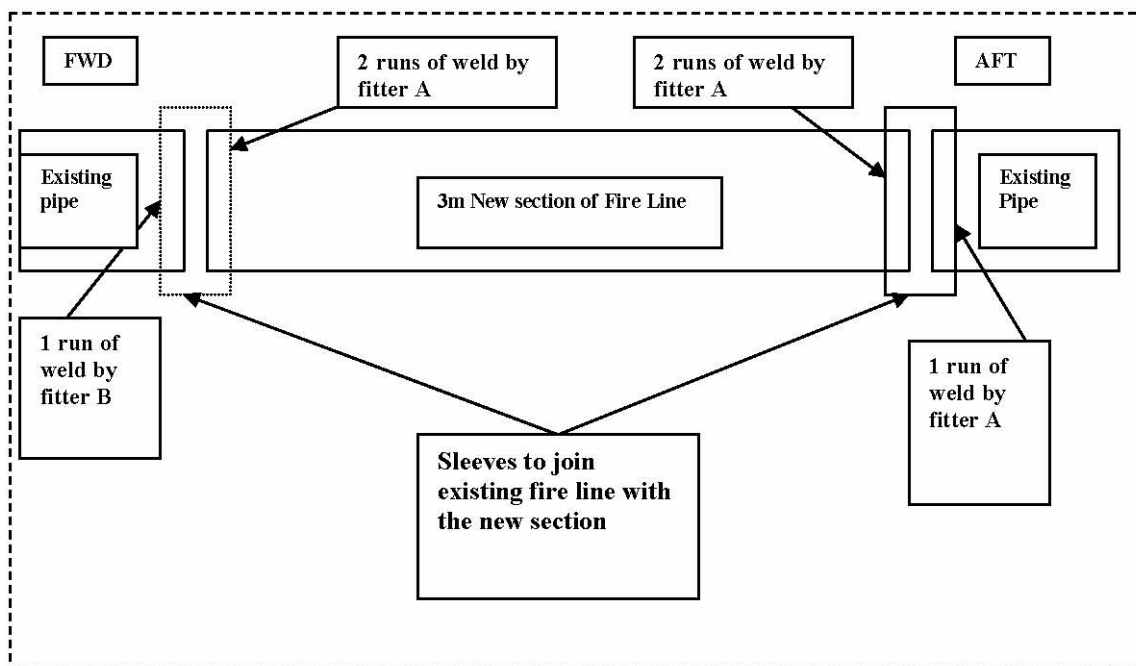
Figure 3 – Sketch showing the repair work

- 4.5 On the morning of 19 November, Fitter A and Fitter B started the work to cut off the corroded section of the fire main and prepared the new pipe. The new pipe was fitted into position using two steel sleeves, one at each end, for connecting to the existing pipeline (see Figure 3). Two runs of weld were required for each of the four joints.

- 4.7 At 1400, Fitter A used the portable welding machine for welding and at 1630, he finished welding two of the four joints (see Figure 3).
- 4.8 In order to complete the repair work by the end of the working day, the Chief Officer agreed at the suggestion of the Bosun that Fitter B should be allowed to take part in the welding using the fixed welding machine located inside No.4 mast house. At 1630, Fitter B started welding to the forward joint of the forward sleeve.

- 4.9 At about 1730, they had completed one run of weld to each joint. The Chief Officer ordered to have a hydraulic test conducted on the fire main to check for any leakage of seawater. It was found that both sleeve joints with only one run of weld were leaking, with the one done by Fitter B more seriously.

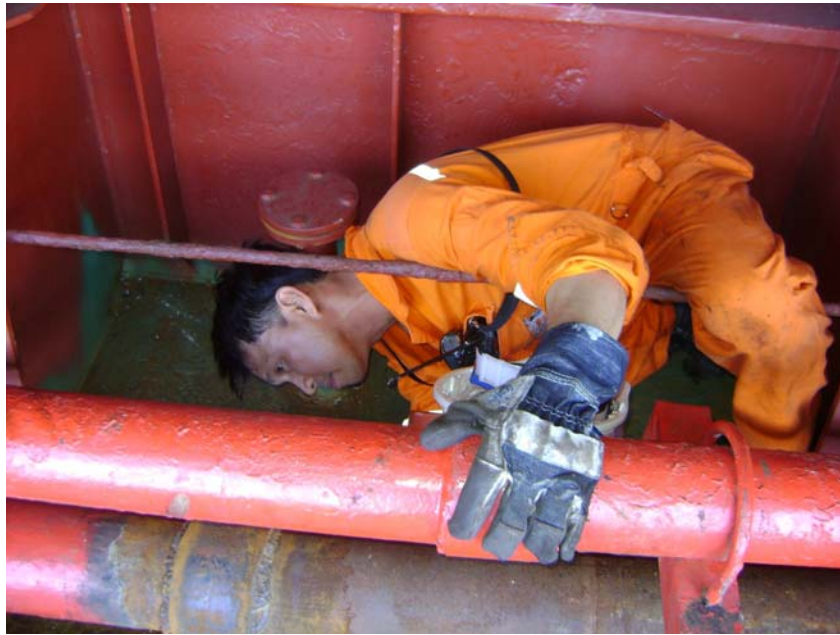
Figure 4 – Position of fire main in relation to the hatch coaming

- 5.11 The fire line is laid under another pipeline, close to the deck surface and runs beside the hatch coaming, resulting in a difficult position for welding by the operators. On the evening of 19 November, the fire main was hydraulically tested for leakage of seawater and then drained. When the work started again on the morning of 20 November, residue of seawater was still leaking from the piping. That made welding to the underneath of the pipeline more difficult.

- 5.41 The pipeline, which ran very close to the deck surface and was restrained by hatch coaming, was leaking with seawater at the welding joints. Fitter B was having

difficulty in making a good weld to the underneath of the pipeline. The difficult position for welding would have caused Fitter B's body to come into contact with the ship structure during welding. Proper insulation to protect the operator should have been provided to avoid electric shock and electrocution.

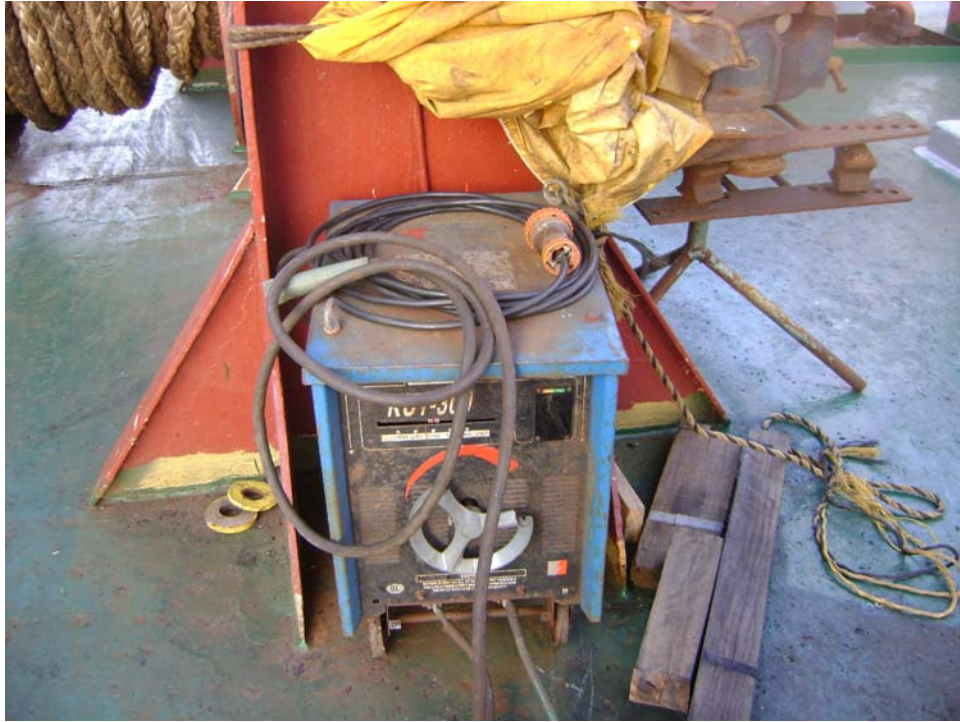
Figure 6 – Portable welding machine used by Fitter A

- 5.12 Fitter A used the portable welding machine (see Figure 6) with its return cable clamped at the site of the welding. The open circuit voltage of the welding machine, checked after the incident, was 68.7V.

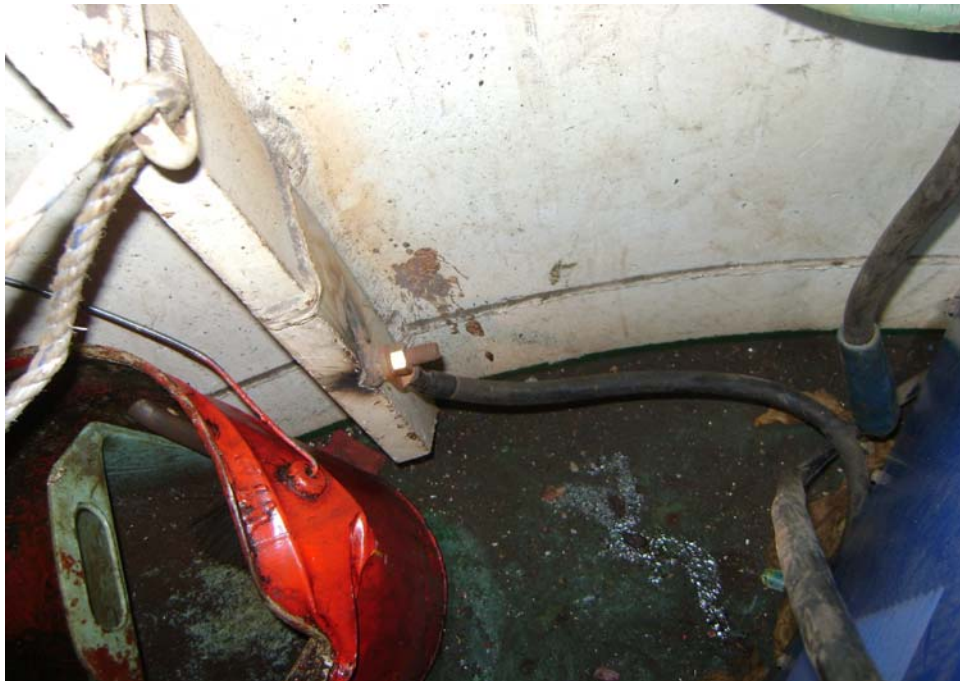
Figure 7 – Fixed welding machine inside No.4 mast house used by Fitter B

- 5.13 Fitter B used the welding machine located in No.4 mast house. The open circuit voltage of the welding machine, checked after the incident, was 67.2 volt. It had a short return line fixed to an internal stiffener of the crane house (see Figure 7).

- 5.17 The return cable of the fixed welding machine inside No. 4 mast house did not comply with the Company’s Electric Arc Welding Precautions Guidance and the Code.

- 5.16 The idling voltages of all welding machines on board were checked after the accident. They were in the range between 67.2 and 75.2 volts. After the accident, voltage reduction devices to reduce the voltage to 12 volts were supplied on board.

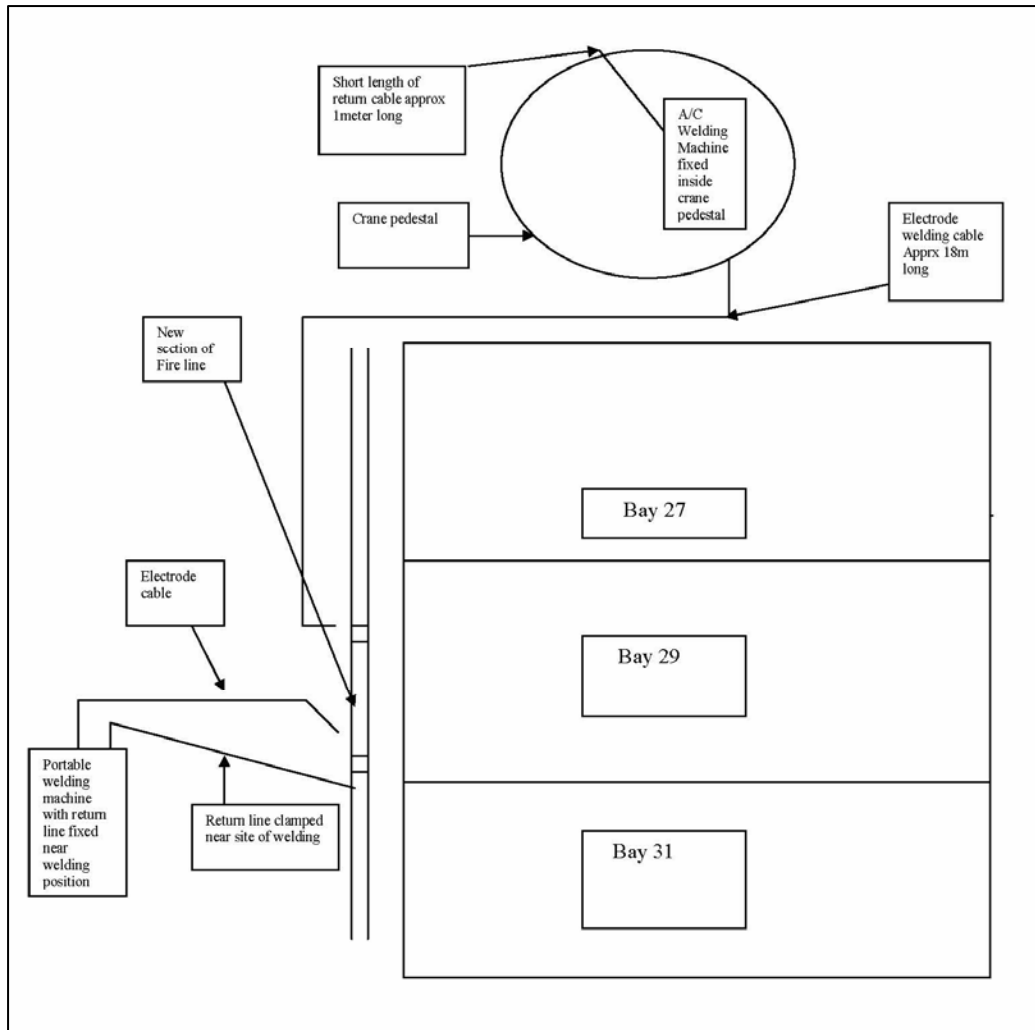
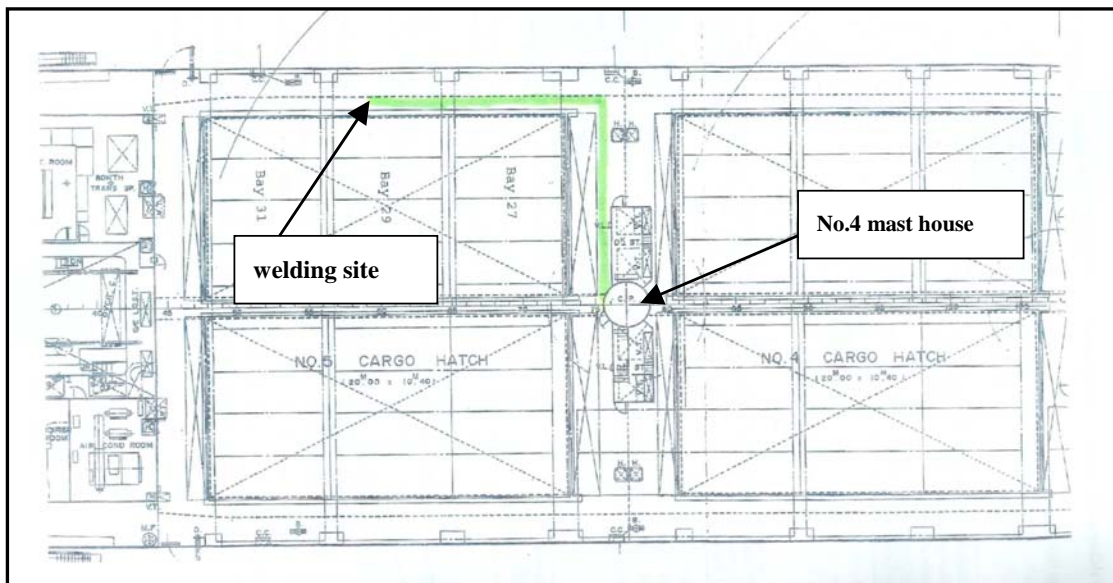
Figure 8 – Welding cable arrangement for the fixed and portable welding machines

Figure 9 – The position of No.4 mast house (where the fixed welding machine was located) in relation to the welding site

- 5.14 Figure 8 and Figure 9 show respectively the welding cables arrangement for the fixed and portable machines, and the position of the welding machine inside No.4 mast house in relation to the welding position of Fitter B on deck.

- 5.40 The return cable of the welding machine used by Fitter B was connected to the ship's hull just beside the welding machine located inside the mast house, which was far from the place of work. The long return path of electric current through the ship's hull during welding would have a higher electrical resistance than the wet body of Fitter B. The risk of electric shock and electrocution was increased.
