Report of investigation
into the fatal accident on board
Hong Kong registered ship
COSCO Indian Ocean in the port
of Rotterdam, Netherlands
on 13 December 2009

The Hong Kong Special Administrative Region
Marine Department
Marine Accident Investigation Section

Completed on 24 May 2011

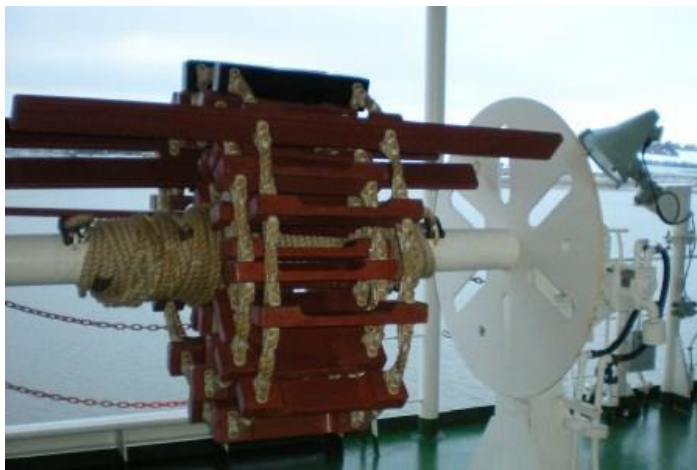
Fig. 3 – Pilot ladder reel

- 4.6 When the sailor arrived at the starboard pilot ladder winch, he found a safety helmet and a pool of blood on the deck and the winch was still working. He saw a sailor was pulled into the pilot ladder reel (figure 3).

- it is probable that the deceased either stood too close to or tempered the reeling ladder caused his winter clothes entangled by the ladder and he was dragged or pulled into the reel; and

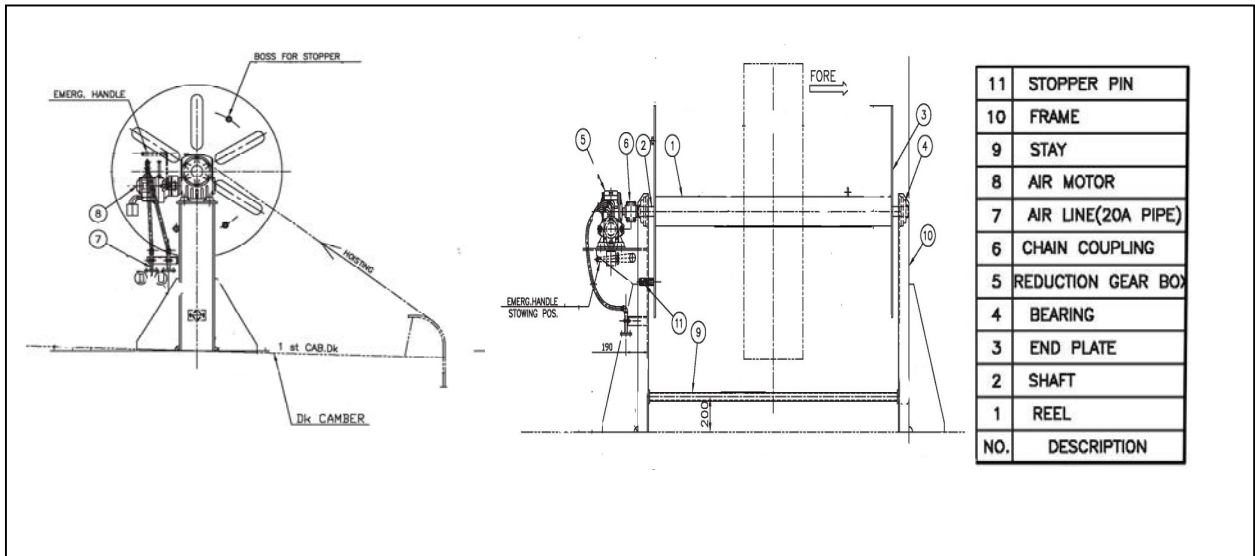
Figure 4 – The mechanical pilot hoist

- 5.4 When the handle of the valve is placed in neutral (middle) position, no compressed air will flow to the motor. When the handle is moved to either left or right direction, the compressed air drives the motor and, through a reduction gearbox, turns the reel either in clockwise or anti-clockwise direction for hoisting or lowering of the ladder over the shipside (Figure 4, 5 and 6).

- 5.5 The directional control valve was not designed for self-returning to the neutral position when the handle is released. As the system was not designed as a mechanical pilot hoist, the requirement for the hoist controls to automatically return to the “stop” position upon release of the handle as stipulated in Resolution A.889(21)¹ is not required.

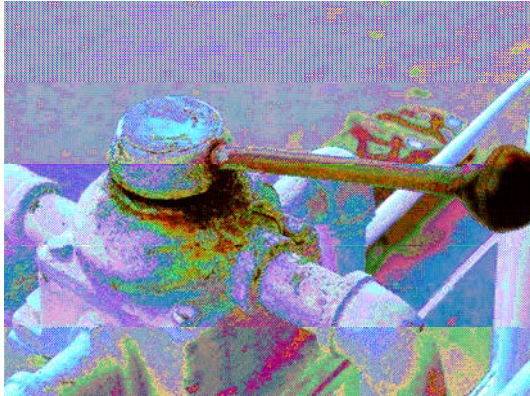
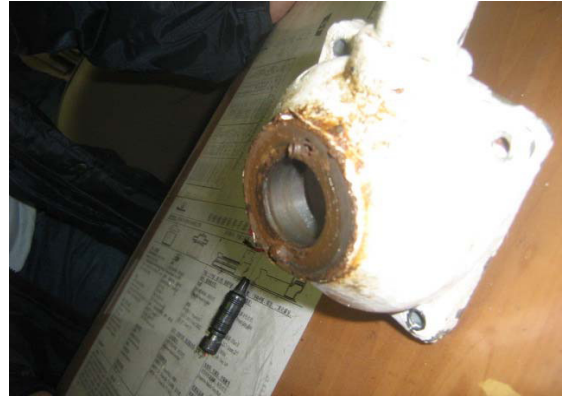
Figure 6 – Directional control valve

5.21 The Netherlands Authority boarded the vessel on 14 December 2009 for investigation. Among other findings, the report pointed out that the position of the directional control valve was close to the pilot ladder reel and that would cause dangers to the operators. Also, the spindle spoon of the directional control valve, which had grease accumulated inside the valve body (see figure 6), would not be able to return to the neutral position effectively for stopping the air motor.

- the winch continued to turn even though the handle of the directional control valve, which was not a self-return type, was released; or the valve might have not been returned to neutral effectively due to grease accumulated inside the valve body.

- the directional control valve for controlling the winch could not return to the neutral position for stopping the air motor as the valve was not of the self-return type; and

- excessive grease had been accumulated inside the valve body of the directional control valve; and
 - the areas around the pilot ladder winches might be tight for crewmember during working and posing dangers to them while operating the pilot ladder winches.

- 5.6 After the accident, the company replaced the directional control valves by the self-returning type in order to enhance safety of personnel on board.

- provide trainings to all responsible persons in order to ensure safety in the operations of pilot ladder winches on board.
- 7.3 A Merchant Shipping Information Note (MSIN) should be issued to promulgate the lessons learned from this accident and to encourage ship owners of Hong Kong registered ship to use self-return type directional control valves in similar type of pilot ladder systems.
