No.: **50/2007**

HONG KONG MERCHANT SHIPPING INFORMATION NOTE

Fatal Accident to a Cargo Loading Master when Transferring between Vessels

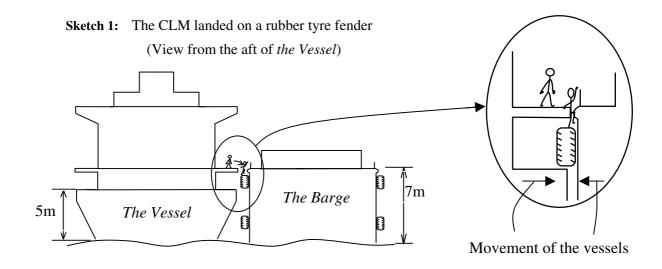
Figure 1: Sketch of the incident

A fatal accident happened when a cargo loading master (the CLM) disembarked from a Hong Kong registered ship (*the Vessel*) to a cargo barge (*the Barge*). While the CLM stepped on a rubber tyre fender and was about to climb up to *the Barge*, he was crushed between the sides of the two vessels due to the effects of the wind and swell which caused the two vessels rolled and swayed suddenly. The CLM died instantly in the incident. The investigation revealed that there had been no safe means of access for personnel transfer between the vessels.

- 1. After completion of cargo loading at the anchorage area in Indonesia on 11 March 2007, the CLM disembarked from *the Vessel* to *the Barge* which was moored alongside.
- 2. The freeboard of *the Barge* was about the same level as the boat deck level of *the Vessel*. The CLM, accompanying by an Able Seaman attempted to board *the Barge* via the boat deck. After the CLM had landed on a rubber tyre fender at the port side of *the Barge*, both two vessels moved suddenly due to passing waves. The CLM was crushed between deck structures of the vessels and died instantly in the incident.
- 3. The investigation revealed that there had been no safe means of access for personnel transfer between the vessels.

4. Safe means of access should be provided for personnel embarking and disembarking between vessels; and

- 5. Personnel should be aware of dangers of any unexpected ship movement while transferring people between vessels.
- 6. The attention of shipowners, ship managers, ship operators, masters, officers and crewmembers is drawn to the lessons learnt above.
