## **Inadvertent Release of a Lifeboat from “OGRADY” after Collision with Loss of Two Lives**

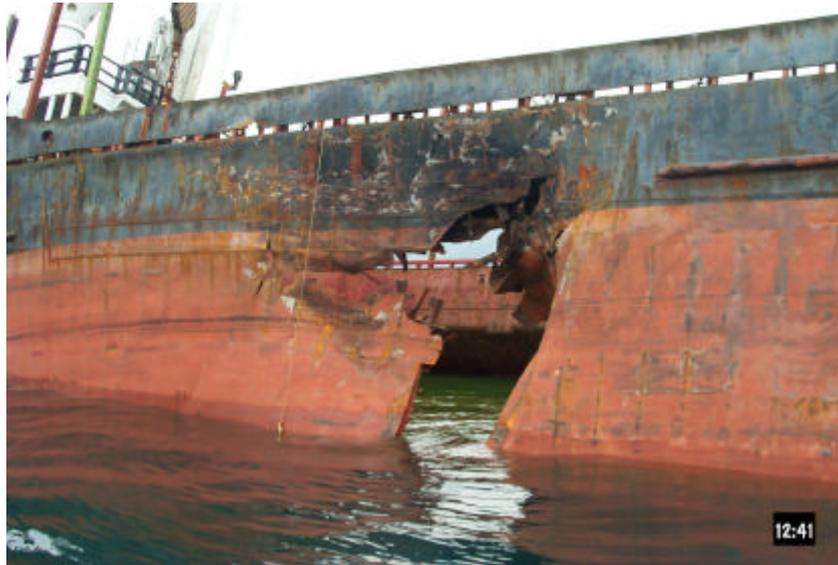
1. At about 2040 hours on 21 February 2003, a Hong Kong registered ship “Ogrady” collided with a Cambodian registered ship “Lora” in the Inland Sea of Japan. “Ogrady” sustained severe damage at the port side shell plating (fig. 1) while “Lora” crushed its stem. “Ogrady” developed a starboard list as a result of water ingress to its cargo hold. The master of “Ogrady” ordered to standby the ship’s lifeboats for emergency use. During the lowering of the port side lifeboat, the forward and aft lifting hooks suddenly released from its secured position and the lifeboat dropped 15 metres into the sea. Two crewmembers were later found dead inside the lifeboat (fig. 2).

1. “Ogrady” was navigating in the opposite traffic lane at Bisan Seto traffic separation zone before collision as a result of incorrectly plotting of ship’s positions. The master was not aware that the vessel was in the wrong lane and hence did not take action to bring the ship back to the correct lane. “Ogrady” also failed to take early action to avoid collision with “Lora”. On the other hand “Lora” was required to keep out of the way of “Ogrady” in a close quarter situation inside the Traffic Separation Scheme failed to take proper action.

Fig. 1 Collision damage of “Ogrady”

1. The Master should have used the passage plan in preparing the voyage. Monitoring of ship’s position should not solely rely on the radar fixed positions. Fixes shall be taken at frequent intervals and

shall be carried out by more than one method whenever circumstances allow.

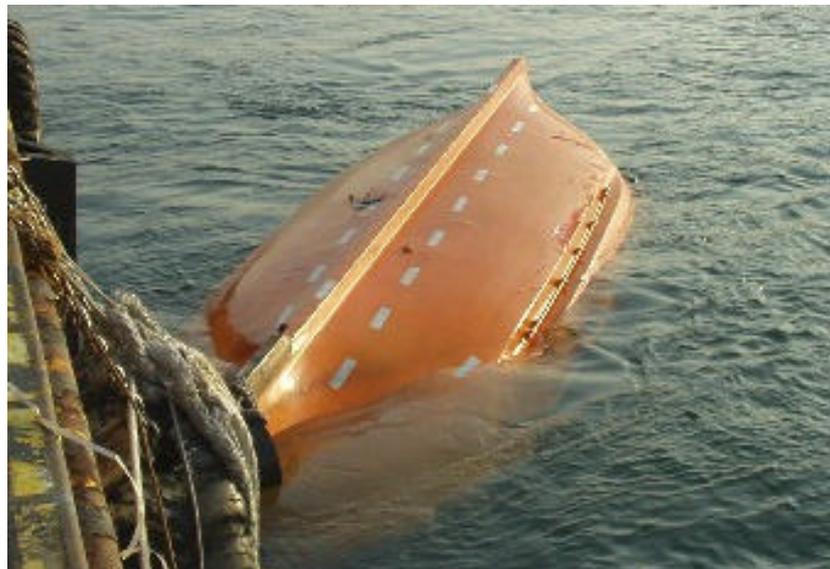
2. The primary cause of this lifeboat incident is believed to be the inadvertent release of the on load release mechanism by person inside the lifeboat. A general lack of appreciation and understanding of the lifeboat launching equipment by the crew and inadequate safety familiarization training were apparent. Other contributing factors are the lack of clear operating instruction and conspicuous warning notice for the lifeboat on-load release mechanism which could enable the crew on board to understand the effect of the operating procedures and their associated danger.

Fig. 2 The capsized lifeboat

2. Adequate familiarization training and detailed operating procedures for the lifeboat on load release mechanism should be provided to the crew. The adequacy of the securing arrangement for the on load release lever should be reviewed and improved as necessary.
