## **Fatality of person inside cargo tank on board the Hong Kong registered chemical tanker “Bow Wind” at Sut Sakra, Singapore on 12 June 2004**

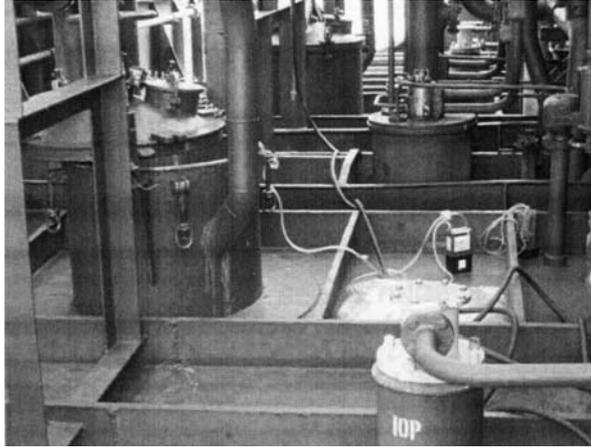
No. 10 P cargo tank dome

- 2.1 There was no witness of this incident. Shortly before the incident the cargo surveyor was taking sample with the Pumpman at the opened cargo dome of No. 10P tank. During the course the surveyor dropped his helmet into the tank. He however left the area after taking the sample. The surveyor stated that he had not seen the entry made by the Pumpman. The second officer and other crew were not staying in the vicinity.

- 2.2 The Pumpman was found collapsed at the upper ladder platform. According to the Company there was no evidence of any bleeding or signs from the body that he had fallen from height. Therefore it is reasonable to believe that the Pumpman had entered into the tank via the ladder. He was not wearing any safety apparatus.

- 2.3 Although the helmet was later found at the bottom of the cargo tank, it is believed that the helmet might have fallen first on the upper ladder platform which is located at a short distance immediately below the cargo dome. This might have prompted the Pumpman to enter the tank to retrieve it, believing that he would be able to return to deck by holding his breath. The helmet might have dropped to the tank bottom later on when the Pumpman collapsed at the

platform.
