Preliminary Inquiry No.1 of 2005

Report of Investigation

into the Engine Room Fire

on Board M.V. "Fleet Trader 1"

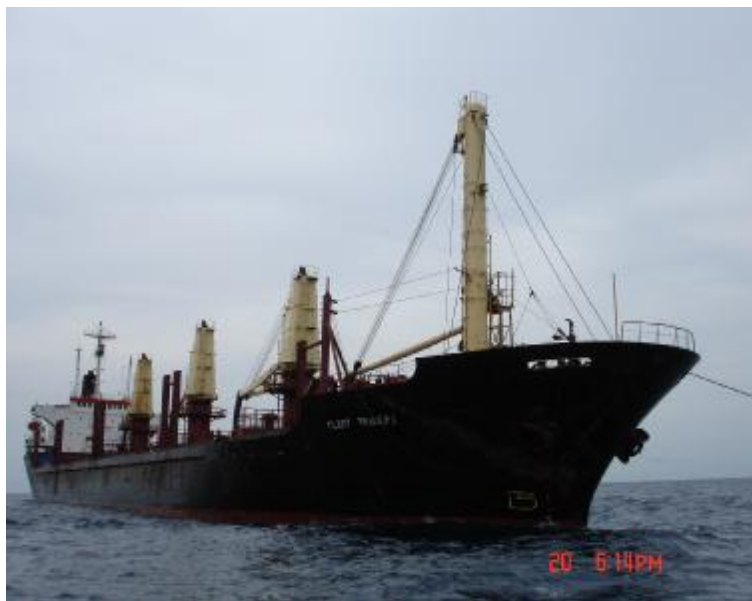
Fig. 1: "Fleet Trader 1" was towed to Lagos after the fire.

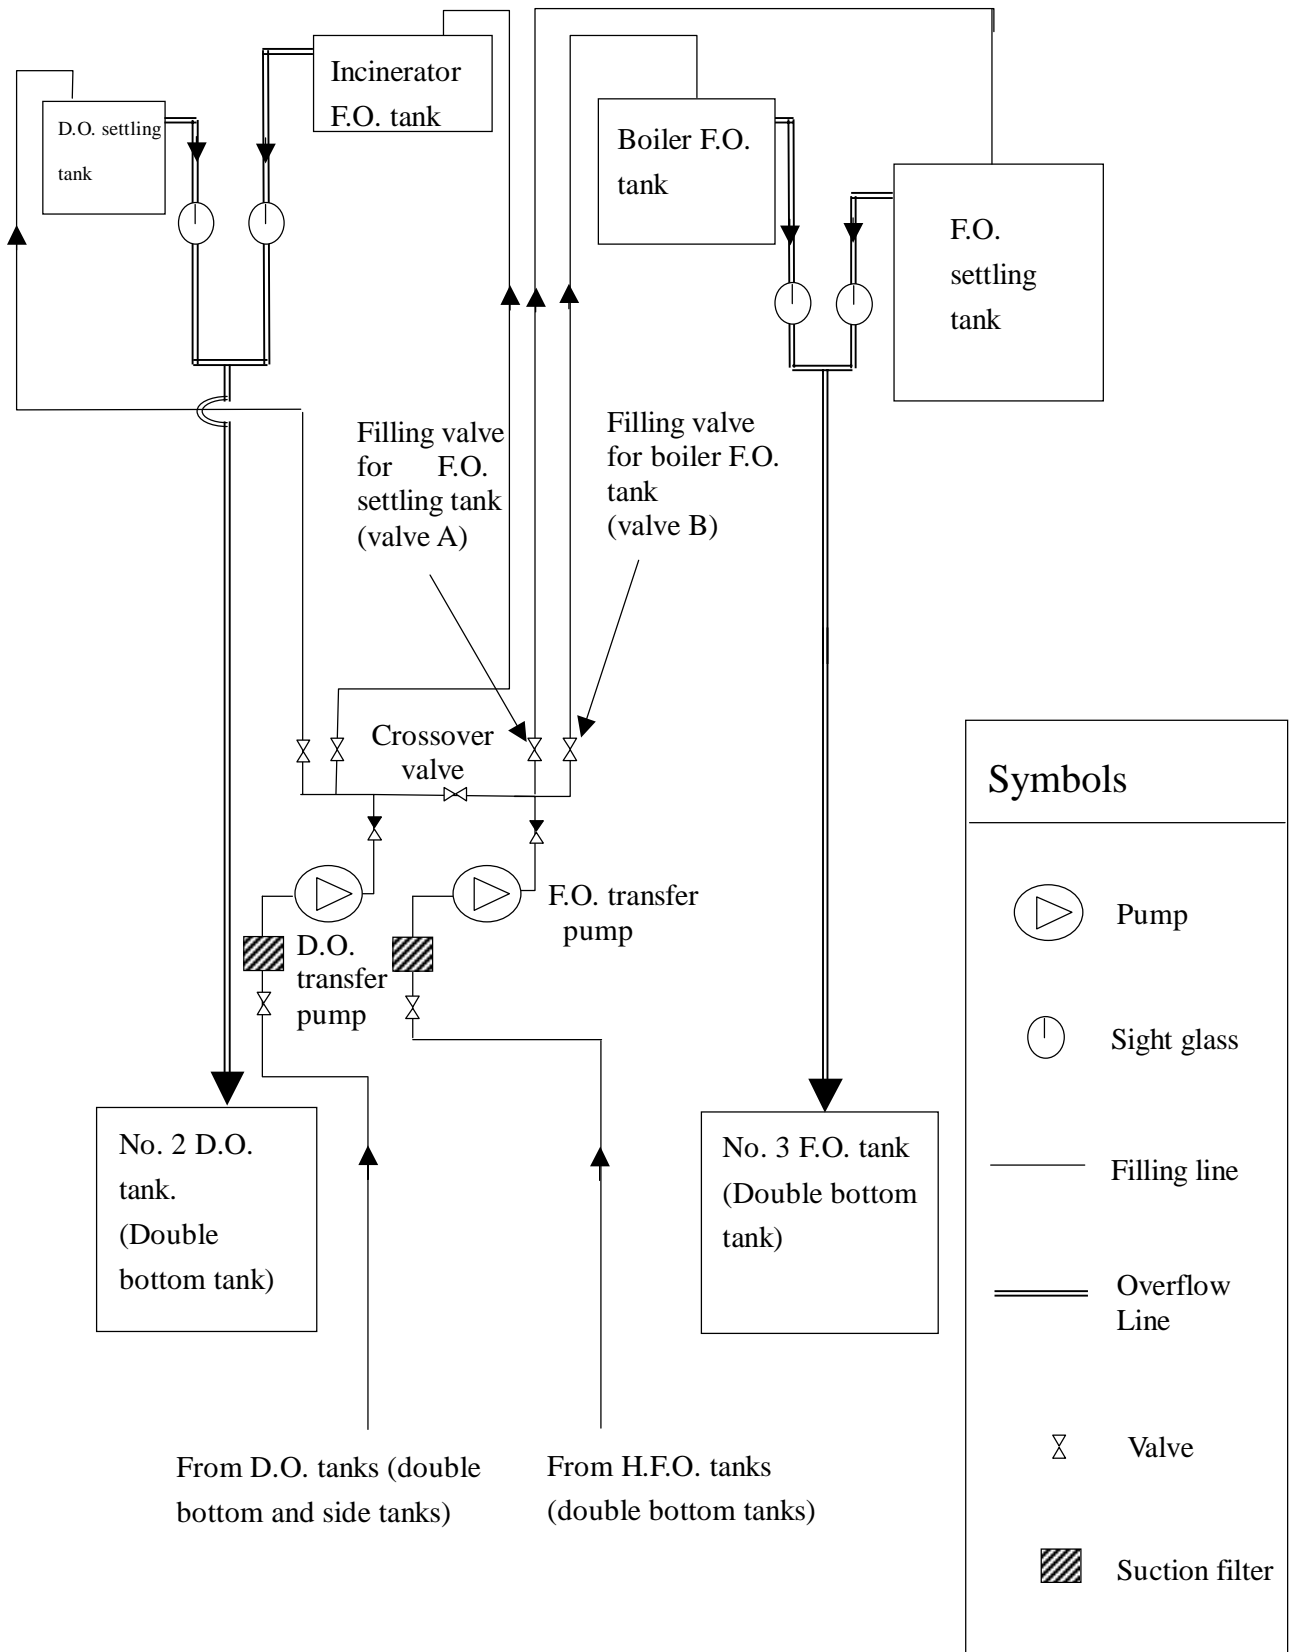
3.3.2 All the F.O. tanks and D.O. tanks including the boiler F.O. tank were fitted with an overflow pipe, which acted as a protection device to allow excess heavy fuel oil and diesel oil to overflow back to the designated double bottom tanks of the Vessel.

Fig 2: Simplified diagram of fuel oil transfer system

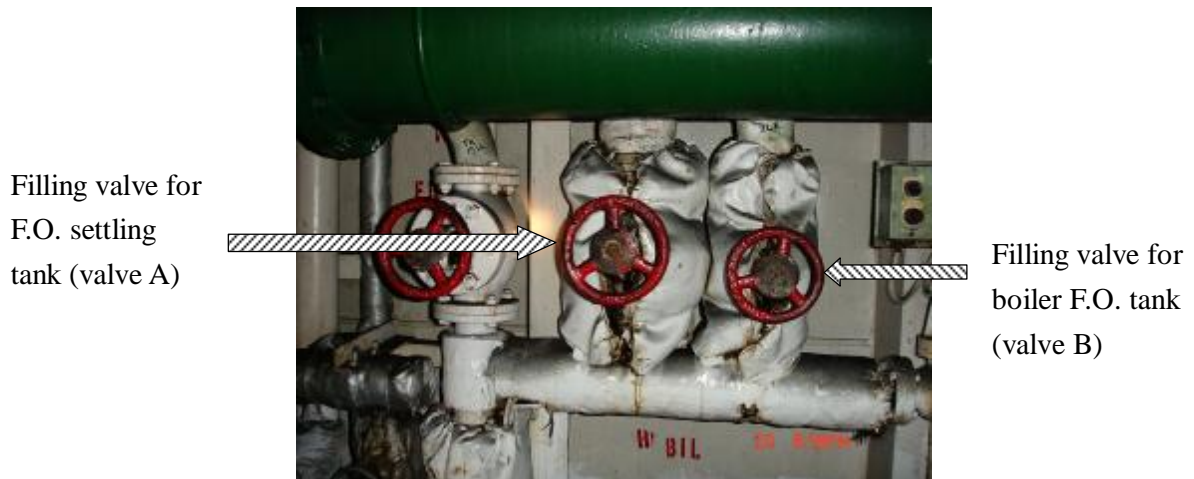
Fig. 4: Filling valves for F.O. settling and boiler fuel oil tanks.

5.4.3. At about 1000 on 24 March 2005, a mistake was made by the Junior Engineer. He opened the wrong valve after cleaning the filter of the fuel oil transfer pump. As a result, the boiler fuel oil tank was filled up instead of the fuel oil settling tank. When the boiler fuel oil tank was full, the fuel oil came out from the opening at top of the boiler fuel oil tank and ran down onto the hot exhaust trunk which ignited the fuel (see fig 7).

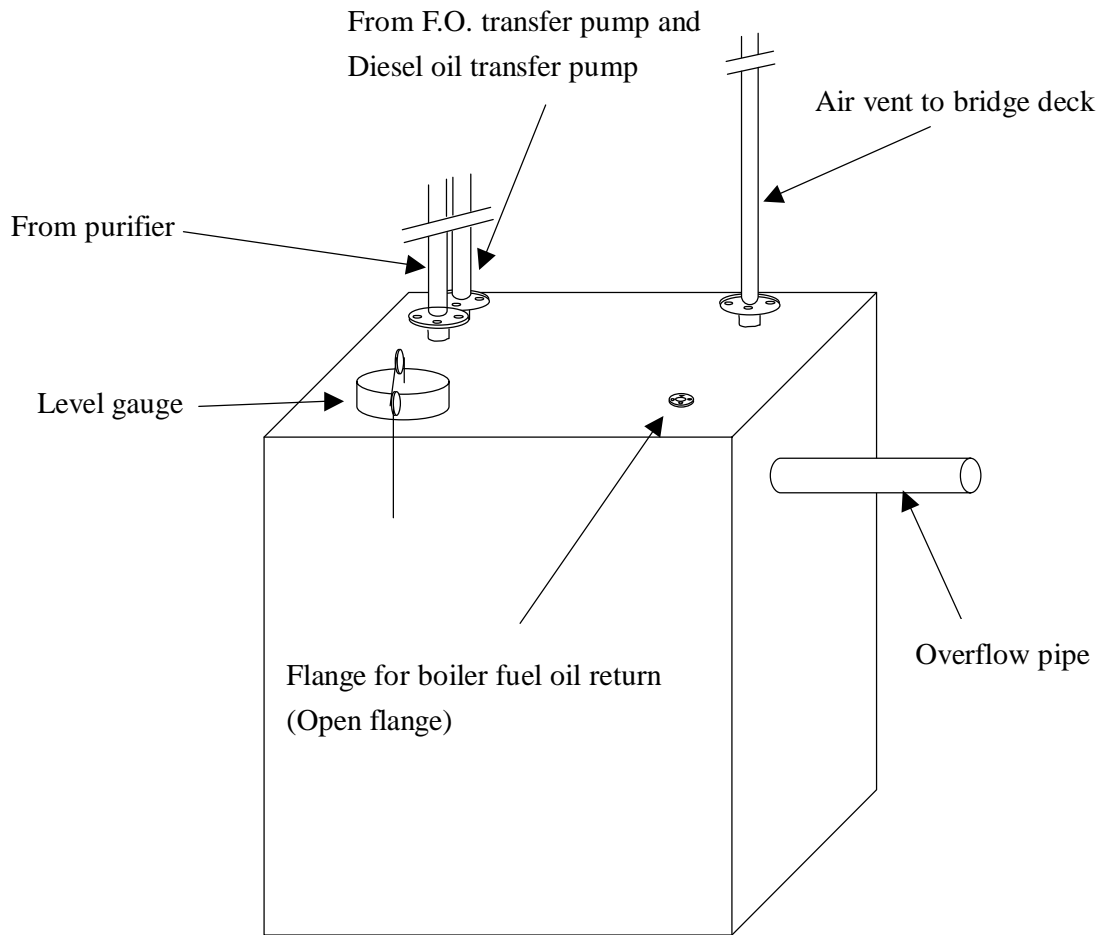
- 5.3.1. The boiler fuel oil tank (See fig. 6) had a capacity of 1.2 m³. Mounted on the top of the boiler fuel oil tank were the inlet pipe from fuel oil transfer pump and diesel oil transfer pump, inlet pipe from purifiers, float gauge and air vent. There should be a boiler F.O. return pipe fitted to the top of the boiler fuel oil tank. However

the pipe was not in place leaving only the opened flange on top of the boiler fuel oil tank. An overflow pipe was connected to side shell of the tank. Diesel oil was normally used as fuel for the boiler, the tank was said to contain about 600 litres of diesel oil before the incident.

Fig. 6: Sketch of the boiler fuel oil tank

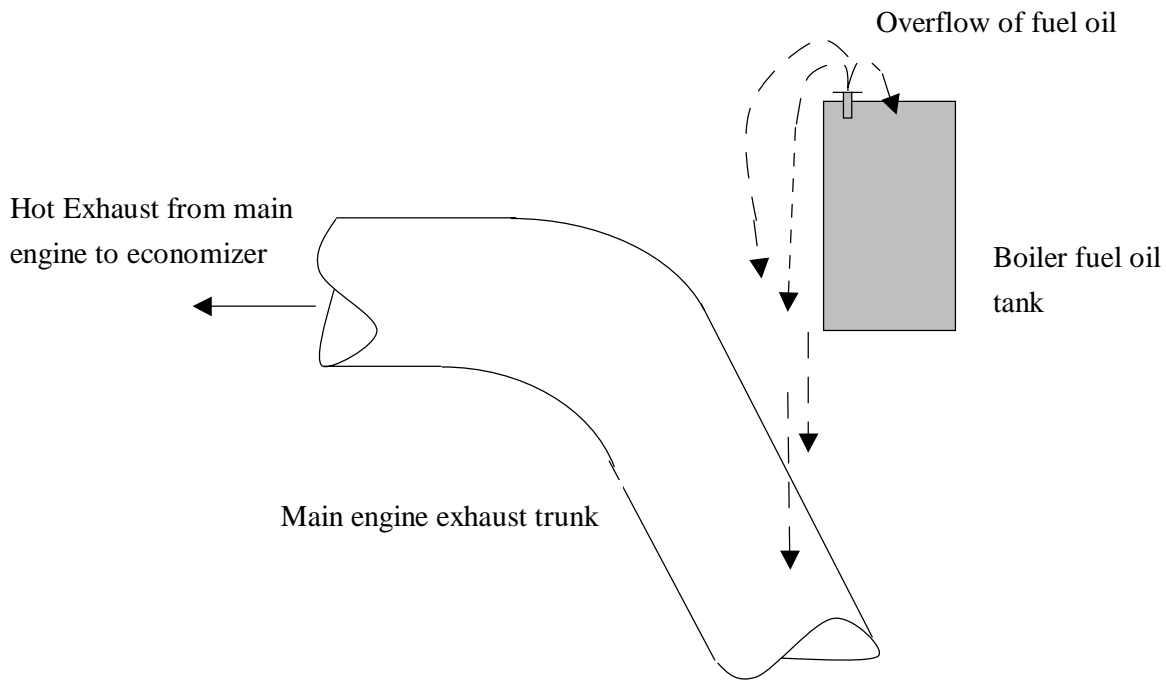
Fig.7: Scene of the incident

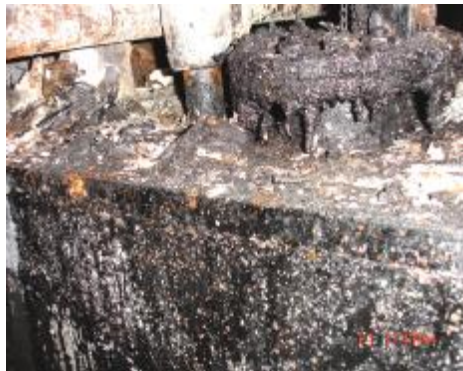
5.5.1. During inspection, signs of unburned and hardened heavy fuel was found on the top of the boiler fuel oil tank (see fig. 8), main engine exhaust trunk, main engine cylinder platform (see fig. 9) and its turbocharger. The trace indicated that oil leakage originated from the top of the boiler fuel oil tank and dropped down to the main engine cylinder platform.

Fig 8: Sign of fuel oil leakage from the top of the boiler fuel oil

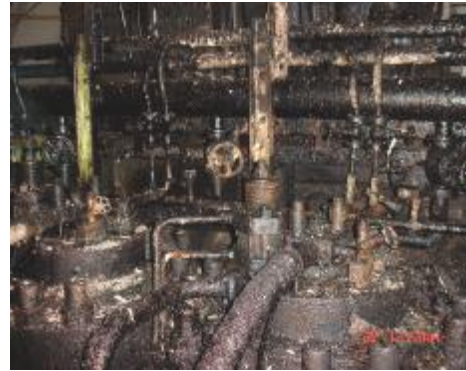
Fig 9: Top of main engine coated with heavy fuel oil.

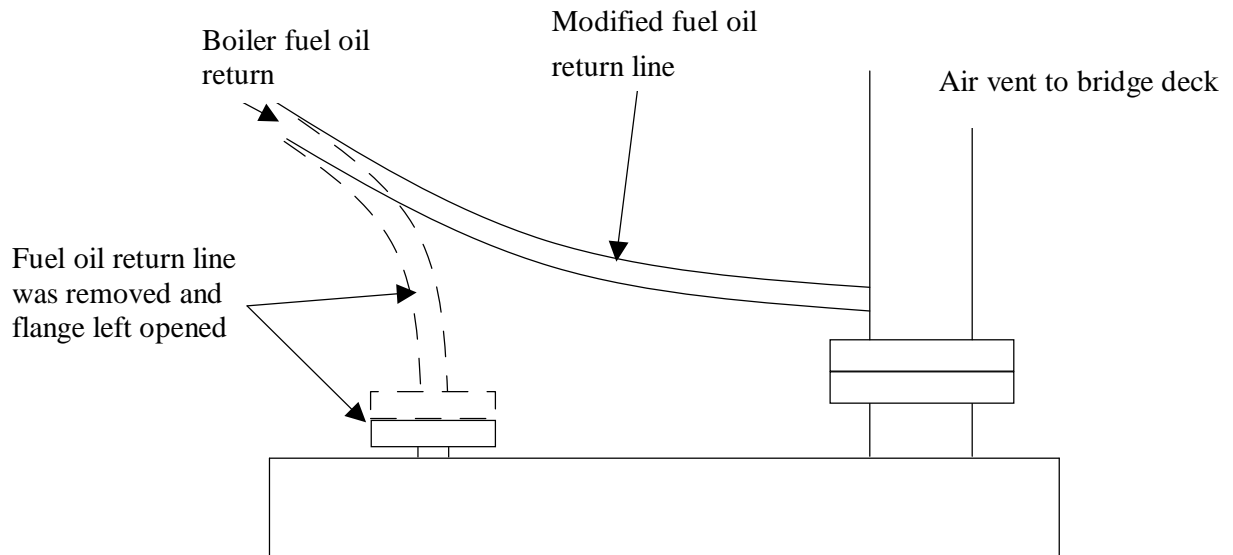
5.5.2. A fuel oil return line was fitted at the fuel oil burning system of the boiler to allow circulating fuel oil to return back to the boiler fuel oil tank. However, this return line had been modified. The length of the boiler return line at the top of the boiler F.O. tank was removed from the original 15 mm nominal diameter flange and connected to the air pipe of the tank. The ship's engineers did not know the purpose of such modification as it had been done a long time ago. However, the original flange opening was not covered and left open to the atmosphere. (See fig. 10)

Fig. 10: The modification of boiler fuel oil return line

5.5.3. According to the survey records provided by NKK, the boiler fuel oil tank was last inspected by NKK as part of the CSM (continuous survey of machinery) in December 2002. There were no records to show the modification which left an opening on the top of the boiler fuel oil tank, it appeared that the return line had been modified without the approval of the authorized body.

- 7.3 A copy of this Report is to be forwarded to the ship owner and ship manager informing them the findings in the investigation and reminding them:
 - i) No modification of the fuel oil system should be made without prior approval from Flag Administration or Classification Society;

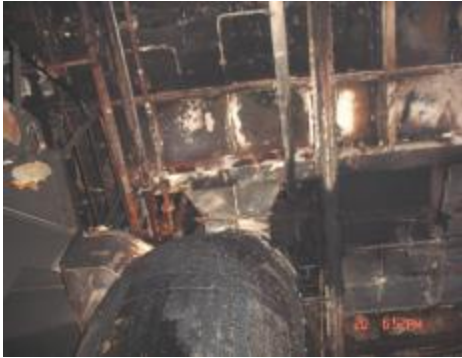
The upper part of the engine room was found badly burnt and darkened by carbon deposits from the level of main engine cylinder platform to the funnel top. Apparently, such damages were caused by the intense heat generated from the fire occurred down in the engine room. (See figs.11 to 14)

Fig. 11: The top of engine room was badly burnt.

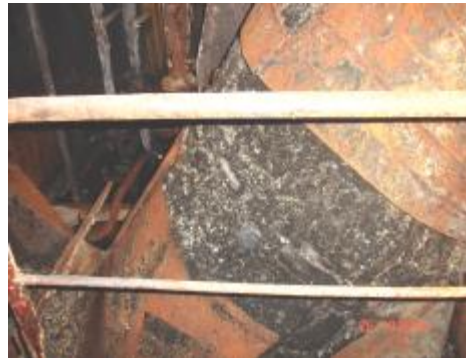
Fig.12: Metal shielding for exhaust M/E exhaust truck deformed and detached.

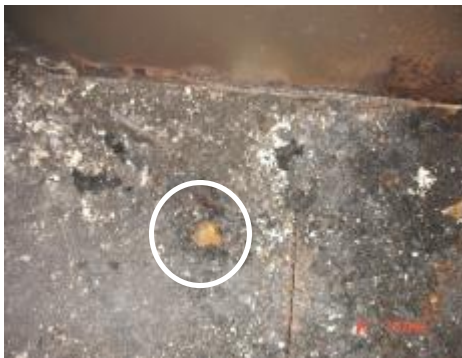
Fig. 13: Shoes of the Third Engineer was burnt, steel toecap remained on the floor.

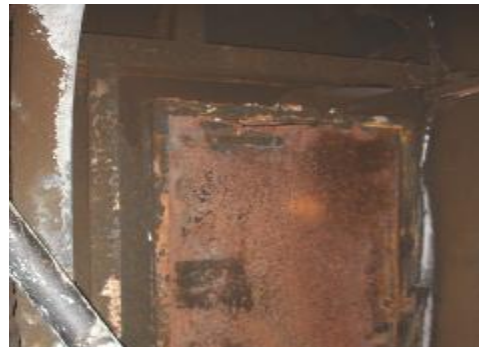
Fig.14: Engine room door at poop deck was badly burnt.

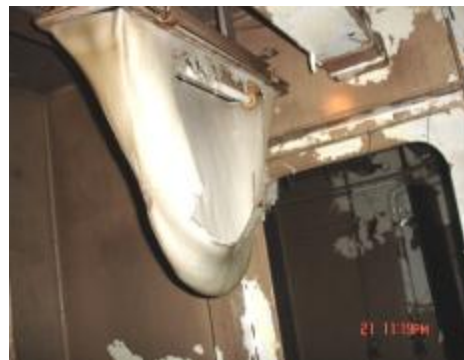
The intense heat transmitted through the bulkheads might have ignited the adjacent painted surfaces and the attached furnishings in the accommodation (see figs. 15 & 16). The safety equipment locker containing the fireman outfit and the SCBA sets was damaged by the fire (see figs 17 & 18). As this safety equipment locker was located adjacent to the engine room bulkhead, it is believed that during the outbreak of fire, smoke propagated to the storage space, deterring crewmembers from entering the space to fetch the fire fighting equipment. Furthermore, during the initial stage of the fire, the steering gear room in which another set of fireman outfit and the associated equipment, emergency fire pump and foam fire fighting system were located, had also been covered with smoke, thus the crewmembers were not able to get access to the emergency stations in the steering gear room. It is therefore apparent that after the onset of the fire in the engine room, the fire went out of control as the fire fighting appliances used for fighting the fire were out of reach by the crewmembers due to the presence of smoke.

Fig. 16: The light cover was melted by the intense heat.

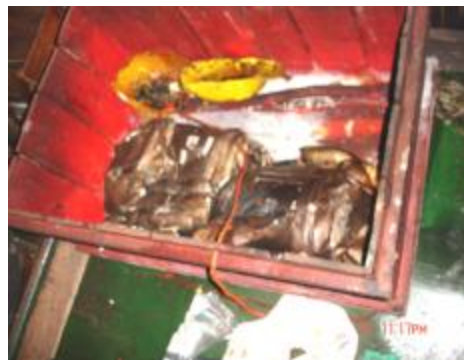
Fig. 17: Fireman outfit was damaged by the heat.

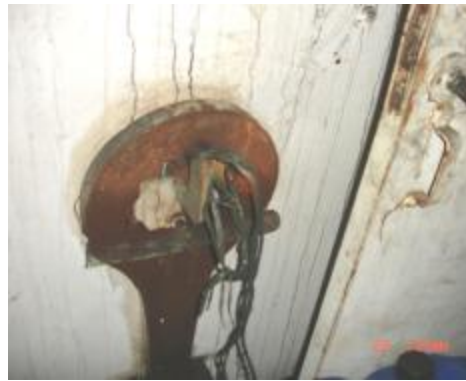
5.7.2. According to the information provided by the crew, the door leading to the steering gear flat had been kept open either by ropes or by drums during the fire (see figs. 21 & 22). The space would thus be filled up with smoke propagating from the engine room. The Second Engineer stated that the steering room door was left open for the sake of convenience. It is apparent that the fire fighting equipment there could not be used in the incident and had caused the fire to become out of control.

Fig. 21: Ropes used for securing the steering gear room door.

- ii) the pipe works should be properly maintained for the intended services;
 - iii) proper oil transfer procedures should be followed on board;
 - iv) no doors should be kept open by preventing proper function of the self closing devices; and

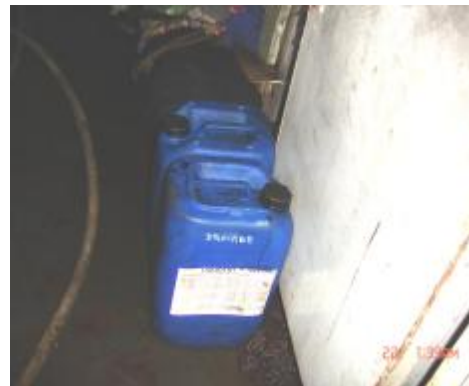
Fig. 22: Drum for keep the steering gear room door open.
