Report of Investigation into

Capsizing

of the Sailing Dingy

Stratos No.9

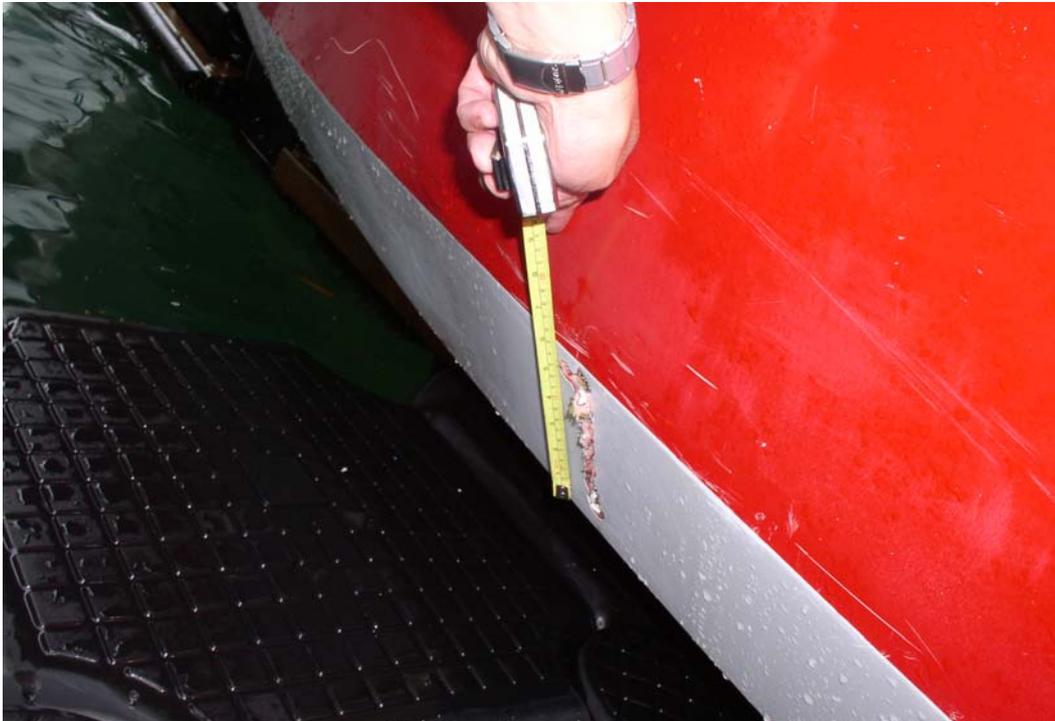
- 5.2.3 *Stratos No. 9* was inspected by a Marine Department surveyor on 24 August 2005 and its hull was found intact except a fracture damage of 12.7 cm x 1.27 cm was observed on the port side shell amidship just above the chine line (Figure 3). The vessel was equipped with

Figure 3 Fracture damage of 12.7 cm x 1.27 cm on the port side shell amidship just above the chine line

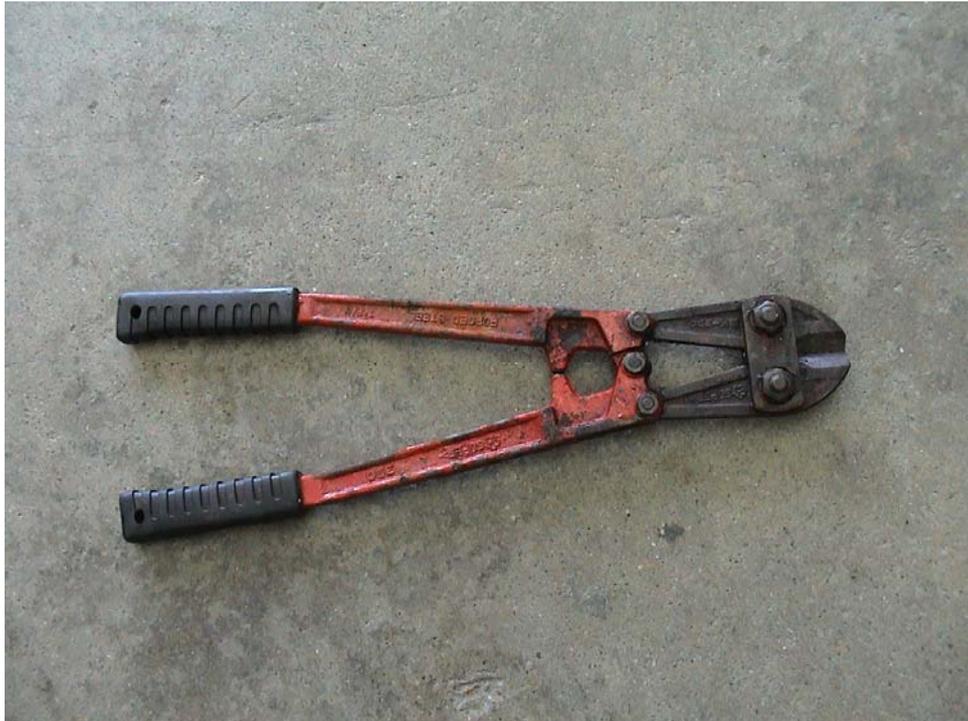
Figure 4 Wire cutter carried on board M68

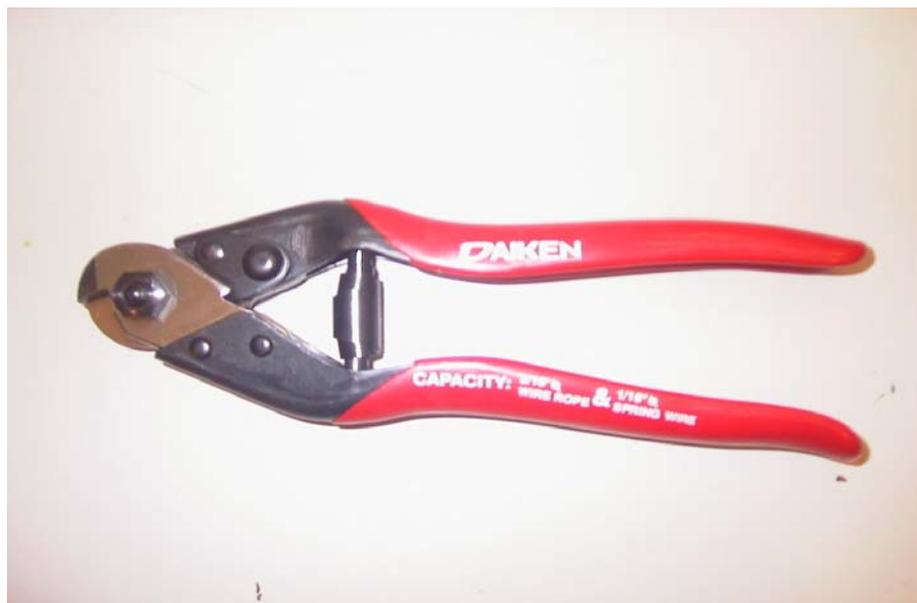
5.4.2 The items were more or less the same as those carried on the Leisure and Cultural Services Department (LCSD) safety boat except the wire cutter carried by LCSD safety boat is very handy and can be operated with only one hand (Figure 5).

Figure 5 Wire cutter carried on board LCSD safety boat

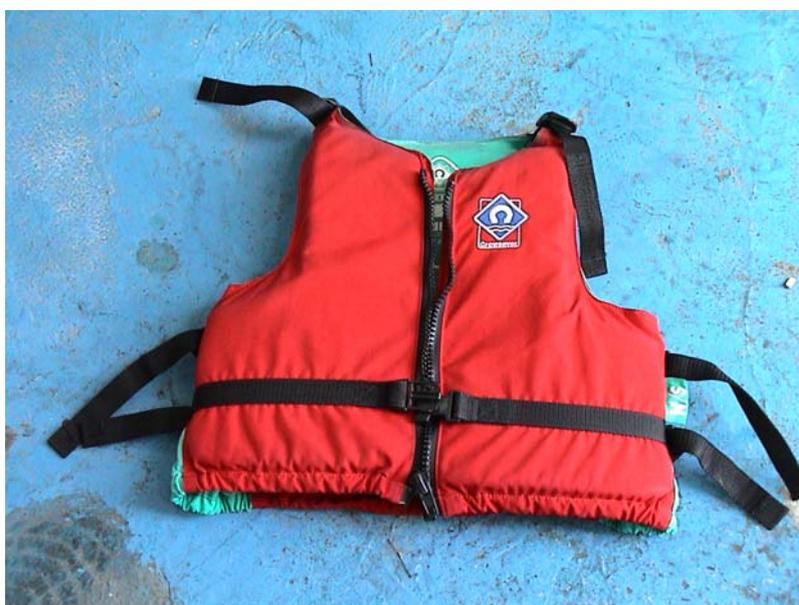
Figure 6 Small/Medium body size of 40-70 kg buoyancy aid

- 5.5.3 Alpha stated he saw a colour-coded green buoyancy aid floating on the sea nearby *Stratos No. 9* when he was trying to rescue the deceased. It is believed that the buoyancy aid belonged to the deceased. It is assumed that when the Assistant Instructor tried to pull the deceased's head out of the water by grabbing his buoyancy aid, the buoyancy aid became dislodged and came off from him.

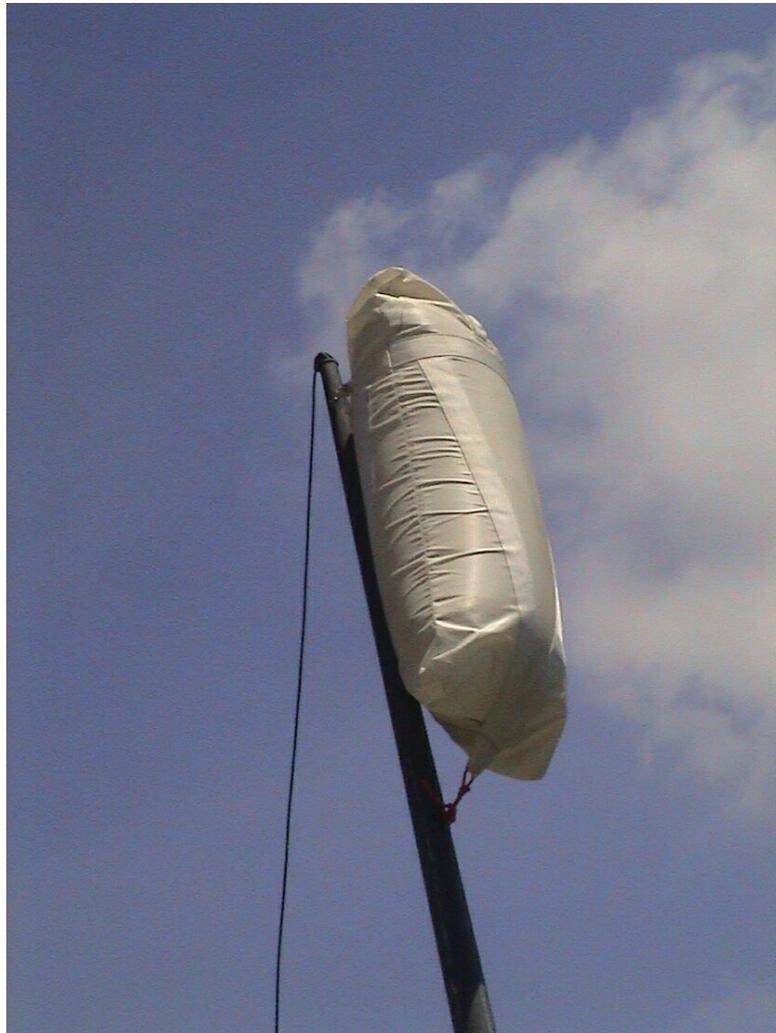
5.7.5 RHKYC stated that it had no reason to consider adopting any other form of masthead buoyancy for the boats, particularly in view of the lack of alternative suitable systems being available on the market. However, as a result of the accident and in recognition that the mainsail flotation panel failed to resist inversion in the conditions prevailing on the day, additional masthead flotation devices have now been fitted to the boats. These have been designed by the Club and made locally by a sailmaker. Figure 7 illustrates the type of additional mast head flotation device consisting of a fully inflated tube.

Figure 7 Inflated Tubes type Additional Mast Head Flotation Device

- 6.5.5 After capsizing of the *Stratos No. 9*, one of the students had clung to *Stratos No. 9* making it inverted faster; and
- 6.5.6 *Stratos No. 9* was not equipped with a mast flotation device which might be able to prevent the dinghy from totally inverted.

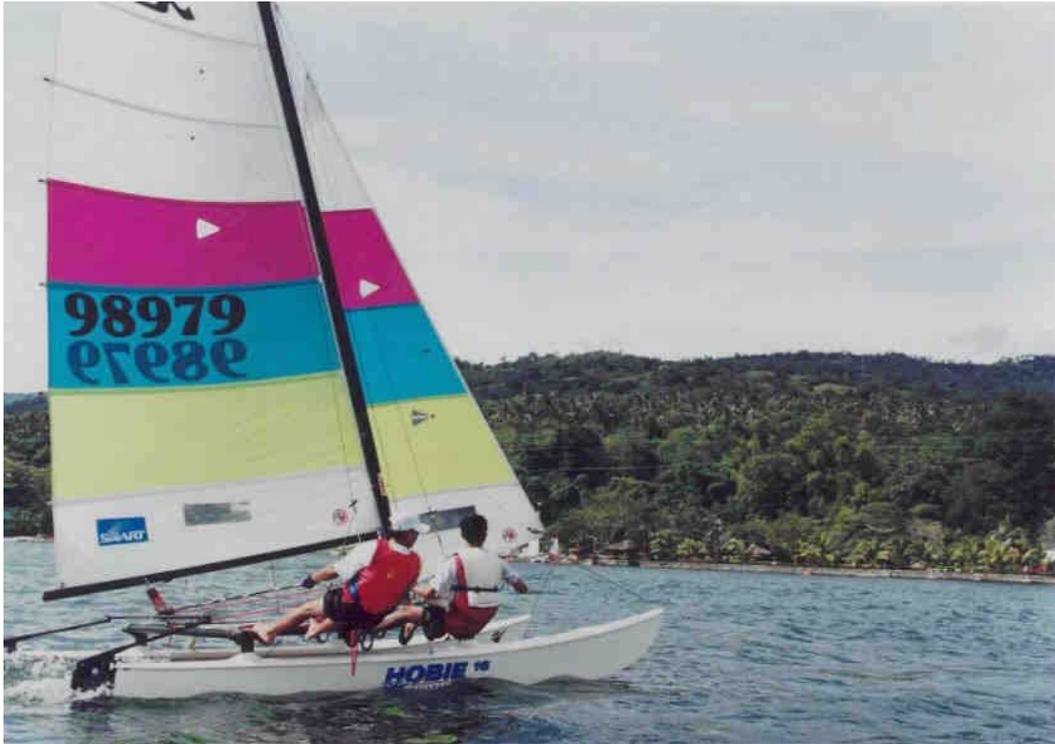
5.7.6 The Stratos dinghies are fitted with trapeze wires. The trapezes are provided for crew with sailing experience to use to help keep the dinghy sailing flat under good wind conditions. With less wetted surface when sailing flat, the dinghy sails faster through the water. When using the trapezes, the crew wears a body harness with a device to hook onto the wire's adjustable rope tail and stands up on the boat's edge leaning out to windward (Figure 8).

Figure 8 Students use the trapeze wire to balance the dinghy under strong wind.

5.7.7 There is no requirement to remove the trapeze wires if not being used and these are stowed in a standard arrangement at the front of the boat's cockpit. However if the trapeze wires are stowed in such position, the danger of entanglement exists.

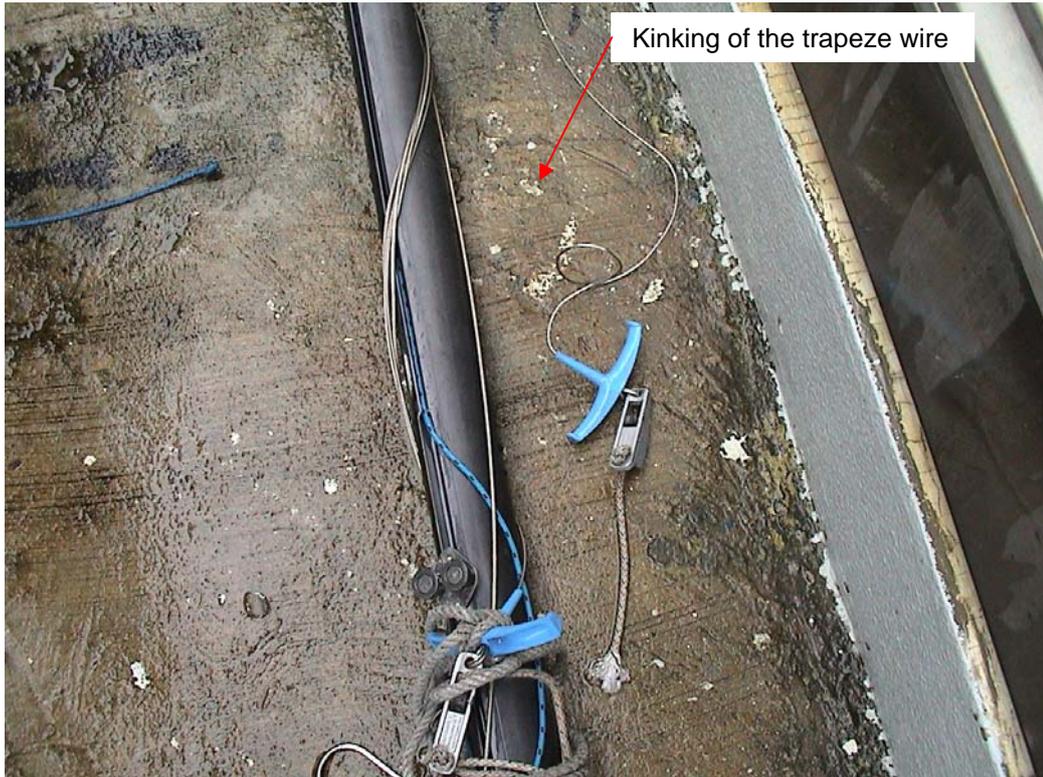
- 5.8.2 After capsizing of *Stratos No. 9*, one of the students had clung to *Stratos No. 9* making it invert faster.
- 5.8.3 According to the Autopsy Report, it appears that the left leg of the deceased was accidentally entangled by the trapeze wire. It was evident that a segment of the trapeze wire was kinked into a circle measuring roughly 30 cm in circumference (Figure 9). Once his left leg was entangled, it was very difficult for him to set it free because the trapeze wire was connected to an elastic cord which was secured to the gunwale of the dinghy. The elastic cord and the connection rope was subsequently cut off by the Marine Police but the deceased had already been drowned after submerging in the water for a prolonged period of time.

Figure 9 The Trapeze wire was kinked with a loop

- 6.5.4 In view of the nature of this entrapment, the simple presence of trapeze wires on dinghies being sailed by young sailors is not an advisable practice;

- 7.1 It is recommended that a letter should be issued to the RHKYC requesting them to review their safety guidelines, safety measures and procedures for sailing to ensure safety especially procedures for capsize drill, rigging of trapeze wires and communication.
- 7.2 It is also recommended that the RHKYC should exchange information with Royal Yacht Association of Great Britain, other Yacht Association and Leisure and Cultural Services Department, Hong Kong for time to time to promote the safety of yacht sailing.
- 7.3 It is further recommended that RHKYC should ensure their Instructors and Assistant Instructors fully familiarize with procedures for handling situations in time of emergency.
