Report of Investigation
into the Grounding of the
Local Passenger Ferry “Xin Jie”
on 12 May 2006

The Hong Kong Special Administrative Region
Marine Department
Marine Accident Investigation Section

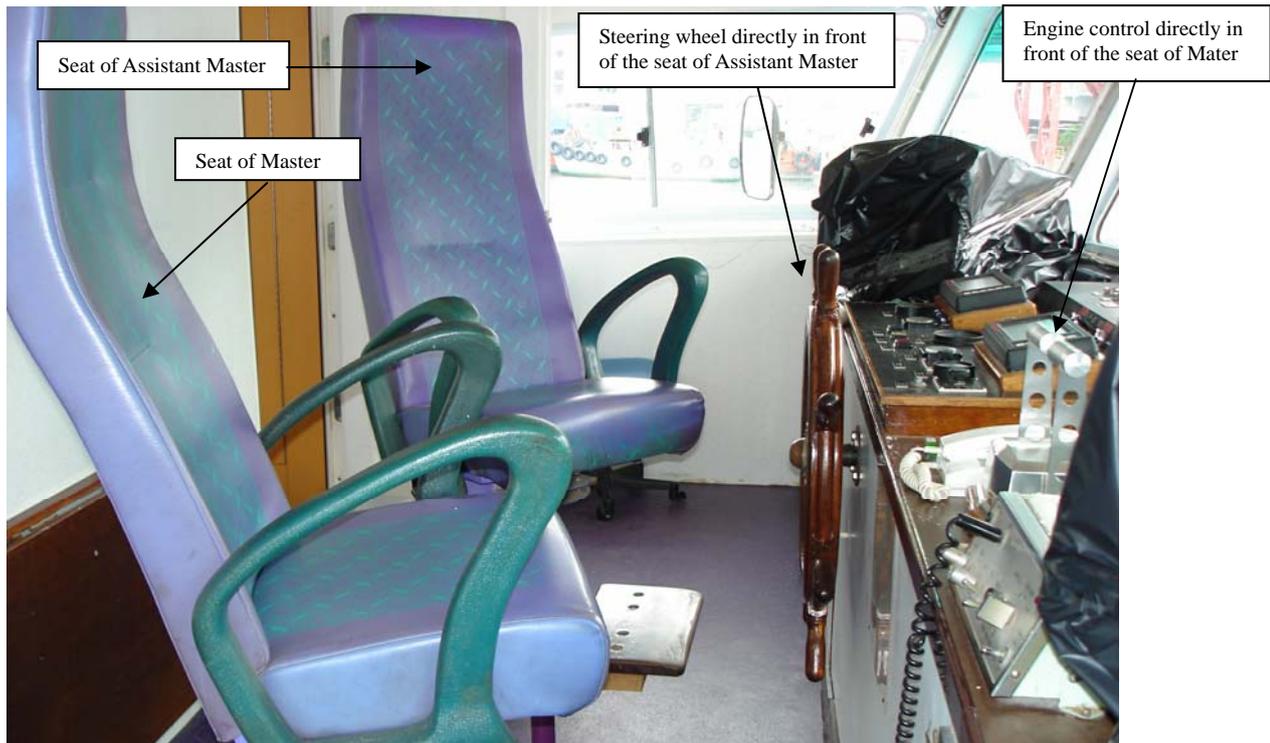
Figure 5 – Bridge Layout of *Xin Jie*

5.7.1 Noting that the Assistant Master suddenly fell unconscious and fell on the steering wheel, the immediate action of the Master was trying to lift the body of the Assistant Master so that he could steer the wheel to port. The Master also put the engines astern to prevent the vessel from running aground. If the Master put the engines astern first prior to lifting the body of the Assistant Master, there might be a chance to save the vessel from running aground. However, it is a natural instinct for every master to take immediate and effective action by steering the vessel away from the potential dangerous area before first stopping the engine and engaging the astern movement of the vessel. The Master also under-estimated the time needed to lift the heavy body of the Assistant Master and this had caused delay in taking action to avoid grounding. Figure 5 depicts that the position of the steering wheel was directly in front of the seat of the Assistant Master while the position of the engine control was directly in front of the seat of the Master. The Master had an easy access to the engine control but it was less convenient for him to reach the steering wheel as it was positioned directly in front of the Assistant Master.

- 6.5 It is believed that the probable cause of grounding was due to sudden onset of dizziness the Assistant Master suffered due to transient ischemic attack when he was altering course to starboard to keep clear of a floating rope and the lack of time for the Master to regain control of the steering of the vessel.

- 7.1 New World First Ferry Services Limited should require their master /assistant master to inform the company if they are ill or have taken medicines.
- 7.2 New World First Ferry Services Limited should prepare a contingency plan for master/assistant master to handle unexpected sudden collapse of master/assistant master.
