Report of Investigation
into the fatal accident on board
the Hong Kong Registered ship
“Saga Spray”
on 16 November 2006

The Hong Kong Special Administrative Region
Marine Department
Marine Accident Investigation Section

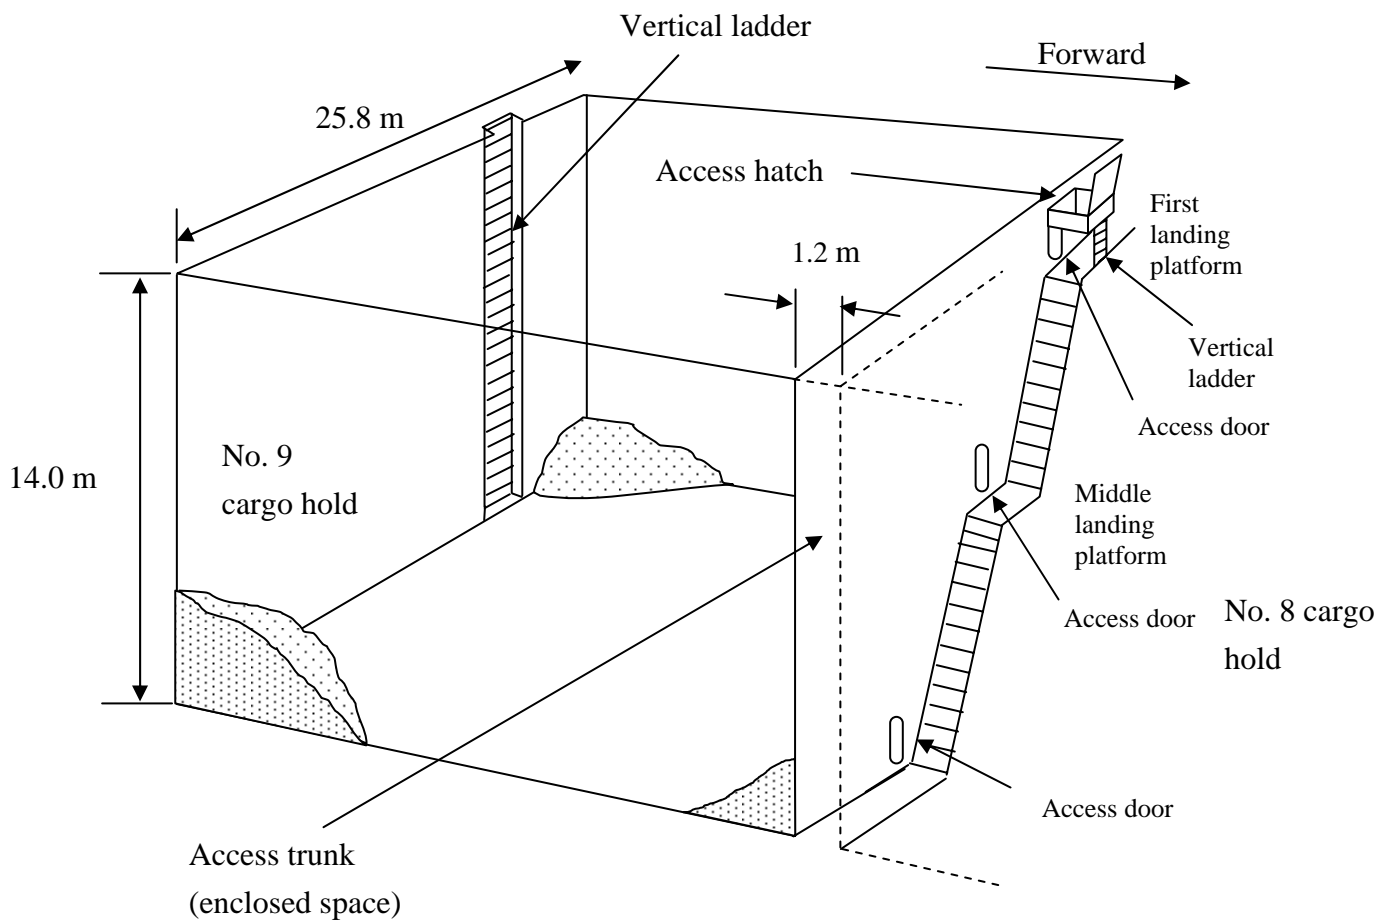
Figure 4: Sketch of the access trunk and cargo holds.

5.2 There are two means of access to No. 9 cargo hold from the main deck. The first was a vertical ladder that was mounted at the aft of the cargo hold. The second was an enclosed stair trunk located at the forward of the cargo hold (see figure 4). The enclosed stair trunk fitted with stairways and access doors for personnel to get entry into the cargo hold. To enter the cargo hold, the enclosed stair trunk would be used whenever cargo work was in progress.

- 5.3 The enclosed stair trunk was about 1.2 m width and 14 m depth. There was no means of mechanical ventilation fitted.
- 5.4 The access doors were non-watertight steel doors. The atmosphere of the cargo hold could get into the enclosed stair trunk through the gaps between the bulkhead and the doors (see figure 5). Gases could be trapped inside the trunk even the hatch was opened for a period of time.

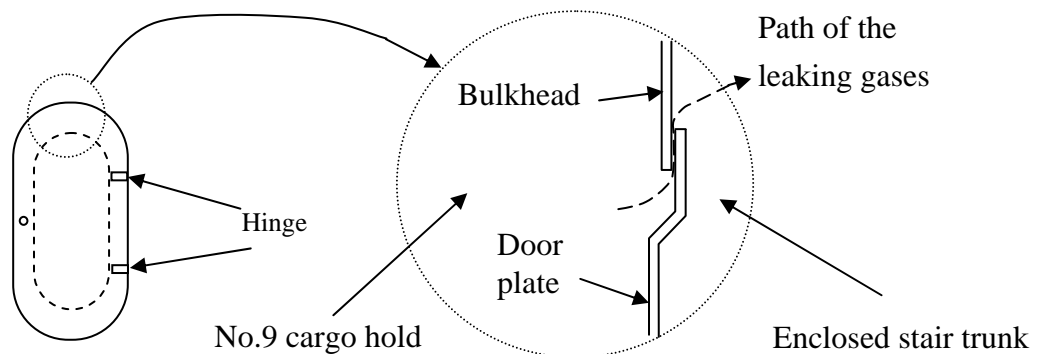
Figure 5: Sketch showing gases may leak through the gap into the enclosed stair trunk

When the cargo holds containing wood pellets had been closed for a period of time, the wood pellets would consume oxygen and emit carbon monoxide. The atmosphere inside the cargo hold could get into the enclosed stair trunk through gaps of the three access doors. Apparently, the atmosphere in the enclosed stair trunk contained a high level of carbon monoxide and depleted in oxygen.

- The enclosed stair trunks should be properly ventilated preferably by mechanical means and tested for the safety levels of oxygen and carbon monoxide prior to the entry of personnel;
- Wood pellets are classified as Group B cargoes, the Master and the Crewmembers should be well aware the safety requirements stipulated in the BC Code.
- Appropriate warning signs should be displayed at the entrances of the stair trunks.
