Preliminary Inquiry No.1 of 2008

Report of Investigation
into the Collision between
two Hong Kong registered
high-speed passenger ferries

Funchal

and *Santa Maria*

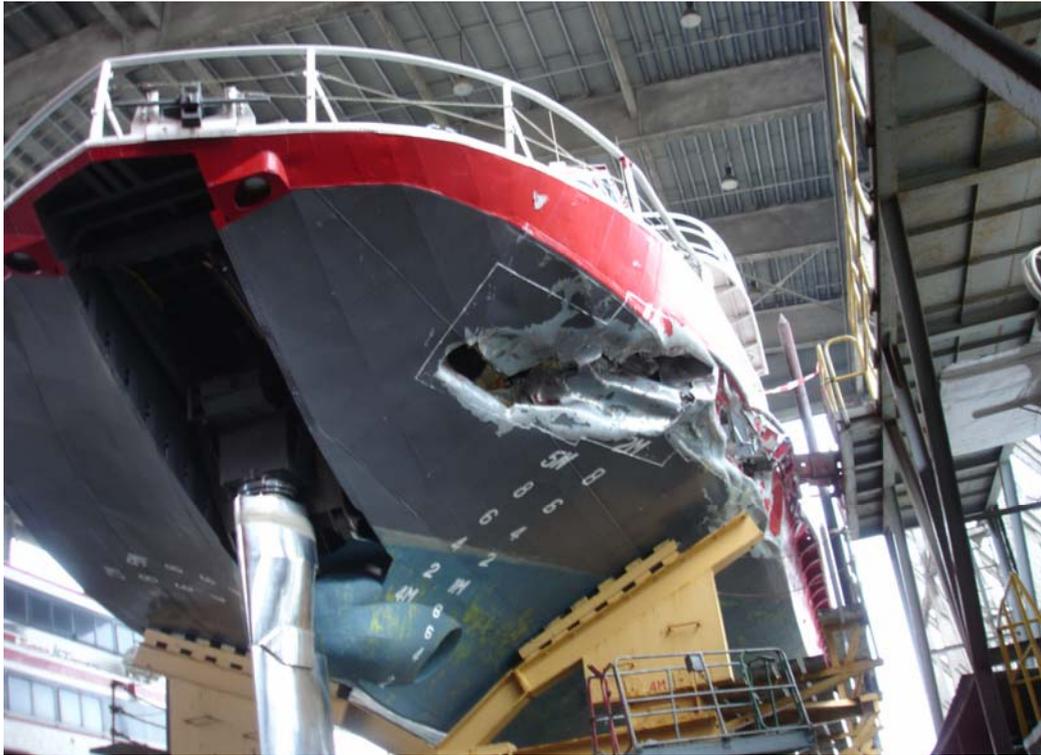
Figure. 1- Port bow damage of *Santa Maria* (金星)

5.7.1 At the time of collision, the port shoulder of *Santa Maria* struck the starboard bow of *Funchal* causing both vessels to sustain serious bow structural damages (Figures 1 & 2). Some passenger seats within the cabin of *Funchal* had deformed due to violent impact force caused by collision. Both vessels remained upright after the collision and there was no ingress of sea water into the compartments of the vessels. No oil pollution was found.

6.3 *Santa Maria* sustained structural damage to its port bow while *Funchal* sustained structural damage to its starboard bow. 133 persons including passengers and crew on board the two jetfoils were injured.

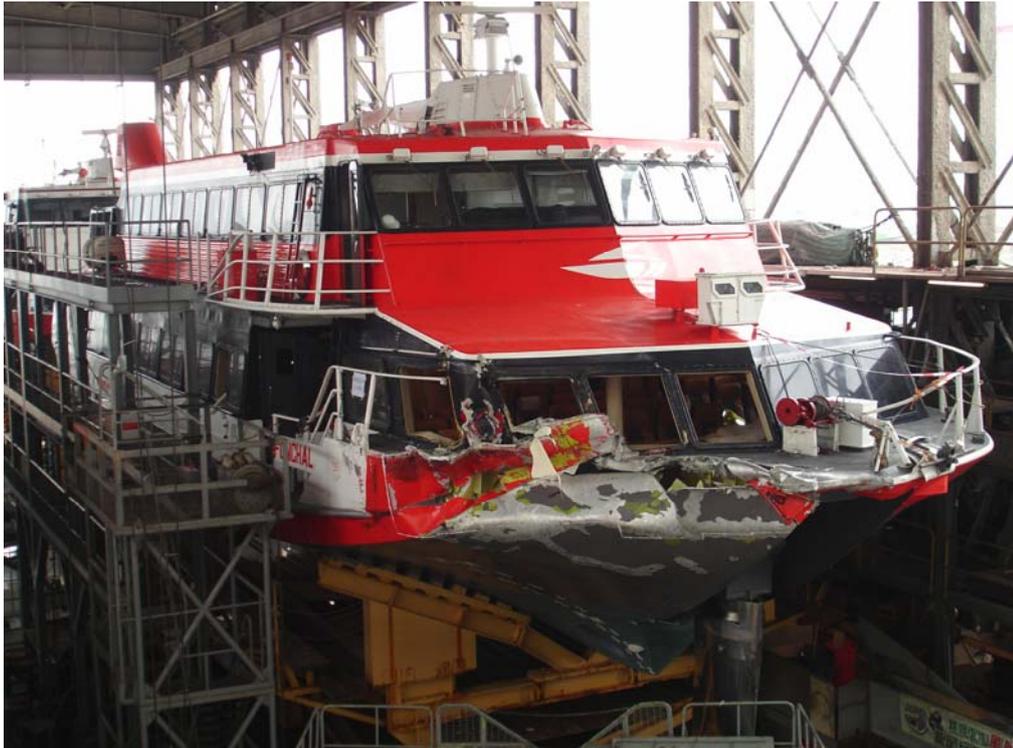
Figure. 2- Starboard bow damage of *Funchal* (天皇星)

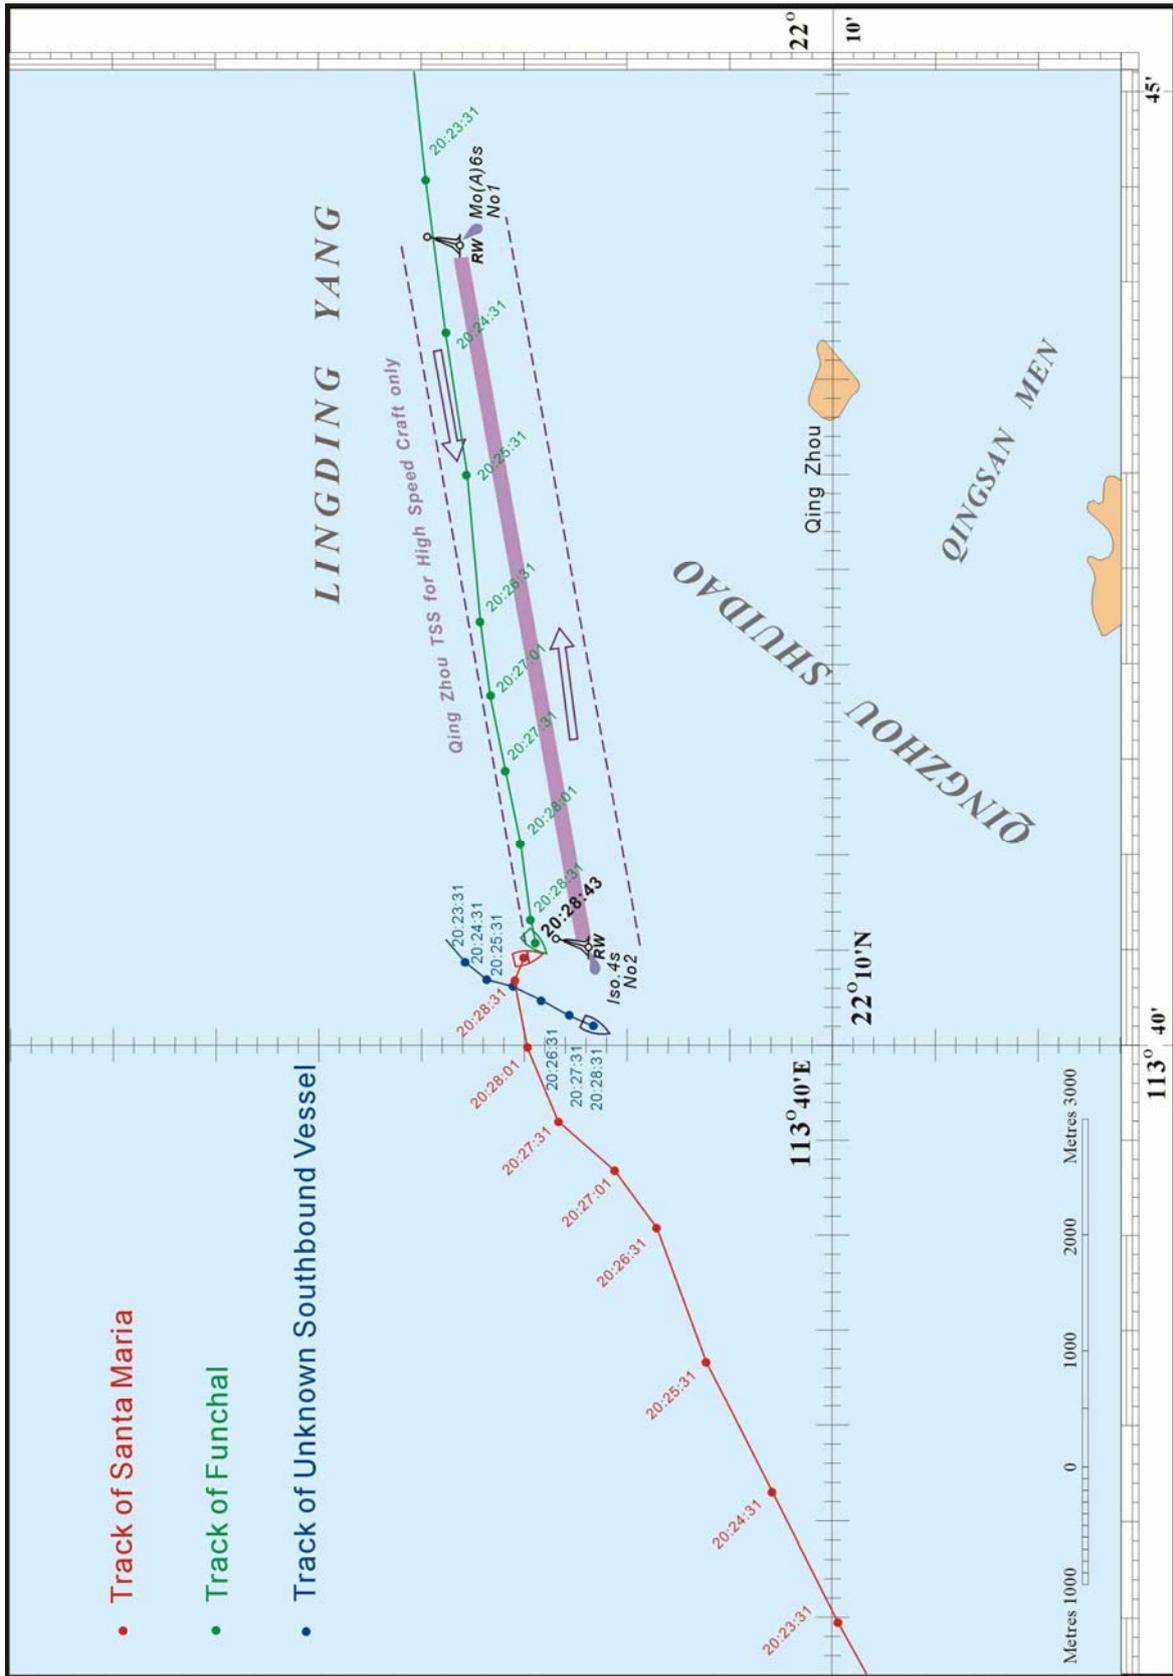
5.4.1 According to the record of the VTS system of Macau Maritime Administration, at about 2023 *Santa Maria* altered course to port to 064°T and increased to foilborne speed of about 40 knots at about 2024. Then the vessel made a slight alteration of course to starboard to 069°T at about 2025. At about 2026, *Santa Maria* altered course to port to about 050°T with an intention to keep clear and pass the stern of an unknown southbound vessel as indicated in the radar plot. At about 2027, *Santa Maria* commenced a turn to starboard intending to enter the Qing Zhou Traffic Separation Scheme. However, the vessel collided with *Funchal* at about 2028 (Figure 3).

- 5.5.1 According to the record of the VTS system of Macau Maritime Administration, after entering the Qing Zhou Traffic Separation Scheme at about 2023, *Funchal* maintained a course of about 262°T with a foilborne speed of about 44 knots until the time of collision with *Santa Maria* at about 2028 (Figure 3).
- 5.5.2 When the Master and the officers of *Funchal* observed the green sidelight of *Santa Maria* visually on the starboard side, they assumed that *Santa Maria* would pass clear on the starboard side and would then turn round the stern of *Funchal*. However, *Santa Maria* altered course to starboard and hit *Funchal*. In order to allow more time to assess the situation, he should follow COLREGS by reducing the speed of the vessel until *Santa Maria* was finally past and clear.

Figure 3 - Radar Plot showing the collision tracks of *Santa Maria* and *Funchal* and the track of an Unknown southbound vessel
