Report of Investigation  
into the fatal accident happened  
on board *m.v. "Najran"* at  
Kwai Chung Container Terminal  
on 15 May 2008

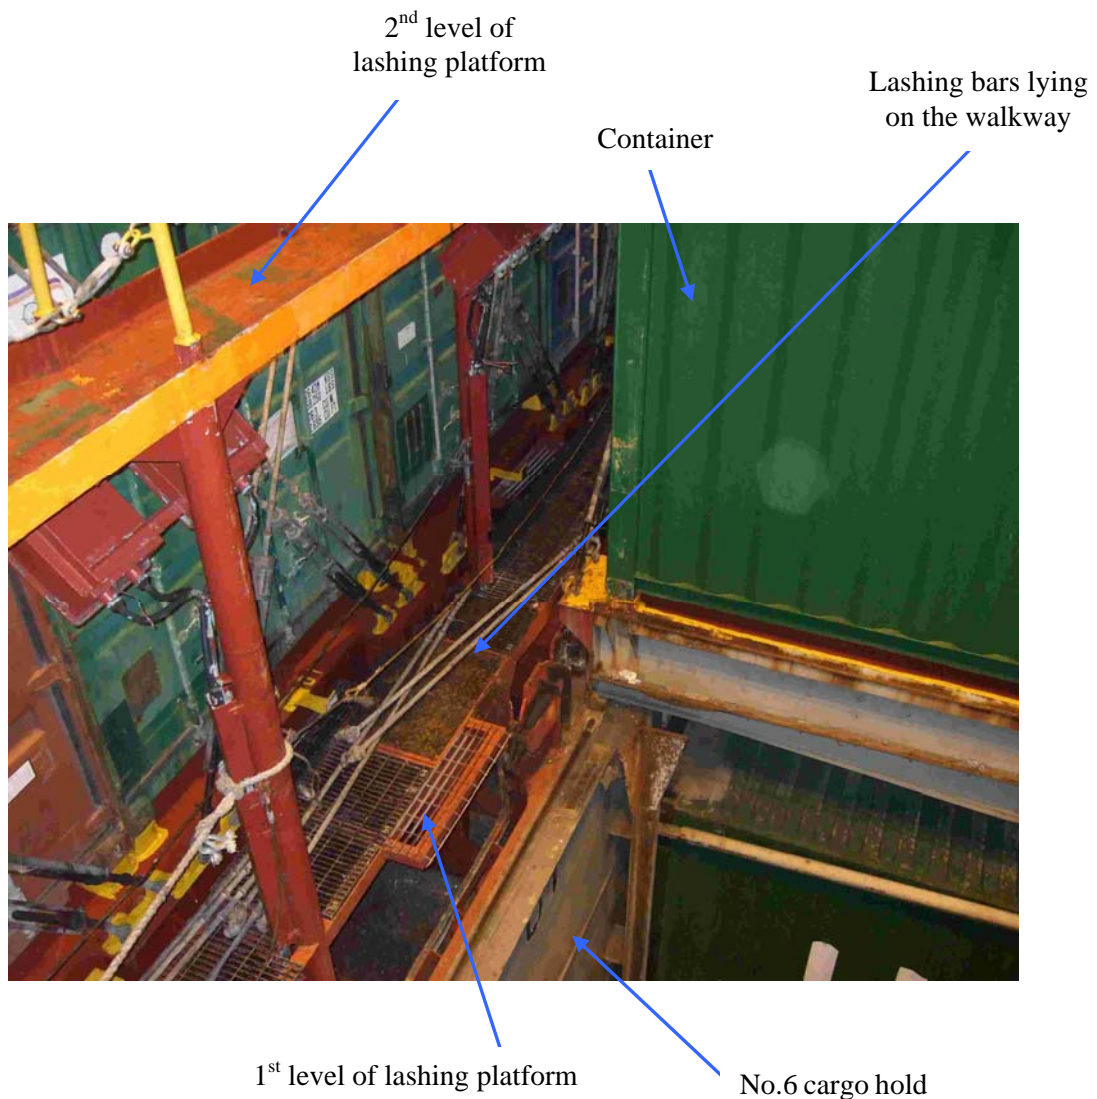
The lashing platform on the main deck in between No.5 and No.6 cargo holds of the *Vessel* is of 2 levels (see Fig.2) and made of steel. The walkway at the first level of the platform is about 2 metres above the main deck and the headroom of the walkway is about 2.6 metres. The width of the walkway is about 0.59 metre. Electric power supply socket outlets of voltage 440 volts, a.c., are installed along the walkway for the use of refrigerated containers (see Fig.3). Stevedores usually stand on the lashing platform to secure container stacks on the deck/hatch covers with lashing bars and turnbuckles.

Fig. 2: The Lashing Platform in between Nos.5 & 6 Cargo Holds on M.V. "Najran"

5.12 There were lashing bars lying on the walkway (see Fig.2). There was a foreseeable risk for the stevedore at the walkway of tripping and falling.

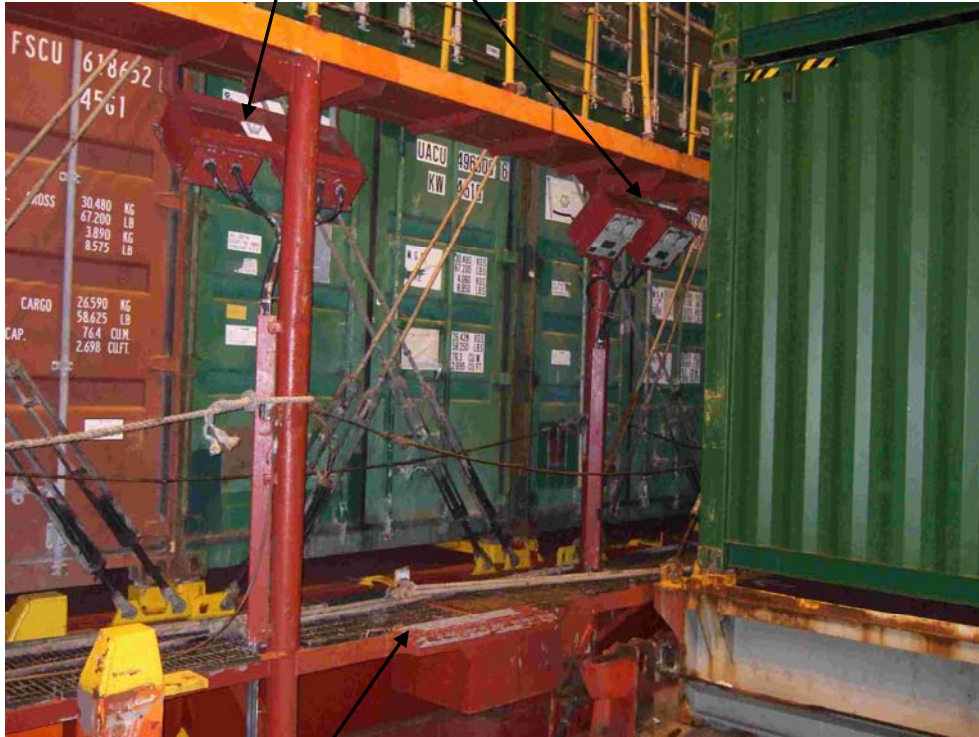
Electric power supply socket outlets

1<sup>st</sup> level of lashing platform

Fig. 3: Electric Power Supply Socket Outlets Installed along the Walkway of Lashing Platform

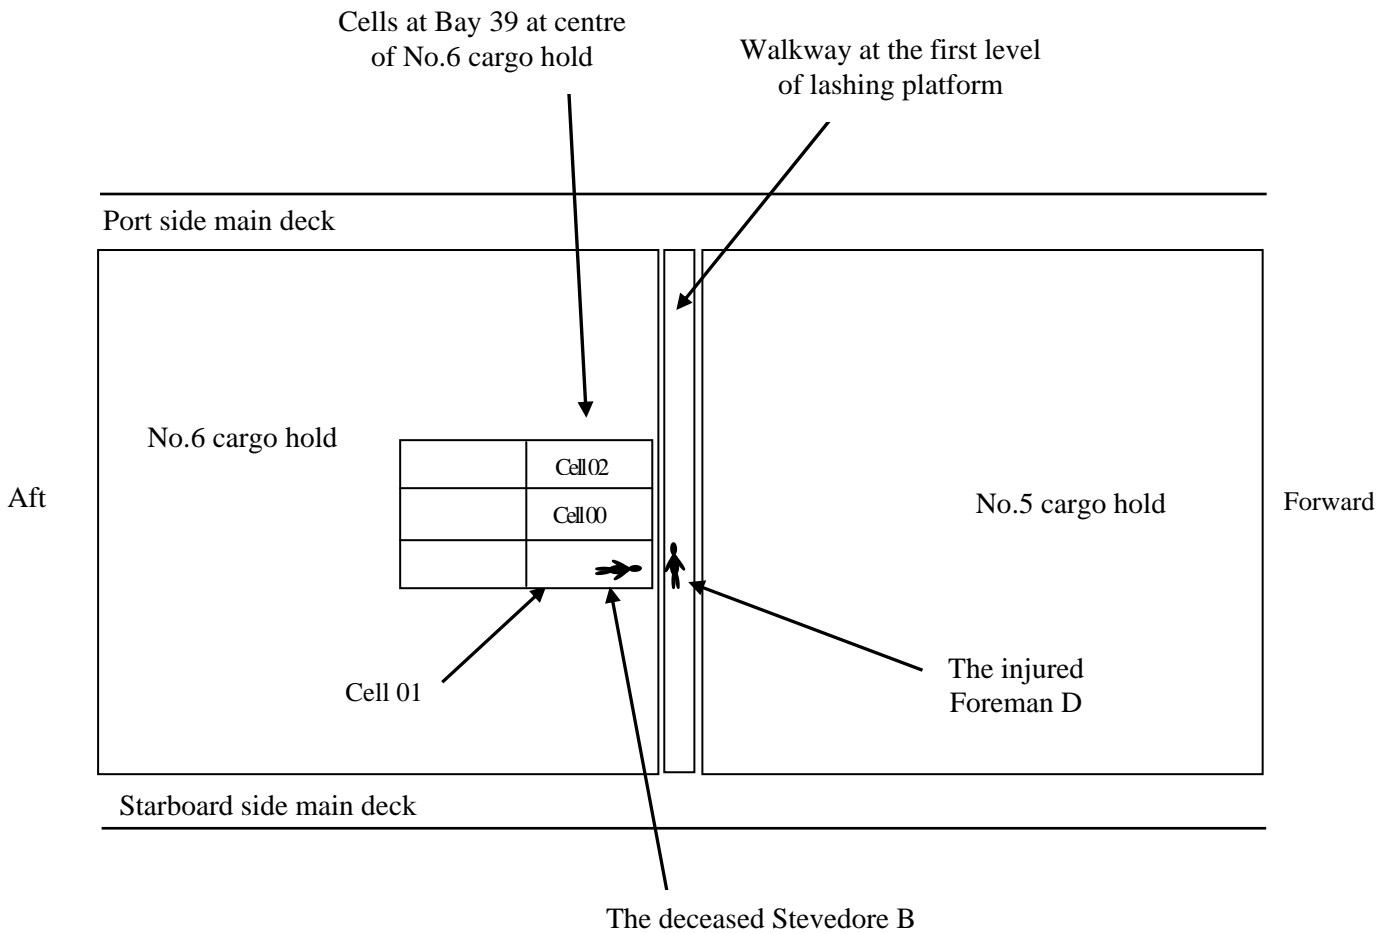
- 4.8 A stevedore foreman ("Foreman D") who was working at shore near the *Vessel* learnt the incident through walkie talkie and he rushed on board to the scene at once. On the way he felt pain at his neck and became dazed on the walkway at the first level of the lashing platform in between No.5 and No.6 cargo holds and he fell down on the walkway (see Figs.6, 7 & 8).

Fig.7: The Scene of Accident on M.V. "Najran"

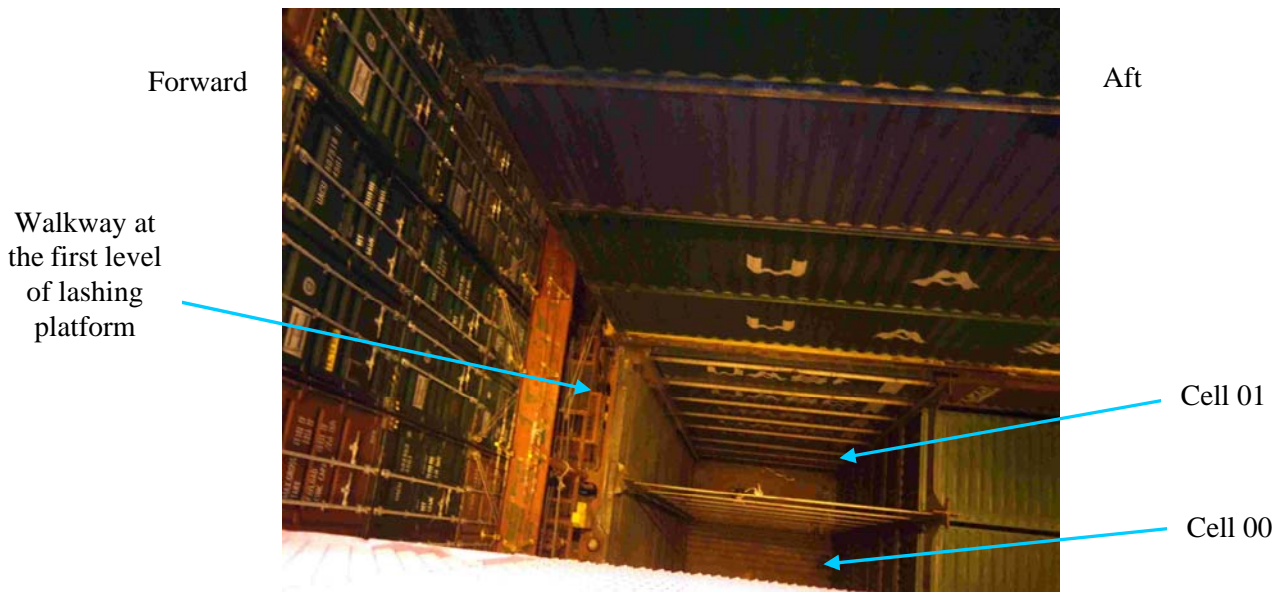
Fig.8: The Cell 01 in No.6 Cargo Hold at Bay 39 on M.V. "Najran"

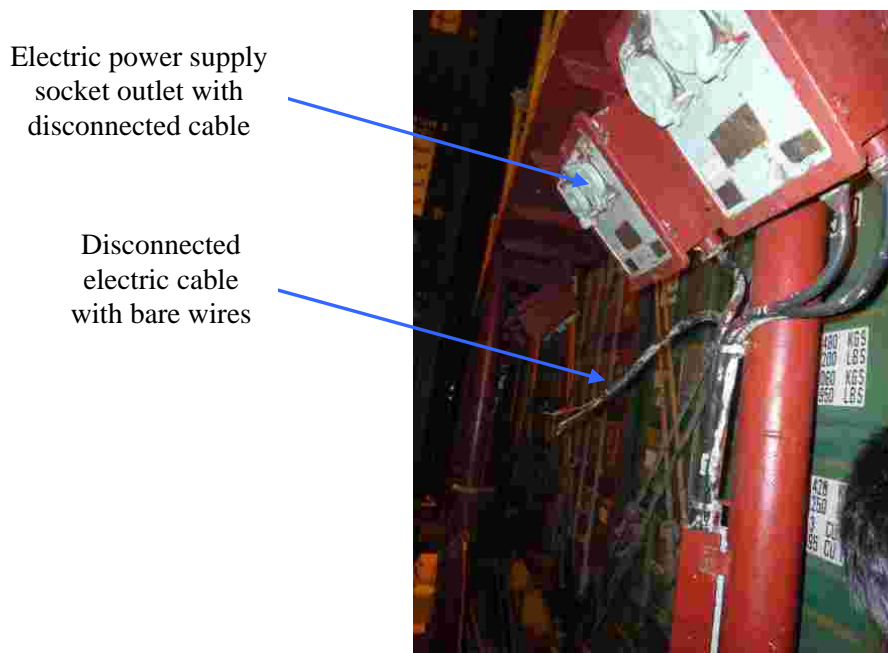
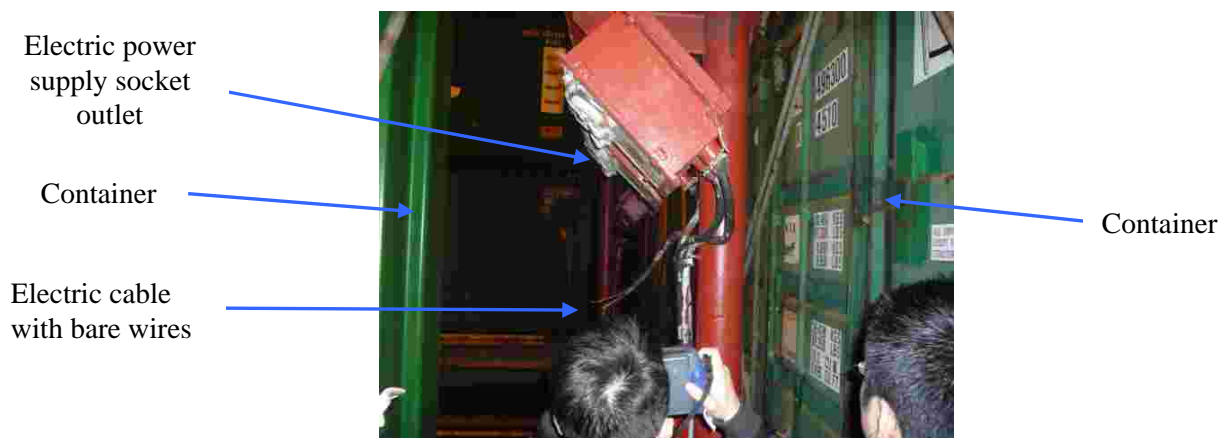
- 5.1 An electric cable with three bare electric wires was found in the walkway at the first level of the lashing platform between No.5 and No.6 cargo holds of the *Vessel* (see Figs.9 & 10). The cable was the power supply cable and it had been disconnected from an electric power supply socket outlet near Cell 01 of Bay 39.

Fig.9: The Electric Cable with Bare Wires at the Walkway on M.V. “Najran”

Fig.10: The Electric Cable with Bare Wires at the Walkway

- 5.7 The bare ends of the electric wires were estimated at 1.65 m high above the walkway. The height of the deceased was about 1.6 m. Hence the deceased might not contact the bare wires at the walkway at the time of accident. The height of the injured Foreman D was about 1.78 m, hence his head or neck would easily contact with the bare wires when he rushed to the scene of accident.

- 5.8 The power supply to the electric wires was 440 volts, a.c. Power had been off deck when the *Vessel* was in dry dock two weeks before the accident. Though there was no refrigerated container carried on board, to supply power to a cleaning machine, power was on deck at the time of accident and the electric wires were live. The circuit breaker of the electric power supply socket outlet was found tripped after the accident.

5.9 Under section 5 of the Shipping and Port Control (Works) Regulation, Cap.313 subsidiary legislation, dangerous parts, such as live electric conductors, of a workplace should be securely fenced.

- 7.1 A copy of this report should be sent to the employer of the stevedores, ship manager, Master of the *Vessel* and flag state advising them the findings of this accident.
- 7.2 A Marine Department Notice should be issued to promulgate the lessons learnt from this fatal accident, drawing the industry's attention on the findings of this accident and urging them to comply with the safety requirements under the Shipping and Port Control (Works) Regulation and to carry out inspection of the electric power supply cables at lashing platforms after cargo operation in order to prevent recurrence of similar accidents.

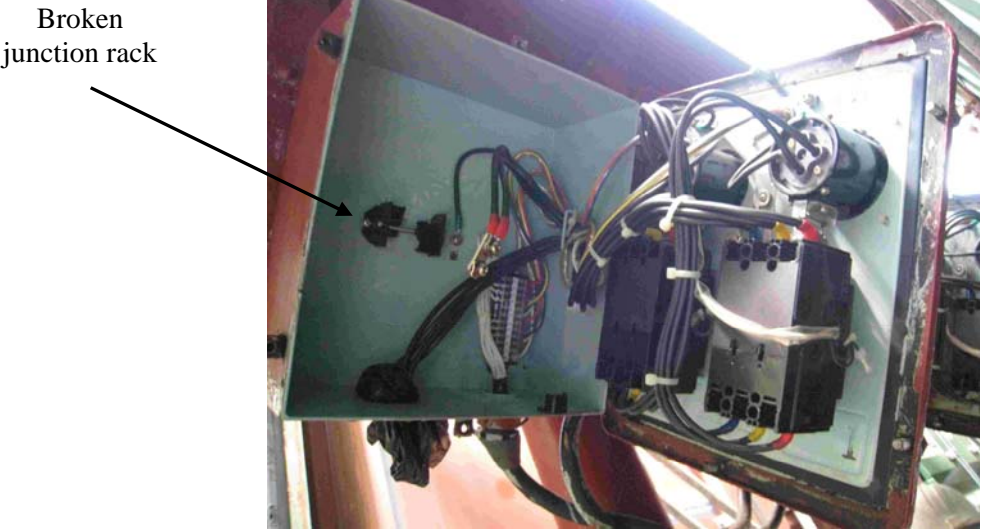
5.2 Inside the electric power supply socket outlet, it was found that the plastic junction rack for connecting the power supply cable had been broken (see Figs.11 & 12).

Fig.11: Broken Junction Rack inside the Electric Power Supply Socket Outlet

- 5.6 It is highly probable that the wires were detached by force when the power was off deck some time before the accident. It is probable that the power supply cable had been struck by a hoisting/lowering container at the loading/discharging port in the two weeks time before the accident.

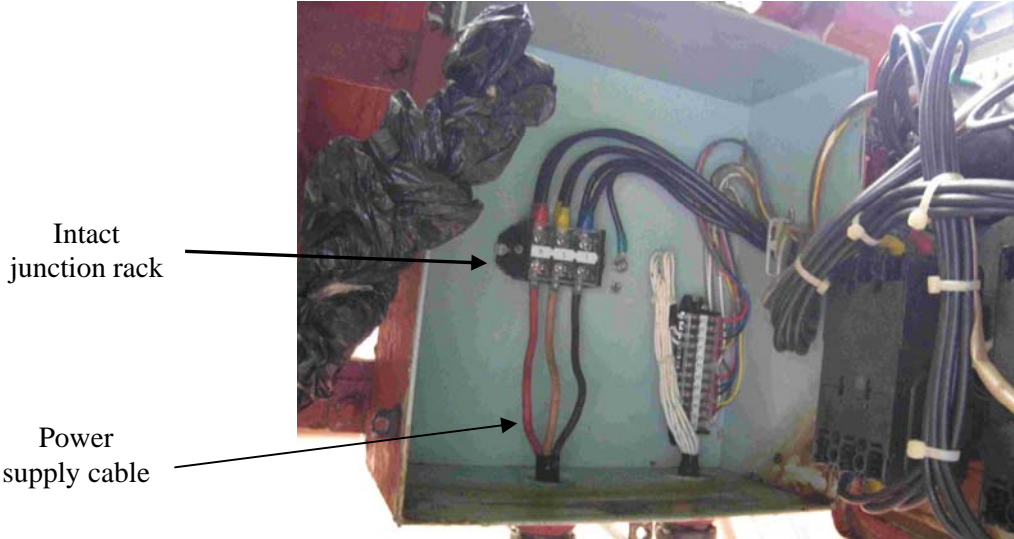
Fig.12: Intact Junction Rack inside an Adjacent Electric Power Supply Socket Outlet

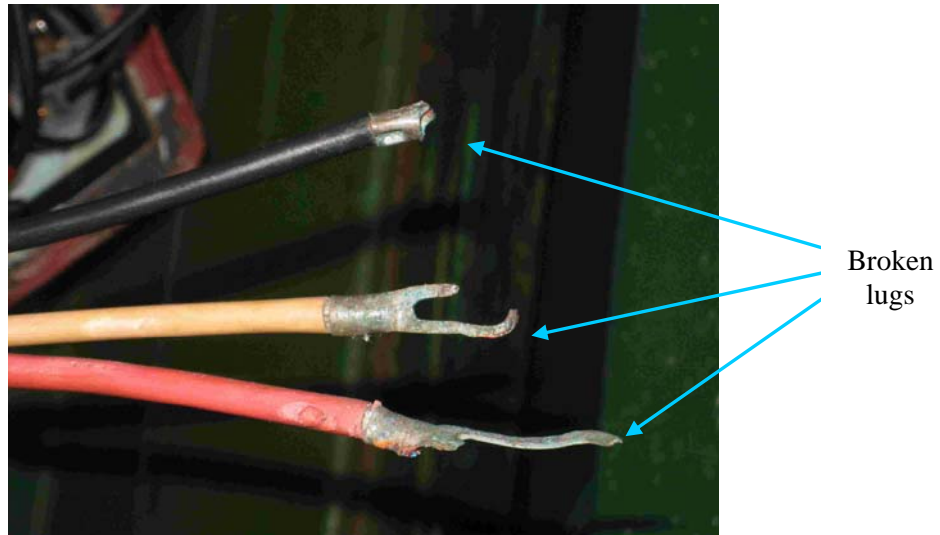
5.3 The lugs of all the three bare wires of the power supply cable were found broken (see Fig.13). Evidence suggested that they were detached from the junction rack by force.

Fig.13: The Electric Power Supply Cable with Bare Wires at the Walkway

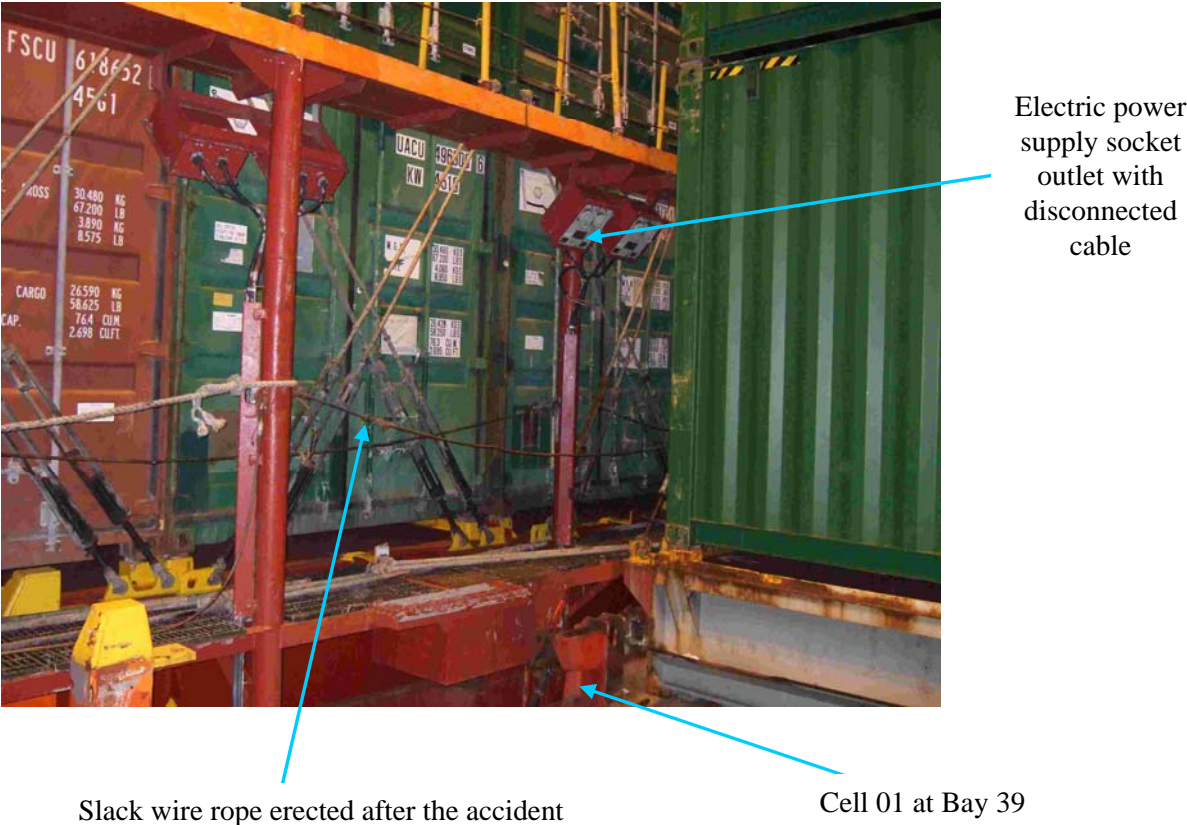
Fig. 14: Walkway of the Lashing Platform

5.13 The walkway was designed with taut wire ropes and stanchions to provide fencing throughout on both sides. It was said that the wire rope had been removed before the

accident and no fencing was erected on the walkway at the aft side where the hatch cover at the No.6 cargo hold was removed. A slack wire rope was erected as fencing after the accident (see Fig.14). Even the wire rope had been erected before the accident, it could hardly prevent persons falling over since it was too slack. Hence there was a foreseeable risk for the stevedore at the walkway of falling down to the bottom of the cargo hold.

5.14 Under section 5 of the Shipping and Port Control (Works) Regulation, a workplace should be securely fenced to prevent persons falling.
