**Report of investigation into the
death of an Assistant Electrical
Officer inside a ship elevator on
board the Hong Kong registered
bulk carrier vessel *Taiju* at the
Ube Anchorage in Japan
on 13.12.2011**

The Hong Kong Special Administration Region
Marine Department
Marine Accident Investigation Section

29 May 2013

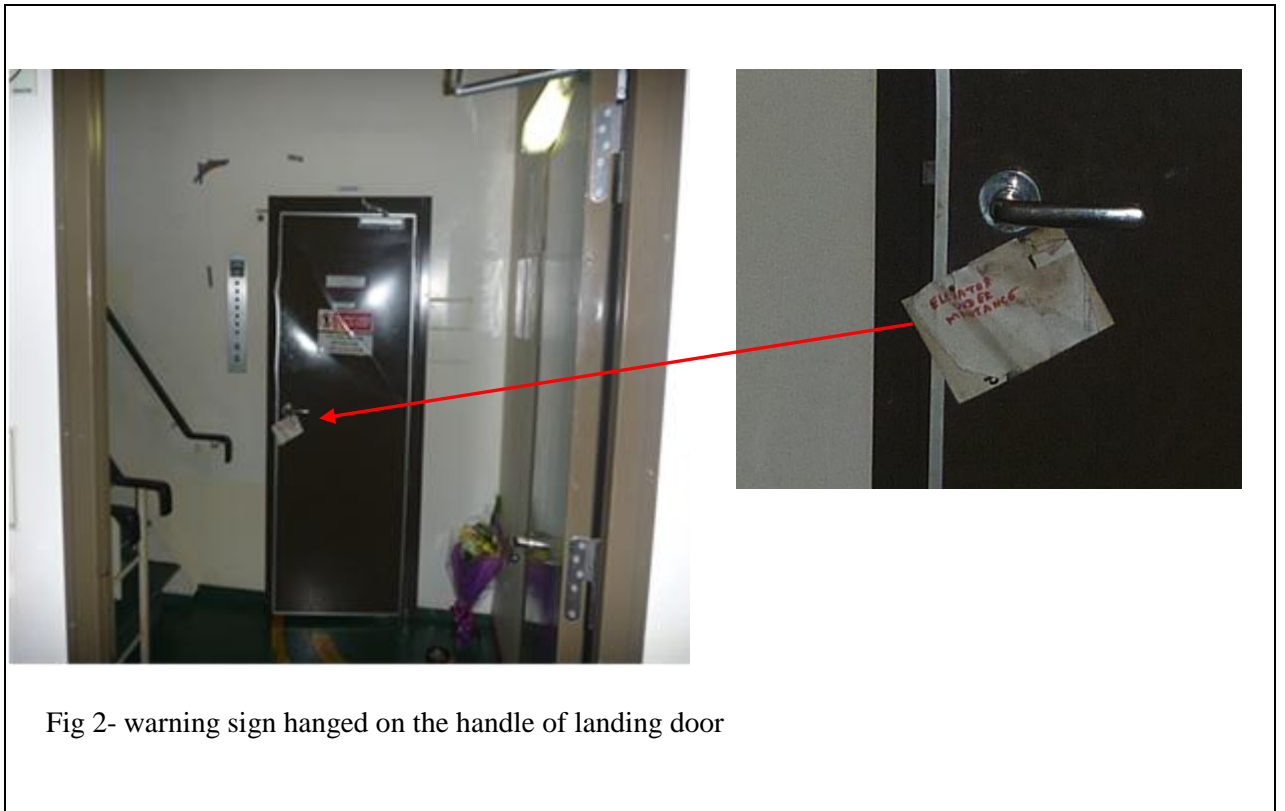
- 4.6 After the lunch break at about 1305 hrs, the AEO and the Fourth Engineer reported to the Second Engineer that they would start inspecting the elevator. The Second Engineer told him to take all precautions and follow the procedures again. At about 1310 hrs, they hanged red colour hand-written warning tags “Elevator Under Maintenance” on every elevator landing door handle of each floor (Fig 2).

5.7 When the AEO and the Fourth Engineer started the inspection of the elevator after lunch break, they hanged a piece of paper written in red letter “Elevator Under Maintenance” warning tags instead of the “UNDER MAINTENANCE – DO NOT USE” on the handle of elevator door landing door on each floor without making or arranging to make the announcement as required in sub-paragraph 5.5(e) above.

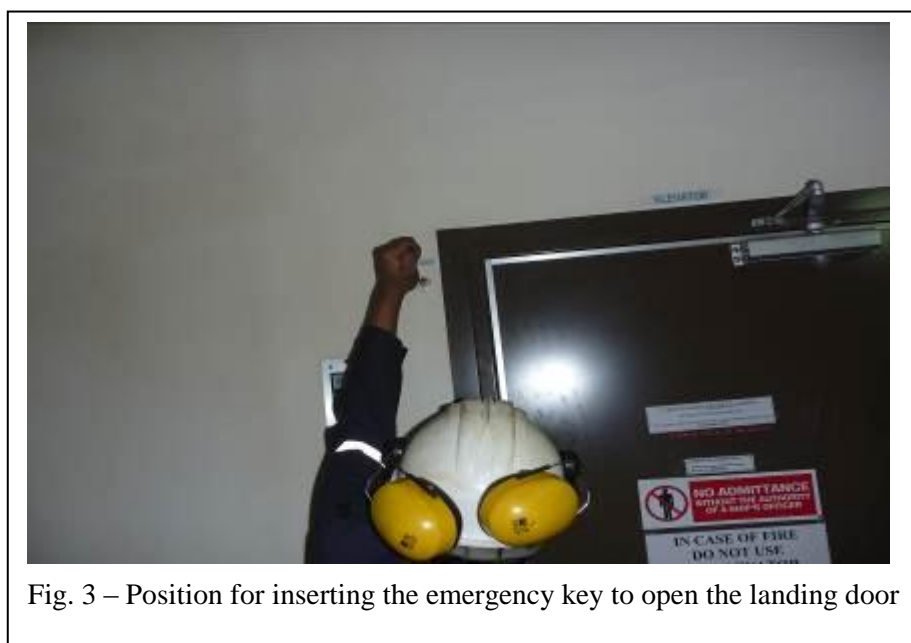
- 4.7 At about 1315 hrs with the cage parked in the A-deck, the AEO used the emergency key (Fig 3) to open the landing door on B-deck. He asked the Fourth Engineer to go on top of the cage to change over the AUTO-MANUAL selector switch on the control panel mounted on the cage top from ‘AUTO’ to ‘MANUAL’ position (Fig 4).

- 5.21 It is probable that the AEO landed on the cage top from B-deck after opening the B-deck landing door with the emergency key while the cage was parked in A-deck as the key was found placed on the first step of the stairway by the side of B-deck landing door. He should have changed over the "MANUAL/AUTO" switch to "MANUAL" as he had required the Fourth Engineer to do so earlier. After that, the B-deck landing door was closed automatically by the door self-closing device. The "DOOR" and "SAFETY" switches should remain unchanged and they are respectively in the Close and Normal positions.

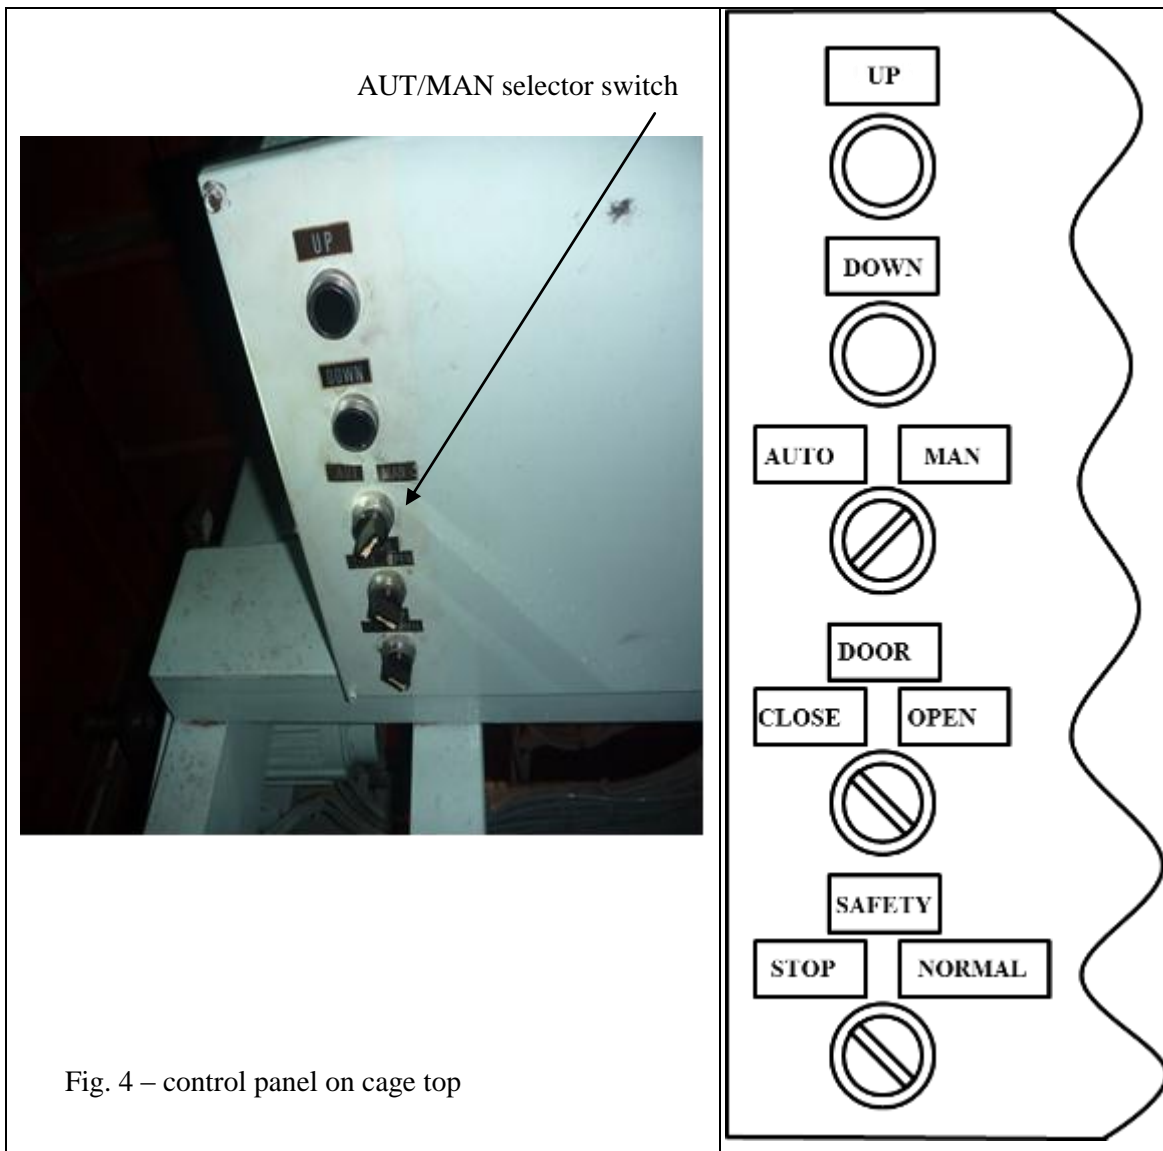
- 5.22 The positions of the switches on the control panel upon inspection by flag State investigator few days after the accident were "MANUAL/AUTO" in "MANUAL" position; "DOOR" in Close position and "SAFETY" in Stop position (Figure 4). The setting of these switches should have been changed by the engineers on board and/or the elevator technician, who attended the elevator, after the accident.

- 5.24 It is therefore deduced that the most probable positions of the switches on the control panel at the time of the accident were: "MANUAL/AUTO" at AUTO position; "DOOR" at Close position; "SAFETY" switch at Normal position. As such, any calls at floors above B-deck would cause the elevator to move up automatically at a speed of 30 meters per minute, which is the nominal speed of the machine.

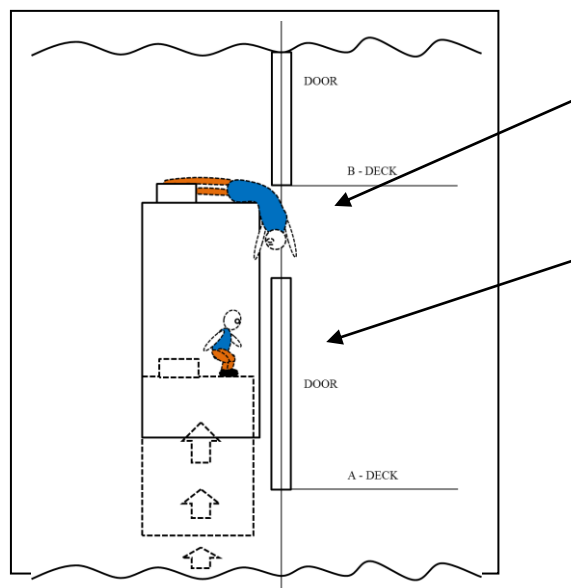
- 4.12 The Superintendent and the Second Officer used the emergency key to open the B-deck landing door. They saw the cage stopped in between A-deck and B-deck. The lower part of the AEO's body and his legs were lying on top of the cage, while the upper part of his body (head and chest) was upside down and stuck in the gap between the cage, the separation between the two decks and the top of the A-deck landing door frame (Fig. 5). They tried to open the A-deck landing door but unsuccessful.

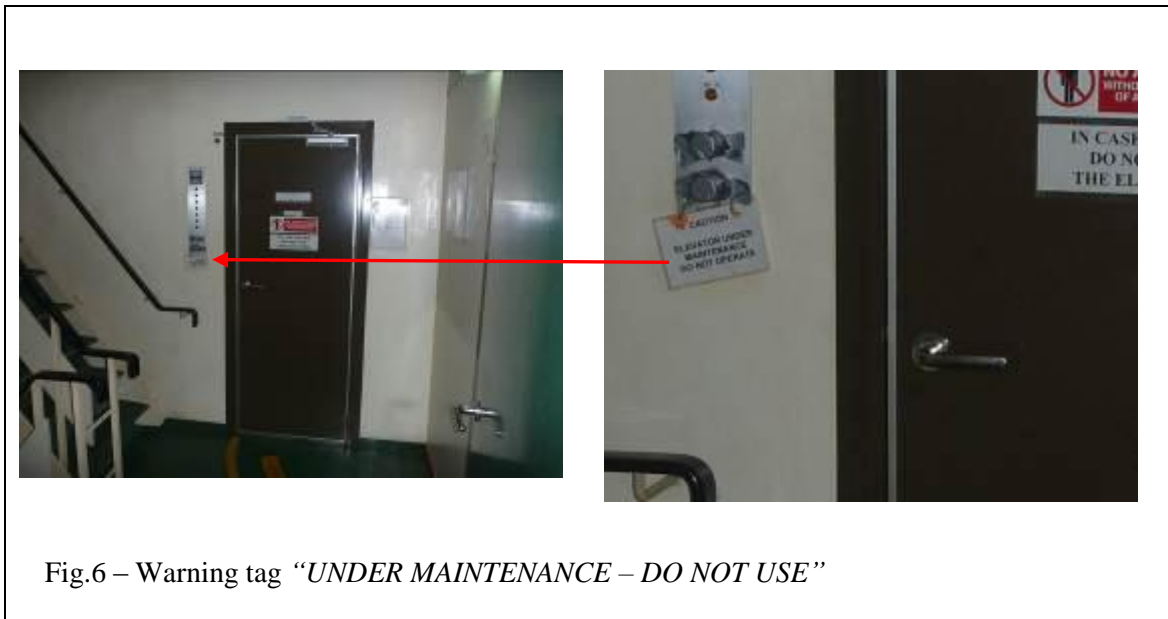
5.9 Apart from the requirement of hanging the warning tags on elevator door’s handle on each floor during inspection or maintenance of elevator, there was no clear instruction in the Safety Measures as to blocking and/or preventing any call buttons on every deck from being inadvertently pressed by crewmember despite the latter requirement has been

specified in the Marine Elevator Handling Guidelines¹ used on board. The warning tags at call buttons on every floor were properly placed after the accident as shown in figure 6.

- 5.25 At the time of the accident at about 1440 hrs, the launching of the port lifeboat had just been completed and the crew members were returning back inside the accommodation. It was possible that someone may have inadvertently pressed the call button since the "Elevator Under Maintenance" warning tag was only hanged on elevator landing door's

handle and the call button could still be pushed.

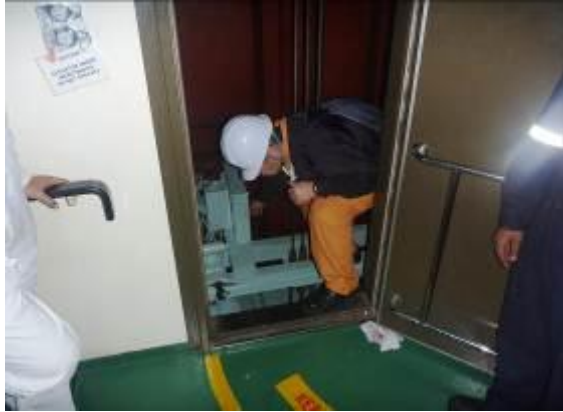
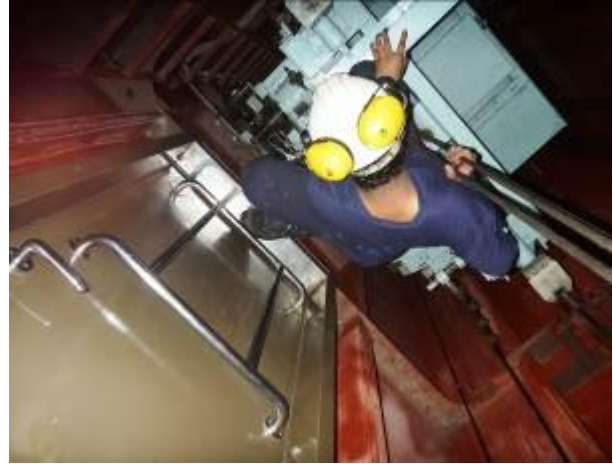
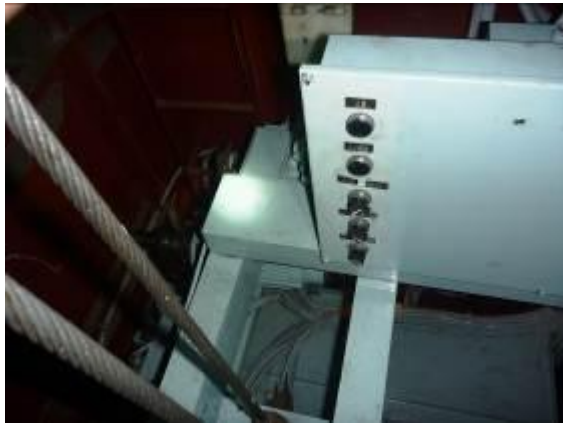
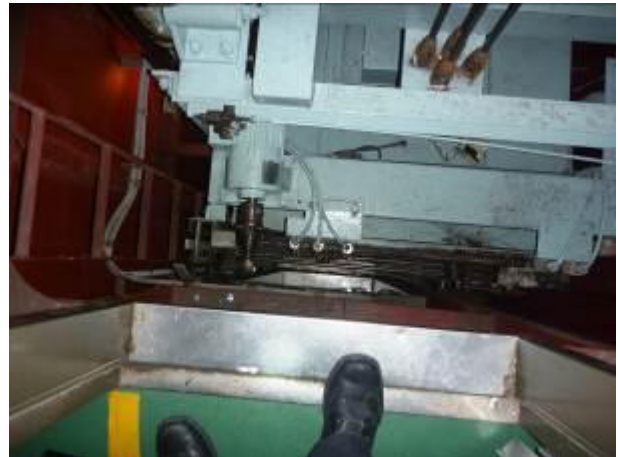
Fig. 7 – working environment on cage top

- 5.27 Figure 7 illustrate the working environment on cage top. It is also probable that, at the time of the accident, the AEO was at the front side of the cage and he lost balance and fell into the gap between the cage and the bulkhead. He was dragged by the upward movement of the cage and it was finally stopped when the door switch of A-deck landing door was deformed rendering the electrical protection circuit to open and stop the movement of the cage. It cannot be determined how far the cage had ascended until it was completely stopped.

View from outside into cage top

View from above to the cage top

Front view of the control panel

View showing the gap between the cage and bulkhead
