Report of investigation into the
fatal accident of a deck cadet on
board the Hong Kong registered
container vessel “OOCL Europe”
at Dammam, Saudi, Arabia
on 12 February 2015

The Hong Kong Special Administrative Region
Marine Department
Marine Accident Investigation Section

1 February 2016

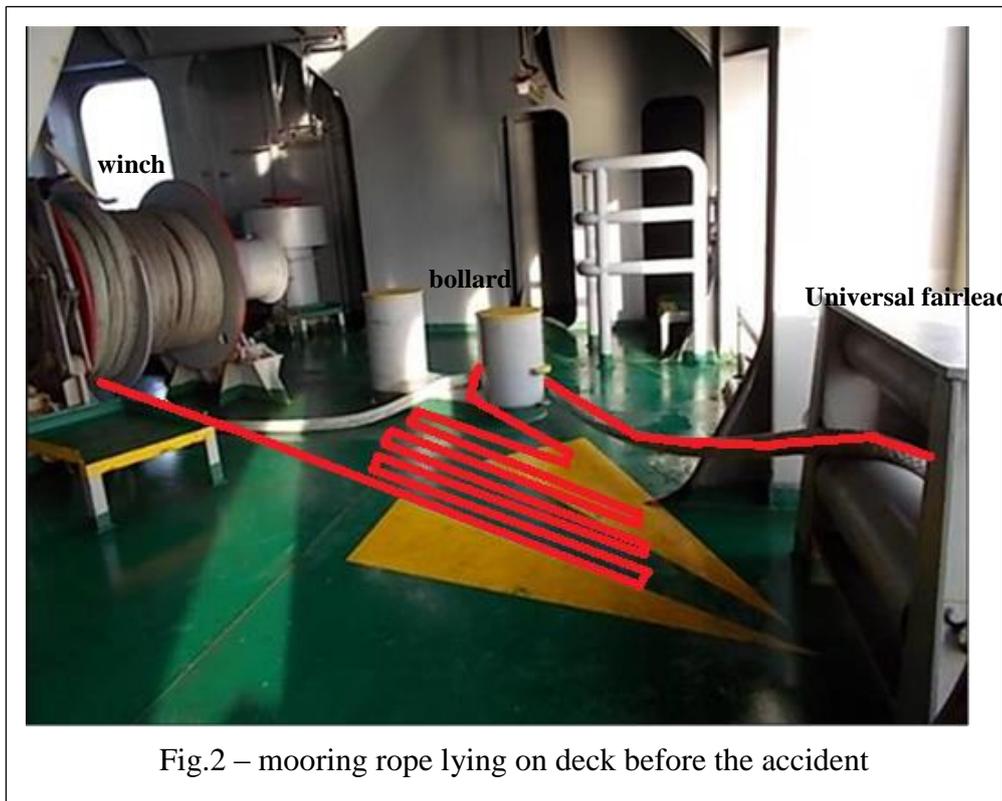
Fig.2 – mooring rope lying on deck before the accident

- 4.4 At 0415, the two stern ropes had already been stowed in the drum of the winch. As one mooring rope on the No.6 mooring winch would be used as towline at aft of the vessel, the QM went to the port side mooring winches remote control station to operate the No.6 mooring winch to unreel the rope partly from the drum. The 2/O, the OS and the DC helped to lay the rope on deck in front of the No.6 mooring winch. The eye splice of the towline was led down over the ship side after passing a bollard and a universal fairlead (see Fig.2).

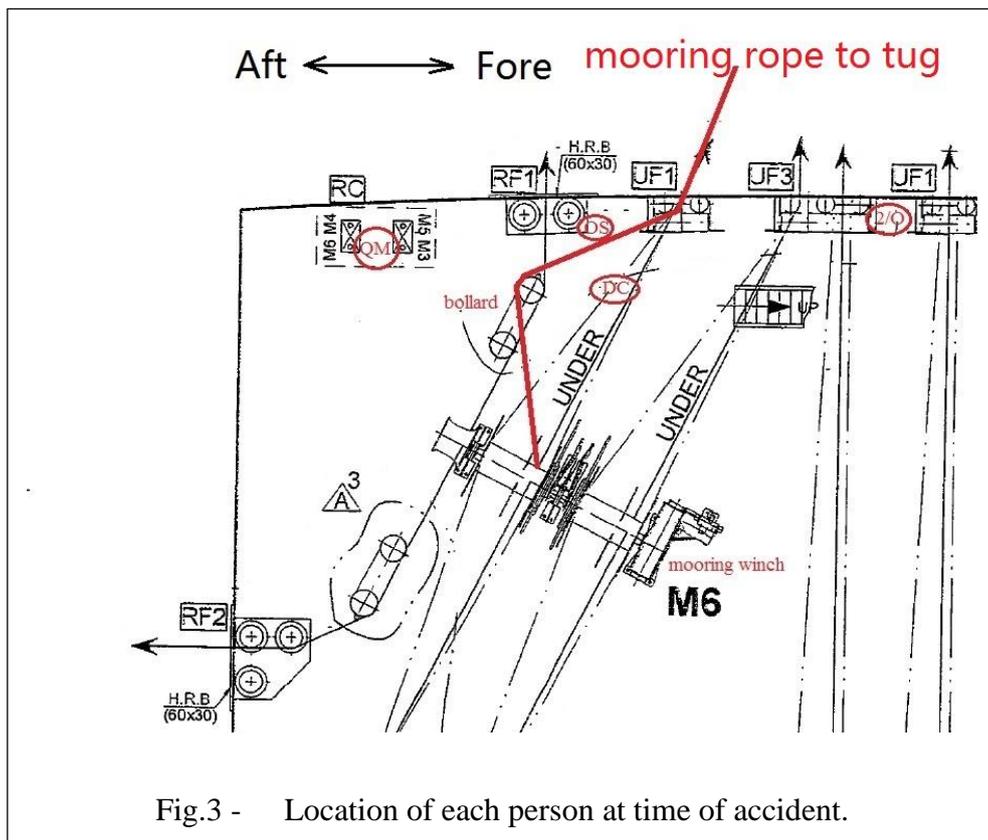
moment, the OS was standing beside the towline on the aft side while the DC was standing opposite to him (Fig.3), monitoring the slipping out of the rope.

- 4.9 Unfortunately, the towline slipped out of the bollard, stretched and straightened under by the pulling force of the tug boat and snapped forward. The DC, who was standing inside the snapping area, was hit by the towline against his chest.

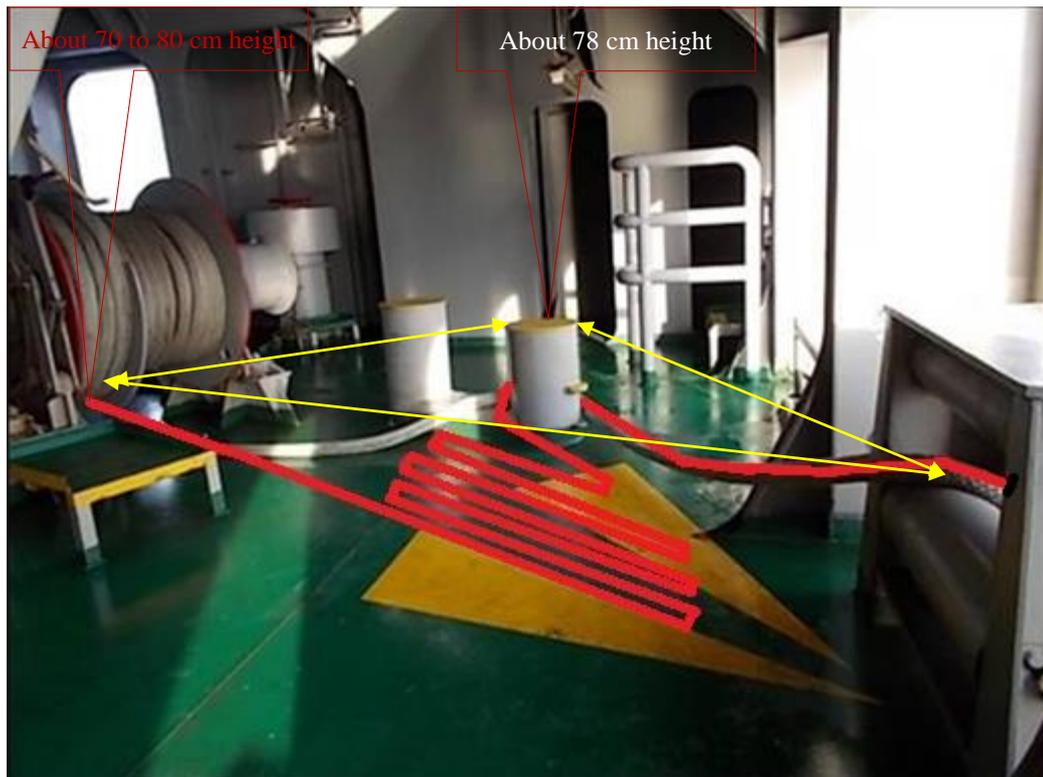
Fig.4 - simulated rope arrangement on deck

- 5.9 The main deck of the *vessel* was about 8 metres from sea level. After the towline was secured to the bollard on the tug boat, the tug boat moved away from the vessel slowly. Since the crew did not use turns of the towline around the bollard to control the speed at which the towline goes out (refer to the code of safe working practice for merchant seaman), due to its own weight, the towline dropped outboard quickly and the rope lying on deck would swing abnormally without control.

- 5.10 To prevent the towline slipping out from the bollard, it should be rigged for at least one turn on the bollard. Also, turns of rope fastening to the bollard should be made for controlling the slipping speed of the towline (Code of Safe Working Practice for Merchant Seaman refers).

- 5.11 In the incident, the towline under tension slipped out of the bollard. Under a pulling force excited by the tug boat, the towline was stretched and straightened and eventually hit and killed the DC, who was staying inside the snapping area.
