Report of Investigation  
into the Collision between  
China Registered  
Bulk Carrier *Yao Hai* and  
Ukraine Registered  
Supply Tug *Neftegaz-67*  
in position 22° 20.7'N, 114° 00.1'E  
at 2113 on 22 March 2008

The Hong Kong Special Administrative Region  
Marine Department  
Marine Accident Investigation Section

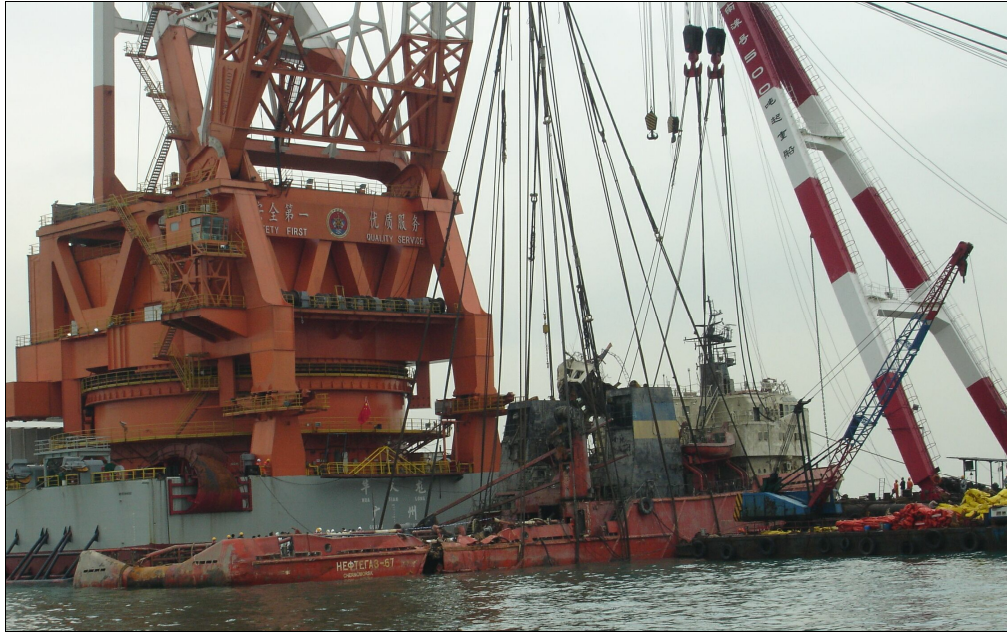
Figure 3 – Wreck of *Neftegaz 67* was lifted up by *Hua Tian Long*

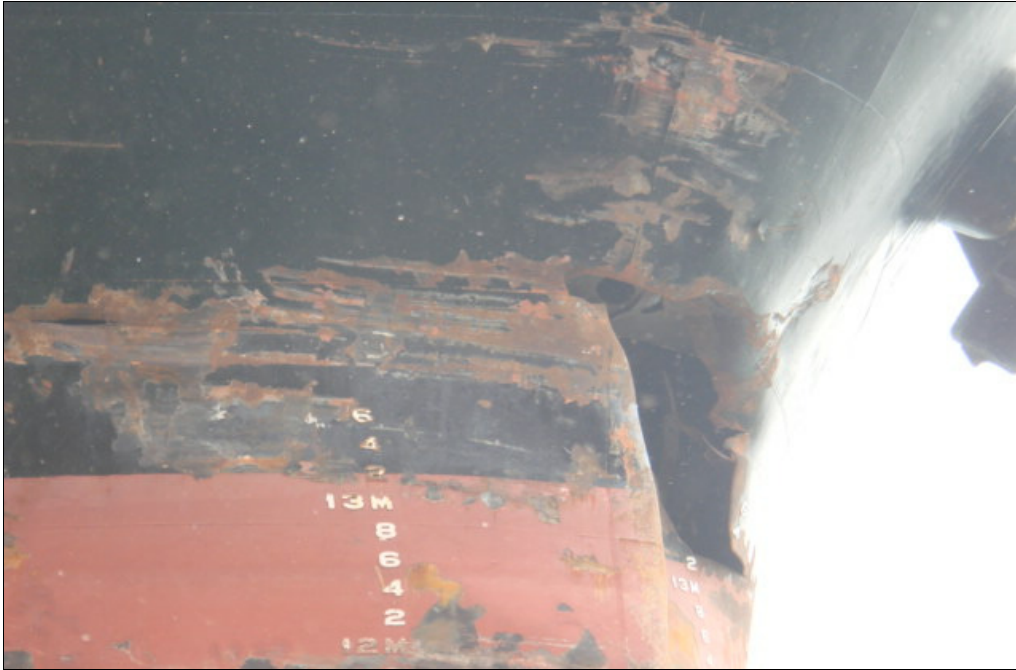
- 5.8.1 *Yao Hai* sustained hull damages to the upper part of its stem and to the top side of its bulbous bow below water.

Figure 8- Damage on the stem of *Yao Hai*

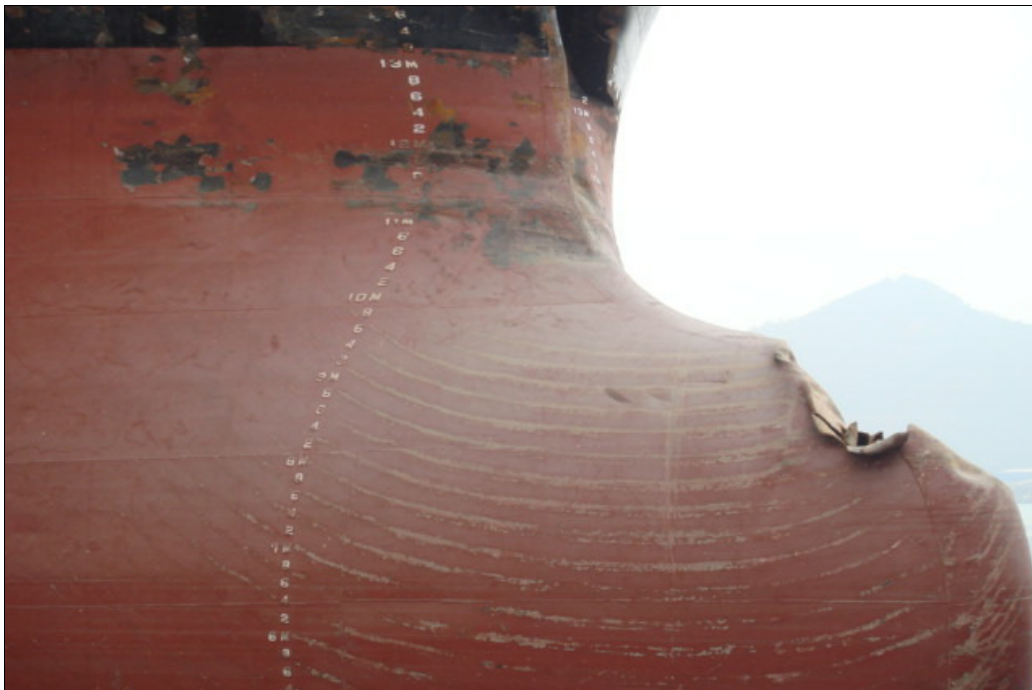
Figure 9- Damage on the bulbous bow of *Yao Hai*

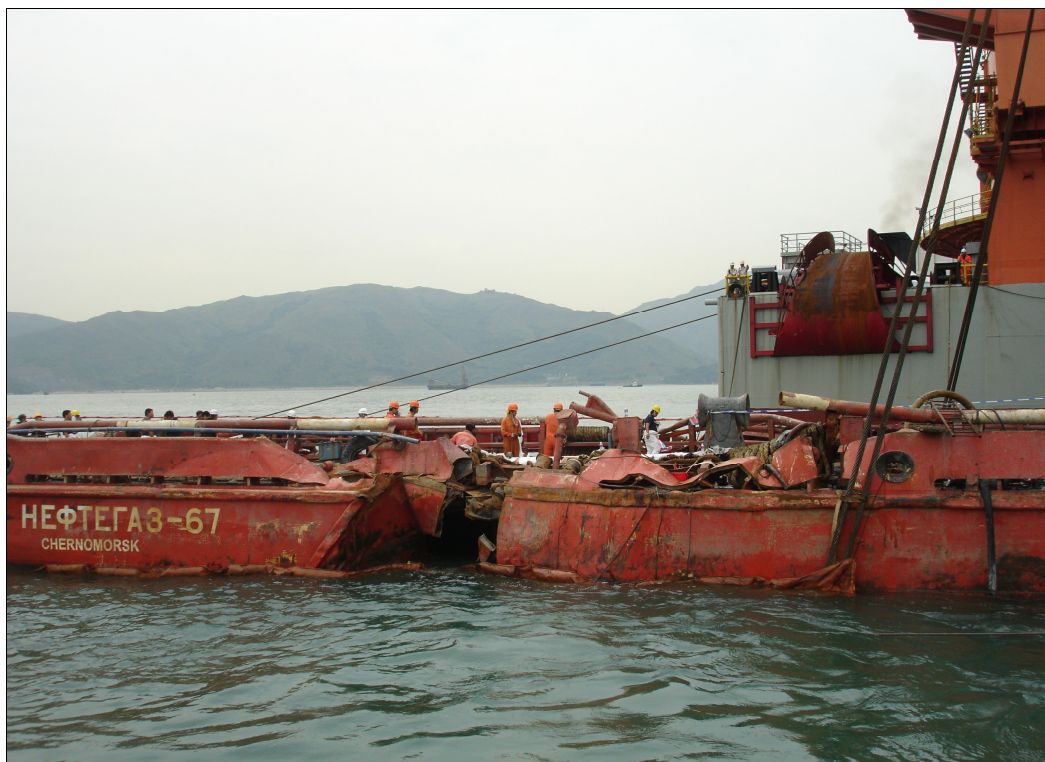
- 5.8.2 *Neftegaz-67* sustained hull damages to starboard side shell aft of amidships near frame no. 25 and to the hull bottom in way of the starboard sterntube.

Figure 10-Damage on the starboard side shell of *Neftegaz-67*

- 5.9.2 After collision *Neftegaz-67* developed a starboard list which was most probably due to its starboard sterntube hit by the bulbous bow of *Yao Hai*. As the upper part of its side shell was holed by the stem of *Yao Hai*, large amount of seawater accumulated into the starboard side of the store compartment momentarily. Also, when seawater entered the cement tank compartment, the cement storage tanks at the centerline blocked the flow of seawater to port side and would have caused *Neftegaz-67* to list further to starboard.

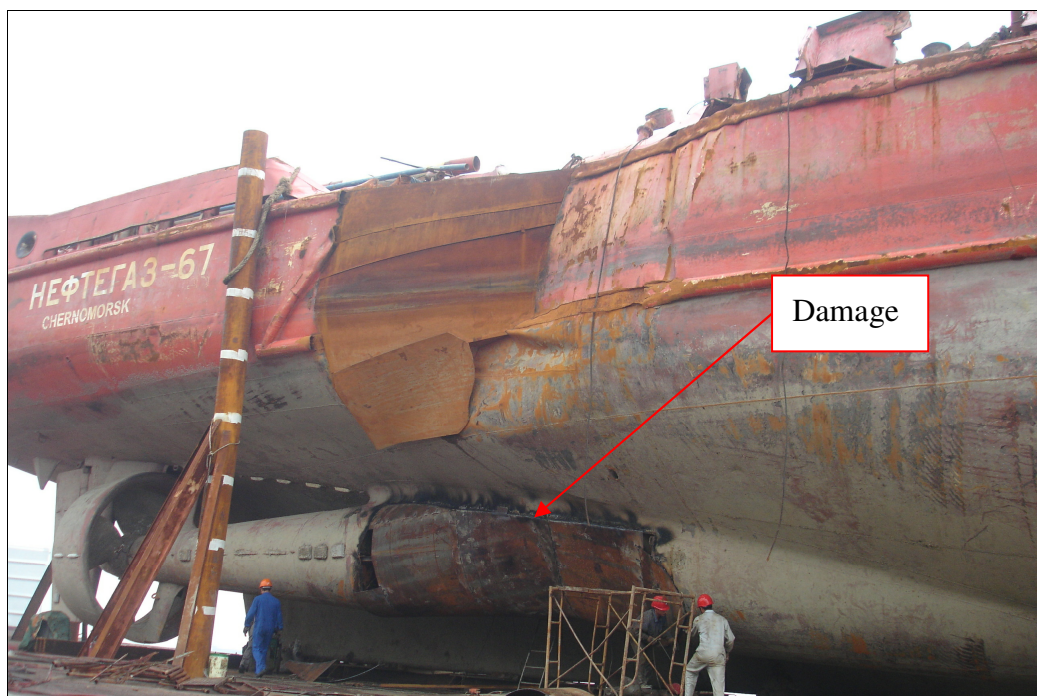
Figure 11-Damage on the starboard sterntube of *Neftegaz-67*

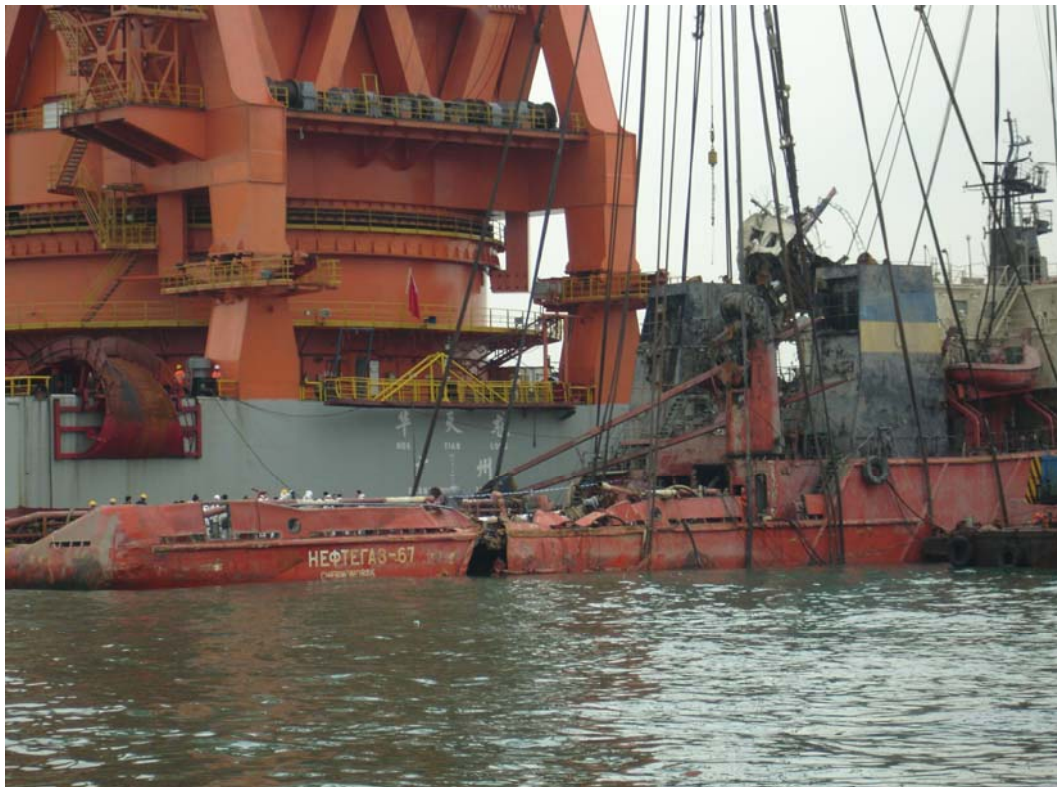
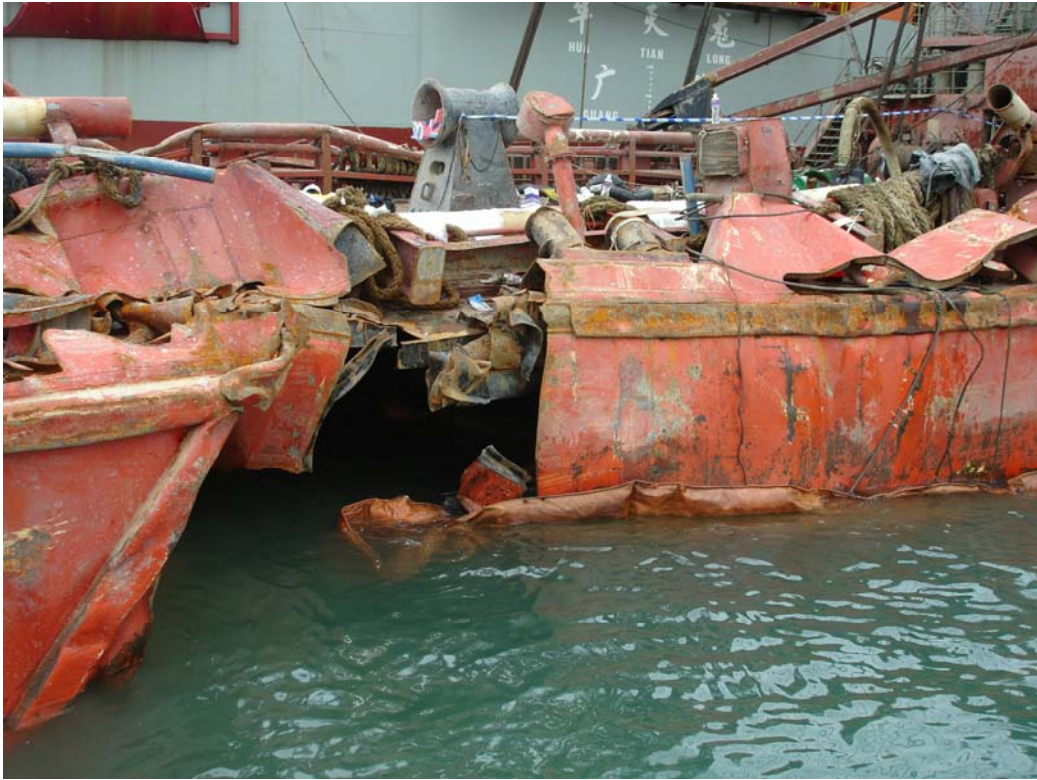
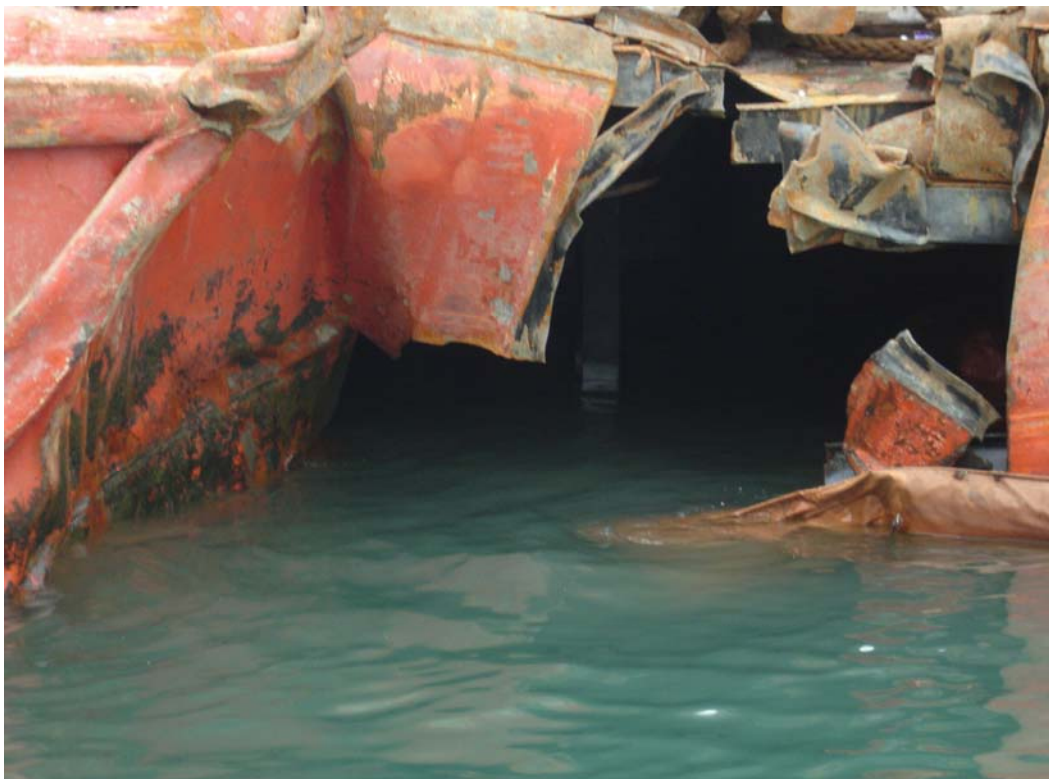
13. The damage to the Tug on its starboard side shell resulted a large hole, measuring approximately 2.5 to 3 metres in width and extending downward by 3.2 to 4 metres. (See Figures 2A, 2B and 2C) The maximum inboard collision penetration at the open weather deck (measured by me during my visit to the Tug at Panyu) was about 1 metre. (See Figure 3) The large hole had a truncated end at aft. At the fore end of the hole the hull side shell plating was pressed inboard. The shape of this hole and the configuration of the pressed in part of the side shell at deck level matched well with the position of the damaged scratch marks and the damaged hole at the bow of the Ship. It was not known whether the transverse watertight bulkhead at frame no. 26 was damaged to become leaking because for safety reasons I was not able to go below deck during my visits to the Tug. Nevertheless with such a severe impact force and that the Tug's hull side was badly pressed in, it would be reasonable to assume damages had been caused to this bulkhead, especially at nearer to the hull side shell plating.

Figure 2A – Damage on starboard side of Neftegaz 67

Figure 2B – Damage on starboard side of Neftegaz-67

Figure 2C – Damage on starboard side of Neftegaz-67

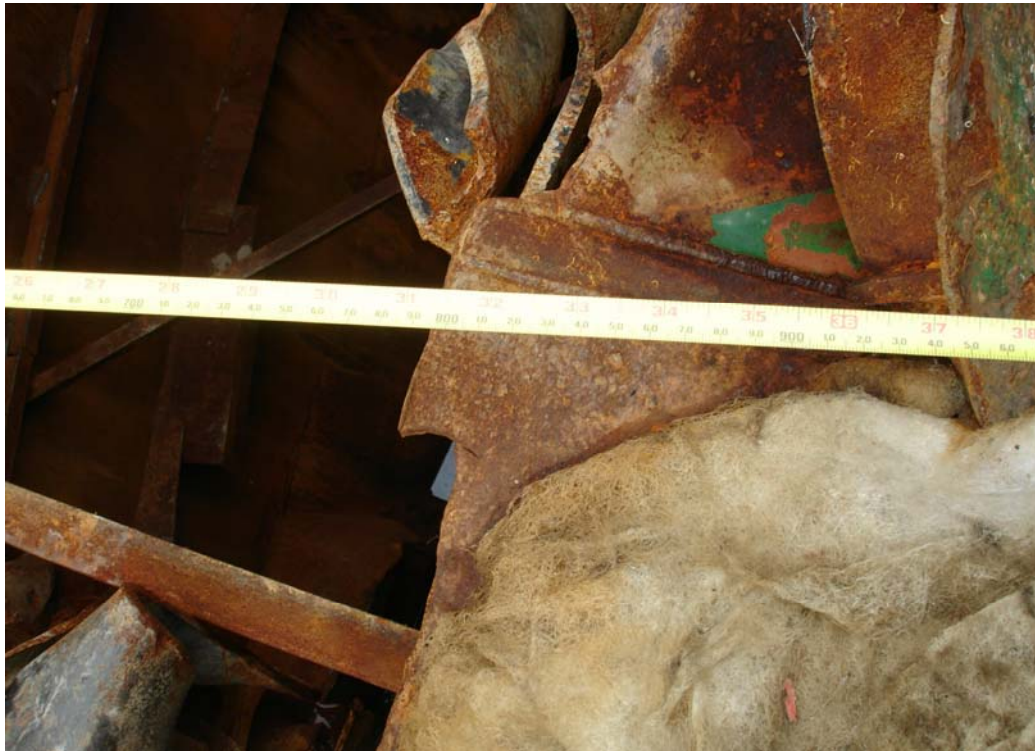
Figure 3 – Maximum inboard collision penetration as measured at open weather deck was about 1 metre

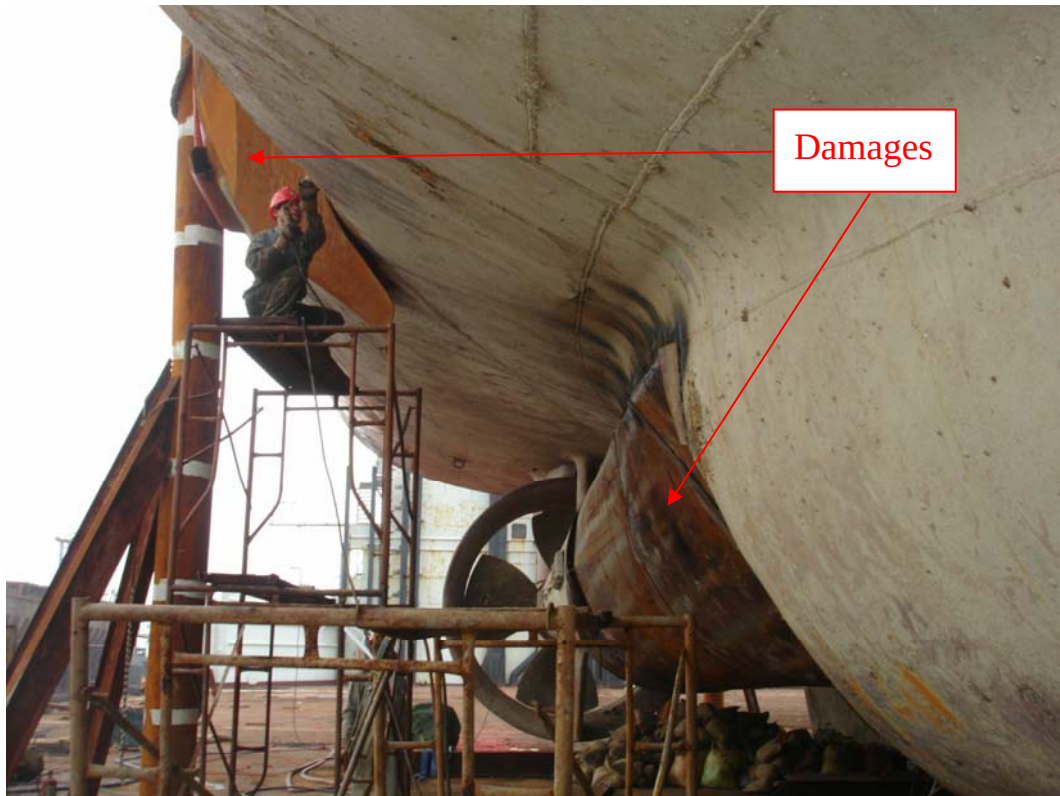
14. The starboard side of the hull immediately beneath the above described hole at the upper hull side of the Tug, however, remained intact (See [Figure 4](#)). There was an undamaged area of hull shell plating, about 2 metres in height, between above described hole and a hole at the hull bottom below that was caused by the hit of the bulbous bow of the Ship. The starboard sterntube and the propellar shaft of the Tug was totally destroyed during first impact. The sterntube was damaged so badly that it was pressed to become closely folded, which indicated the extremely large impact force. The hull bottom at the inboard side of the sterntube was also holed, leaving a large hole at hull bottom on both sides of, and in way of the starboard sterntube. The overall dimensions of the hull bottom hole was as large as 6 m in length and 1.5 m in width.

Figure 4 – Damages on starboard side and starboard sterntube of Neftegaz-67

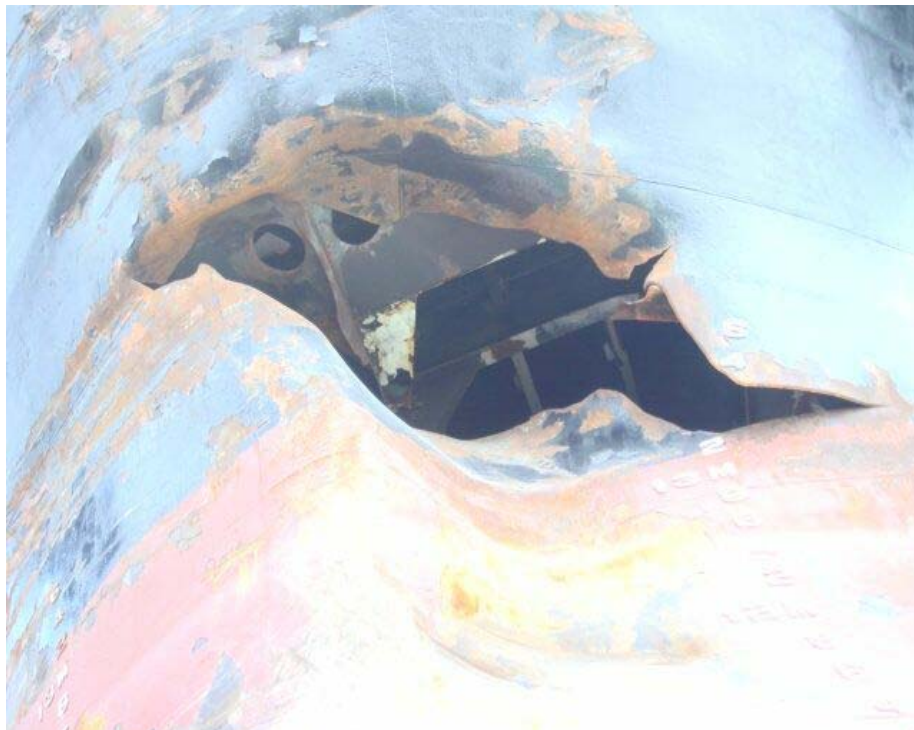
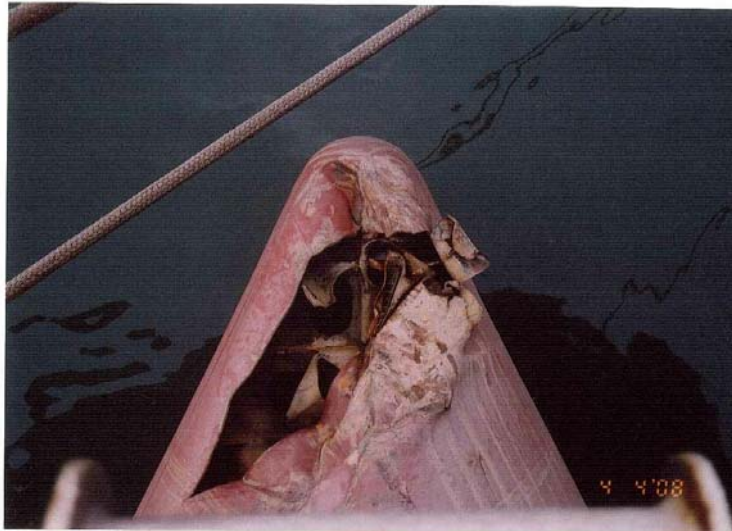
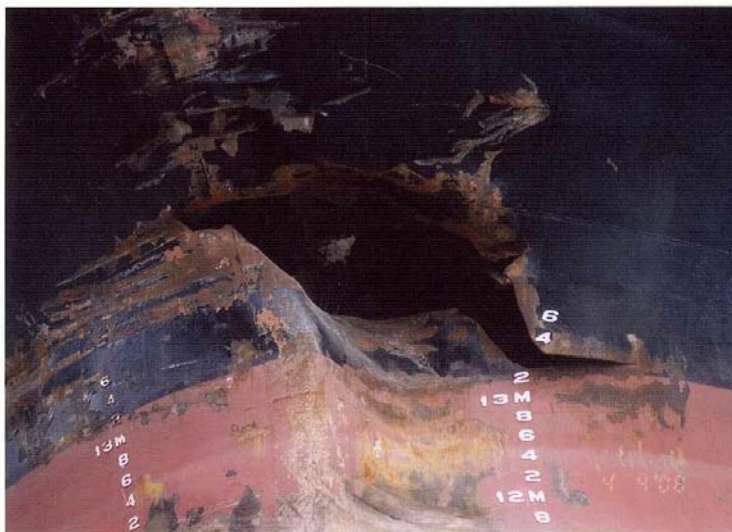
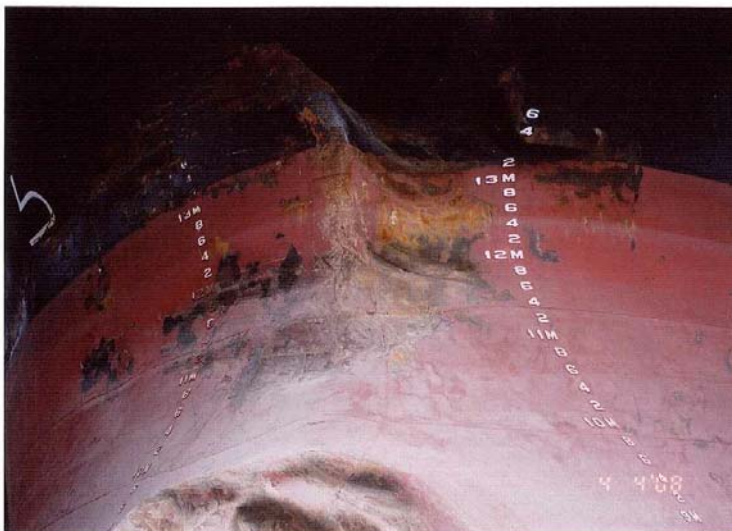
16. The Ship was holed at its fore end in two areas, one at the upper part of its stem and the other at the top side of its bulb below water at bow. The impact resulted a large hole in the stem. (See Figures 6A, and 6B) This hole was of an eye shape parallel to the waterline. It was at a height of about 14 m from hull bottom. (See Figure 7) This hole appeared to be caused by the main deck edge of the Tug cutting into the Ship's stem at first impact. There were dents and scratch marks within the vicinity of this upper damaged hole. The height and shape of the scratch marks as seen on photographs agreed well with the corresponding profile of the damaged part of the hull of the Tug where its side shell was pressed in. The protruding bulb of the bow (bulbous bow) was badly holed at its top near the tip. It was a large hole with badly folded metal at its aft edge, exposing its internal steel structures. One of the flanges of the Tug's propeller shaft coupling was left embedded in this hole. (See Figure 8). The hole at the upper part of the stem was about 6 metres above the damage hole at the top of the bulb. (See Figure 7) This height agreed well with the vertical distance between the damaged hull bottom of the Tug and the damaged part of main deck edge of the Tug. The transverse view of the Ship and the Tug in the collision is shown in Figure 7. It can be seen that the Ship was much larger and taller than the Tug that in the collision, the Tug could be push around by the Ship easily.

Figure 6A – Damage on stem of Yao Hai

Figure 6B – Damage on stem of Yao Hai

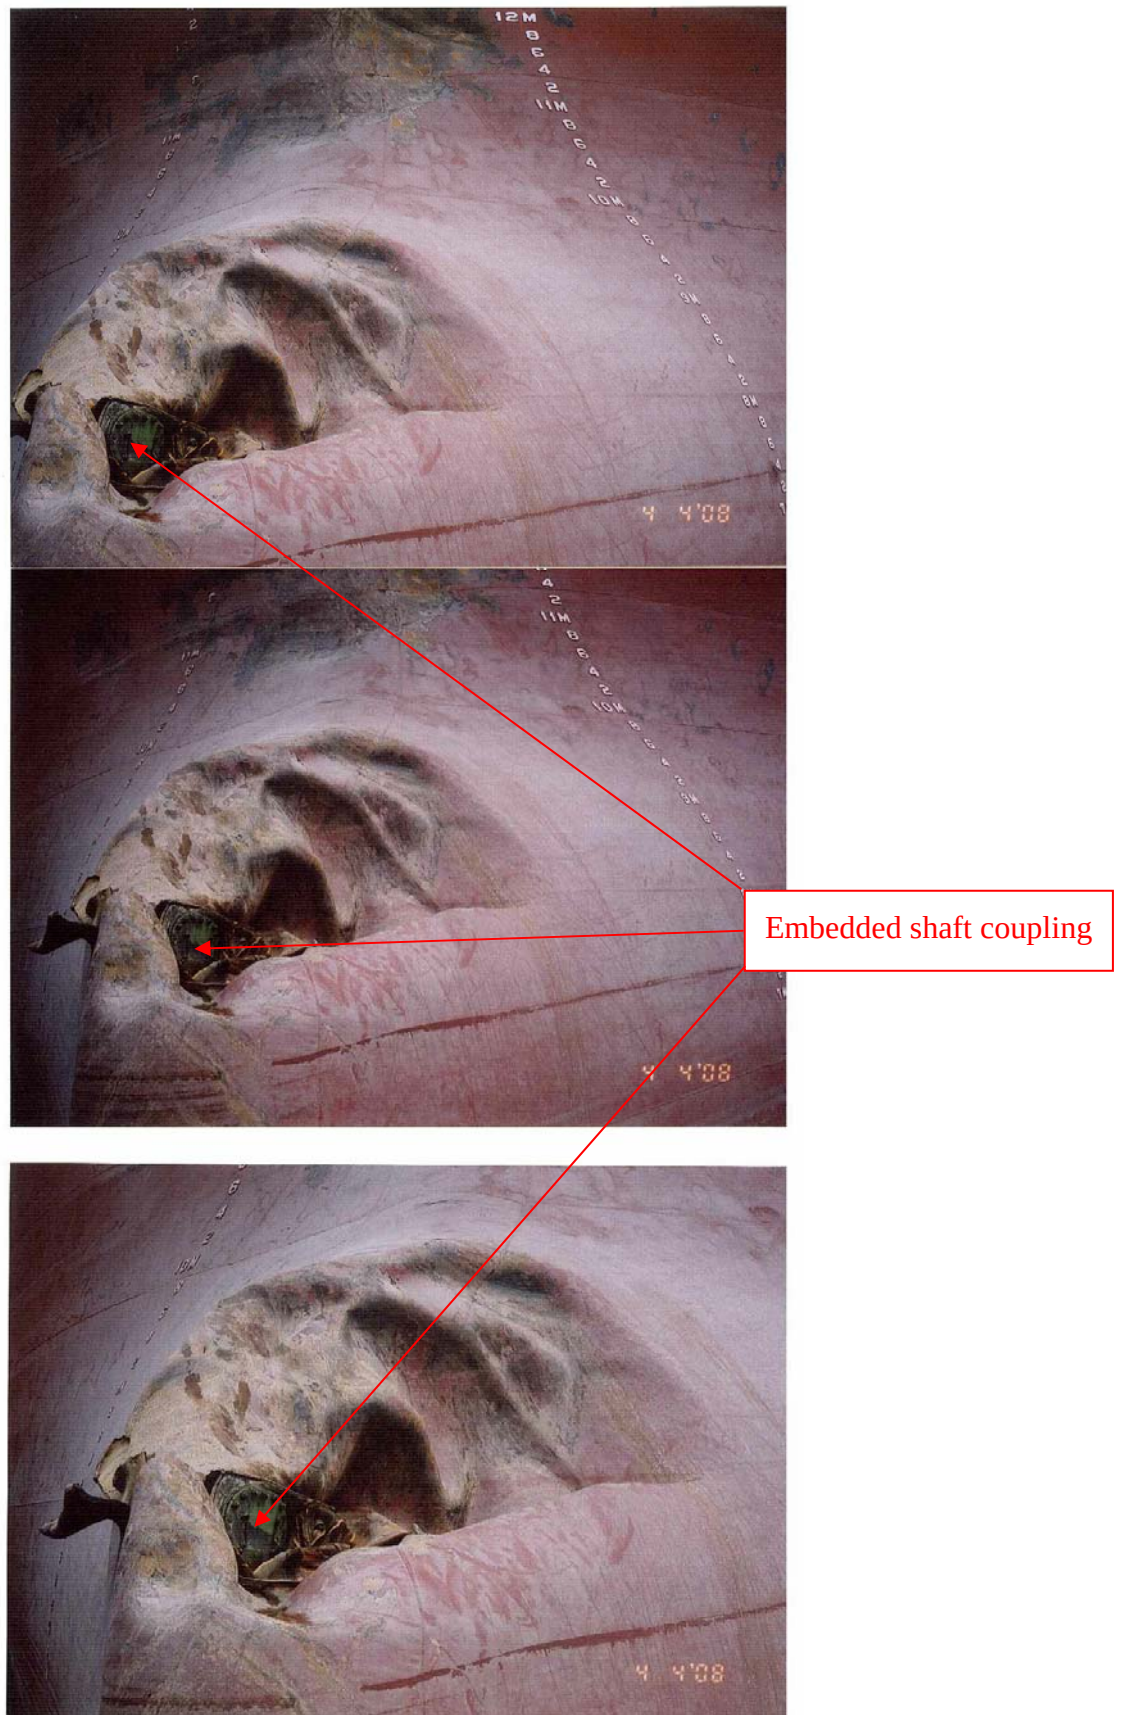
Figure 8 – Damage on bulbous bow of Yao Hai
