Report of Investigation
into the Collision between
the Hong Kong registered
high-speed passenger ferry
COTAI STRIP COTAIGOLD
and the local open sampan
P40707C in Adamasta Channel
off Cheung Chau
on 20 March 2009

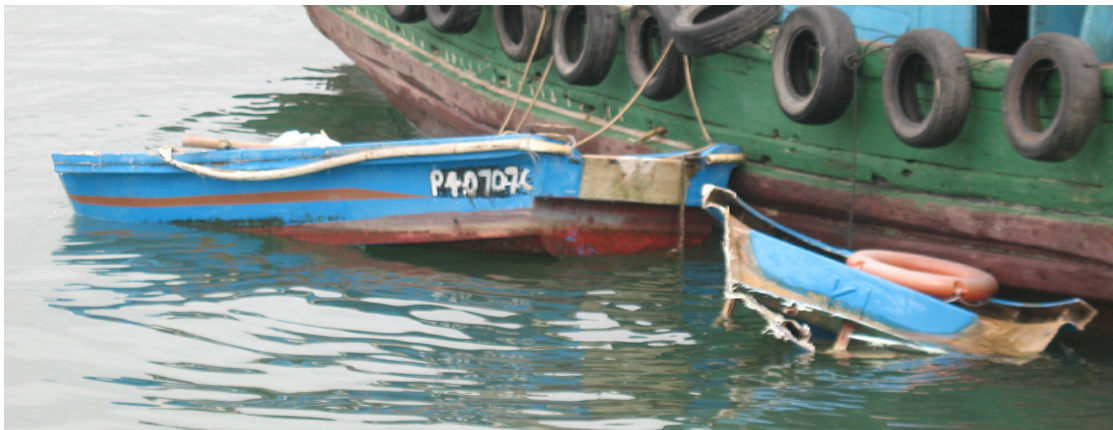
Figure 2- Photograph of *P40707C* which was broken into 2 pieces

- 5.8.1 According to the statement of the Coxswain of *P40707C*, the port hull of *COTAI STRIP COTAIGOLD* struck the port side of his vessel which was cut into two pieces (Figure 2). Some scratches on the port hull of *COTAI STRIP COTAIGOLD* could be observed after the collision (Figure 4). Due to the sharp edge of the port stem of *COTAI STRIP COTAIGOLD*, *P40707C* could easily be cut into two pieces when meeting broadside to *COTAI STRIP COTAIGOLD*.

- 6.2 At the time of the accident, the weather was foggy and the visibility was poor about 10 metres to 0.1 nautical mile (i.e. 185 metres).
- 6.3 *COTAI STRIP COTAIGOLD* sustained minor damage i.e. scratches at the bow of its port hull while *P40707C* was cut into two pieces after the collision. As a result of the collision, the woman on board *P40707C* fell overboard and was seriously injured. She later died in the hospital.

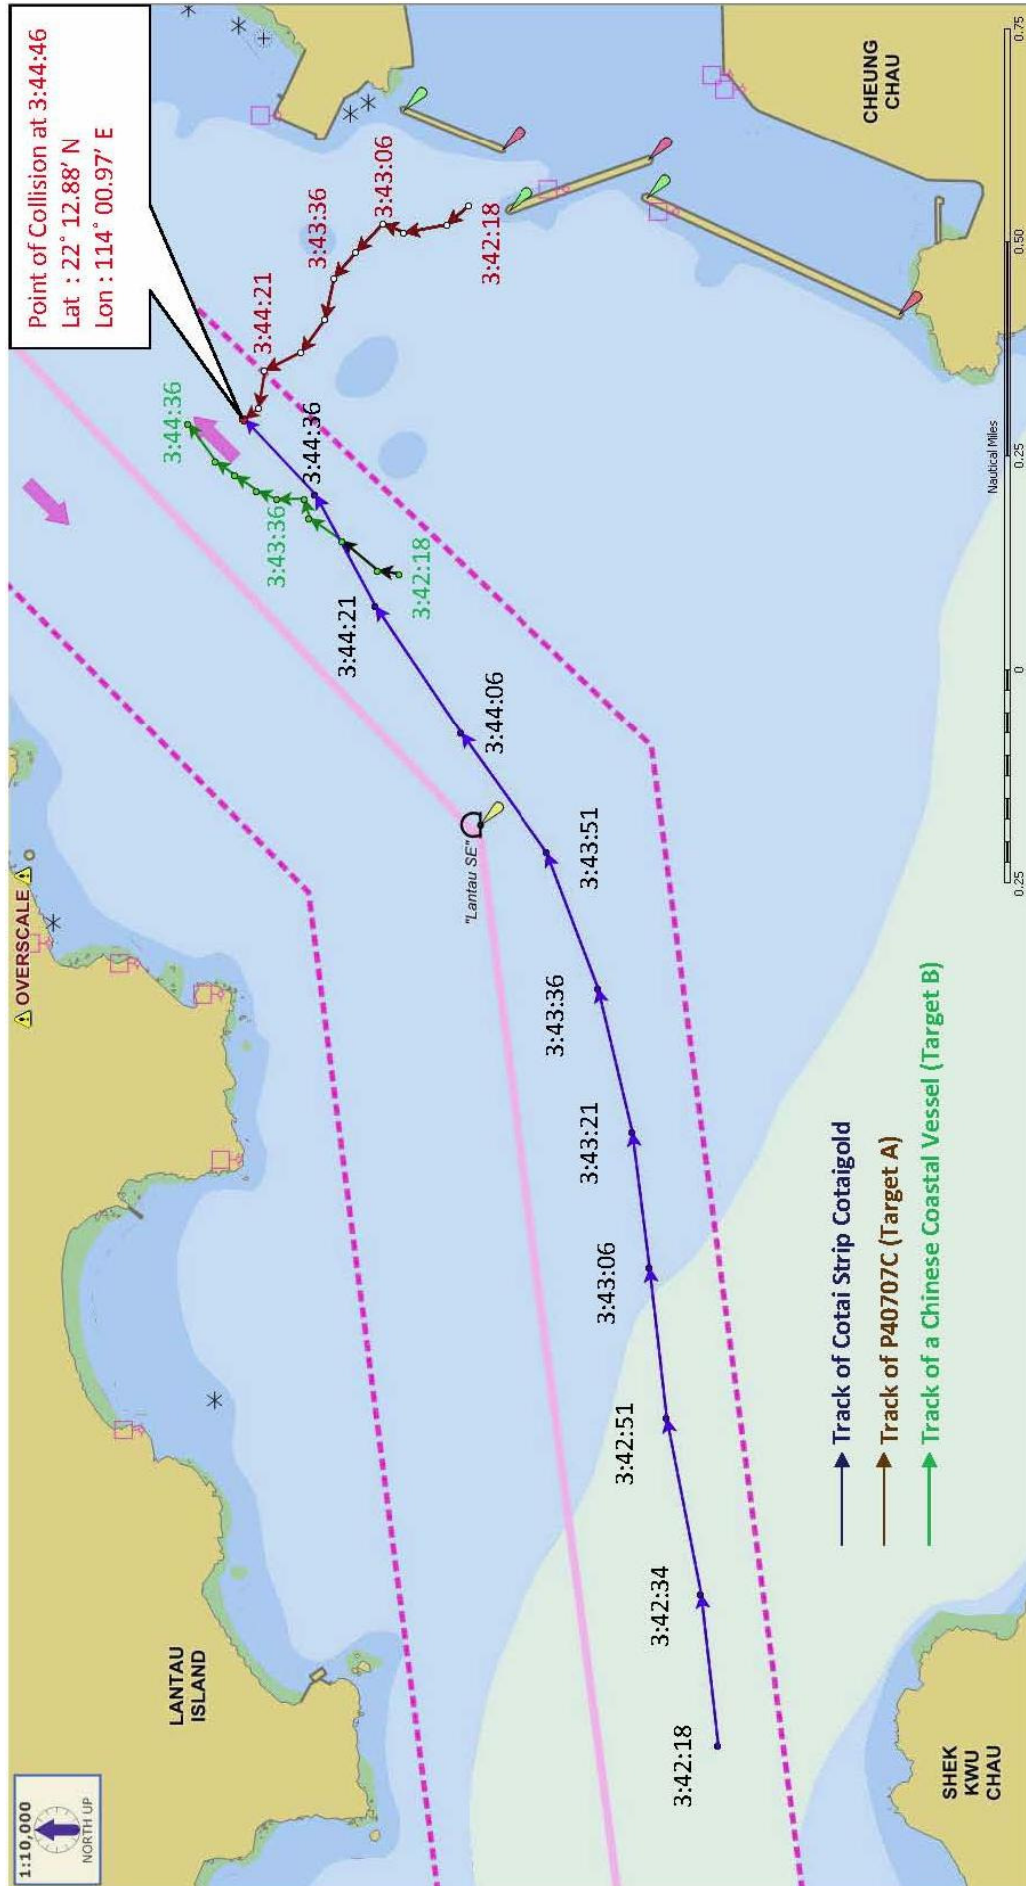
- 5.6.1 According to the radar plot of VTC, after leaving the Cheung Chau Typhoon Shelter, *P40707C* followed a course of 303°T with a speed of about 9 knots until the vessel collided with *COTAI STRIP COTAIGOLD* at about 0344 on 20 March 2009.
- 5.6.2 *P40707C* was not equipped with a radar or any sound signal appliances. Therefore, under the prevailing weather and poor visibility condition, *P40707C* should not navigate outside the Cheung Chau Typhoon Shelter and cross the traffic separation scheme where a lot of high-speed craft traffic would be expected. *P40707C* had failed to comply with Rule 10(j) of the COLREGS by impeding the safe passage of *COTAI STRIP COTAIGOLD* following the traffic lane of the Adamasta Channel Traffic Separation Scheme.

Figure 3 – Plot showing the collision tracks of Cotai Strip Cotaigold and P40707C and the track of an unknown Chinese coastal vessel

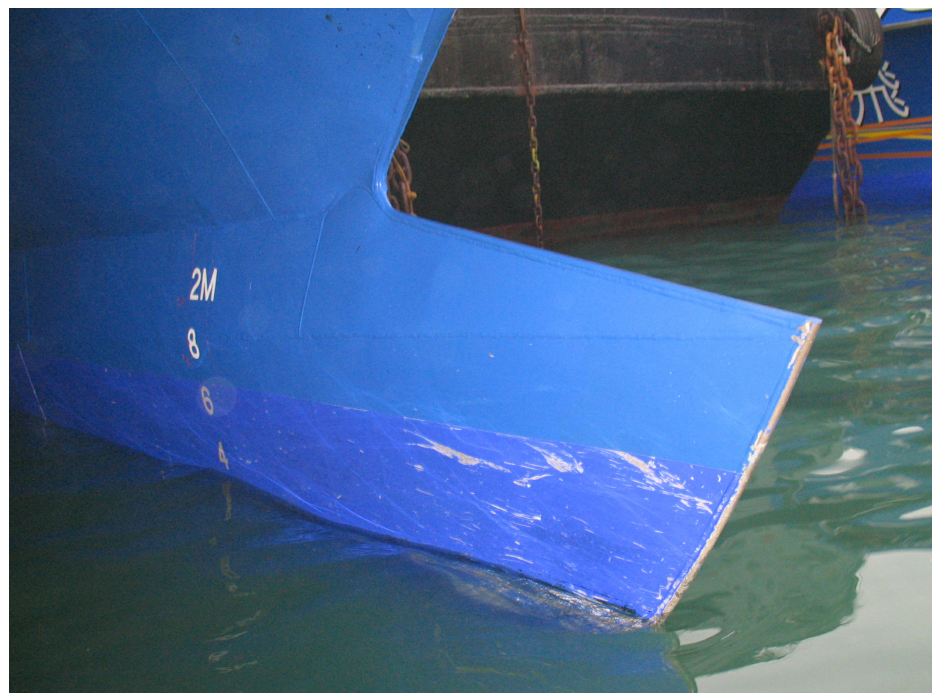
Figure 4 – Scratch marks on the forward port hull of *COTAI STRIP COTAIGOLD* after collision
