**Report of Investigation into the
grounding of the Chinese registered
cargo vessel “Zhong Fu Fa Zhan” on
the Adamasta Rock in North Cheung
Chau Traffic Separation Scheme on
08 May 2011**

The Hong Kong Special Administrative Region
Marine Department
Marine Accident Investigation Section

Completed on 25 April 2012

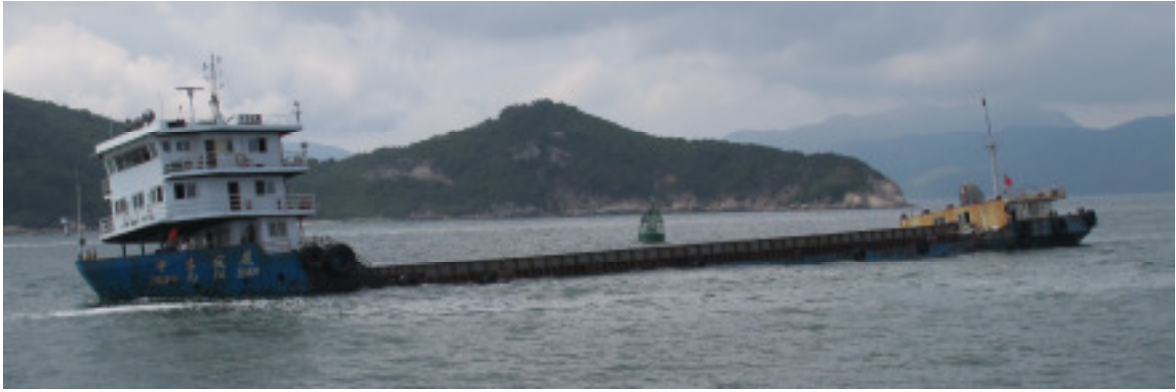
Fig.2 – *Zhong Fu Fa Zhan* grounded on the shoal near the Adamasta Rock (view from south)

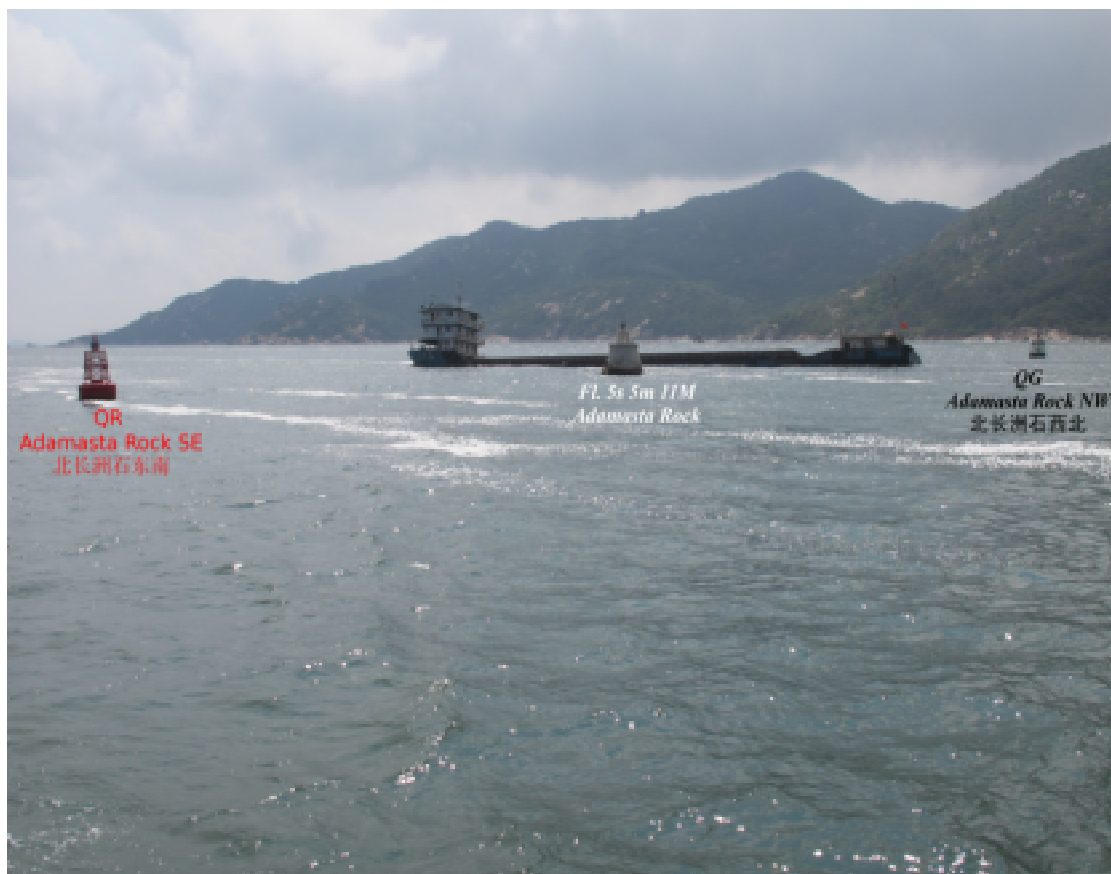
Fig.3 - The overview of Zhong Fu Fa Zhan grounded on the extended shoal of Adamasta Rock on her south-bound voyage

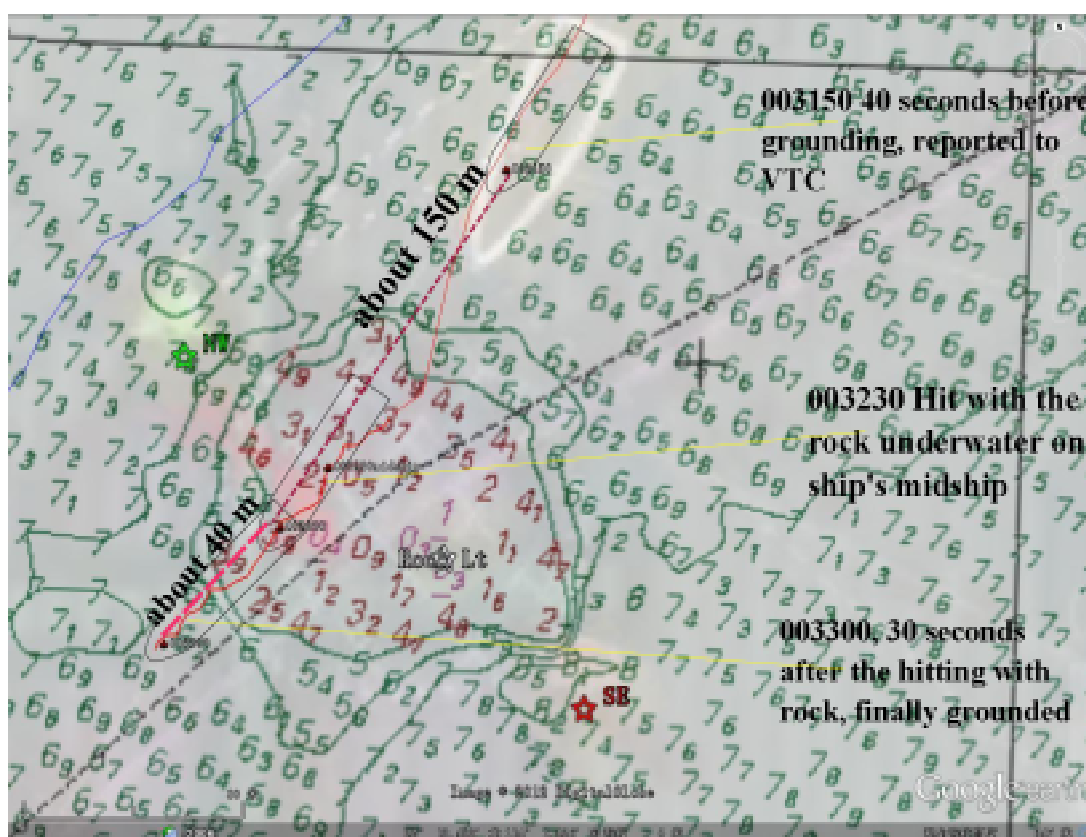
.2 The oval-shaped Adamasta Rock shoal is located at the middle of the Adamasta Channel. It is about 150 metres long with a minimum depth about 0.1 metre (chart datum) (Fig.5). The Adamasta Rock Light tower was erected on the shallowest point (about 0.1 metre depth in datum).

.3 The VTC radar image record showed that the vessel entered the shoal at position about 22-13.42N 114-01.38E with depth of 2.1 metres (chart datum). The shoal rises steeply to about 0.4 metre depth (chart datum) within 10 metres distance on the port side of the vessel. The vessel finally seated at position 22-13.39N 114-01.34E with water only about 2.6 metres deep (chart datum).

Fig.5 – The hitting point of the rock and the final grounding position of the vessel

.5 The vessel ran aground at about 0032 on 8 May 2011, the tide height is estimated to be about 1.32 metres⁵ in the shoal. At the time of grounding, the depth of water at the point of grounding would be 3.42 metres (2.1m + 1.32m), and the water depth on its port side would be reduced steeply from the depth 3.42 metres to 1.72 metres (0.4 m + 1.32 m) within about a distance of 10 metres. The ship's draft readings were 3.20 metres forward, 3.60 metres midship, and 3.70 metres aft. Therefore it is suspected that the vessel hit the underwater rock at its midship area when the port side water depth changed from 3.42 to 1.72 metres depth. When hitting the rock, the vessel gave off a big banging sound and also caused severe vibration to the ship. The bottom of the hull on her port side of cargo hold was also starved. Soon after the grounding, the master stopped and reversed the engines immediately. The ship finally stopped after proceeding further in the southwesterly direction some 40 metres away from its first stranding position. Water flooded continuously into the cargo hold. The water depth at the final position of the vessel after grounding was about 3.9 metres (chart datum about 2.6 metres plus 1.32 metres tide). The immediate stopping of

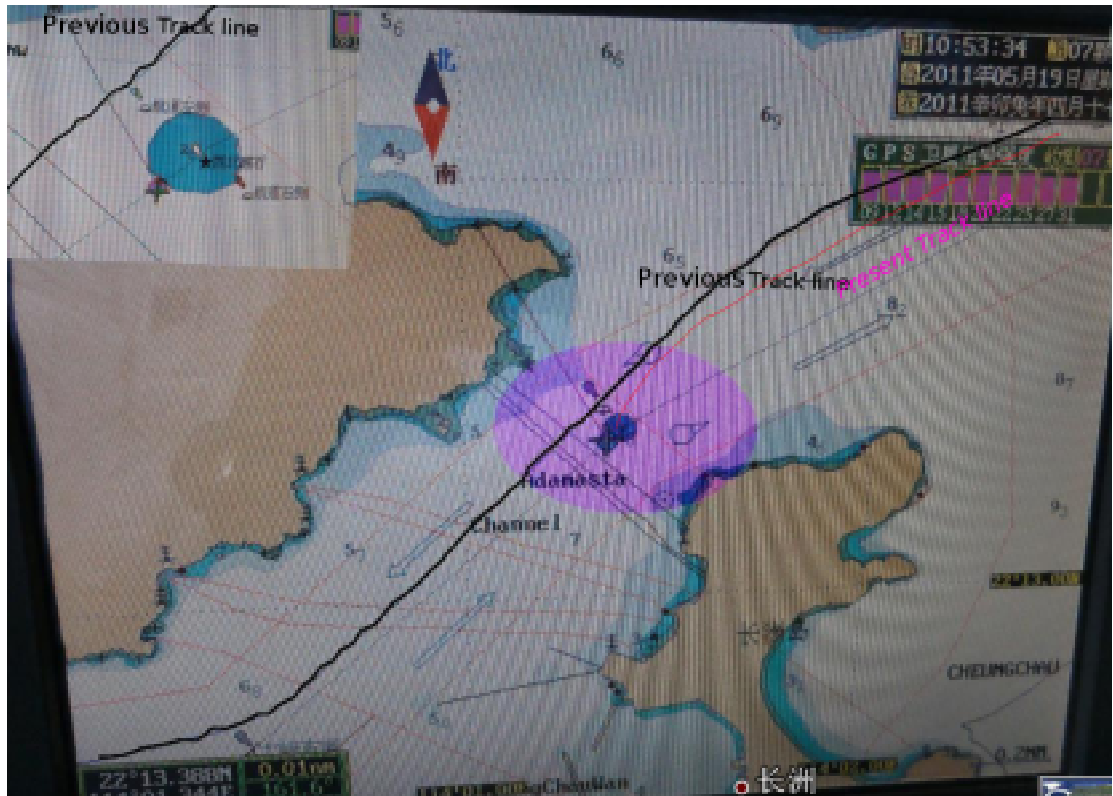
.4 The track for the voyage was neither marked on ECS nor on paper charts. As shown in *Fig.7*, a previous track (shown in black) marked on the ECS indicated that the vessel had in previously voyage passed close to the Adamasta Rock NW Buoy. Compared the track of vessel at the time of accident (shown in pink) with the previous track, the vessel had moved on a track similar to the previous one but off-set to the south. As a result of such deviation, the vessel ran aground on the shoal.

Fig.7- The previous and the present track lines showed on the ECS screen

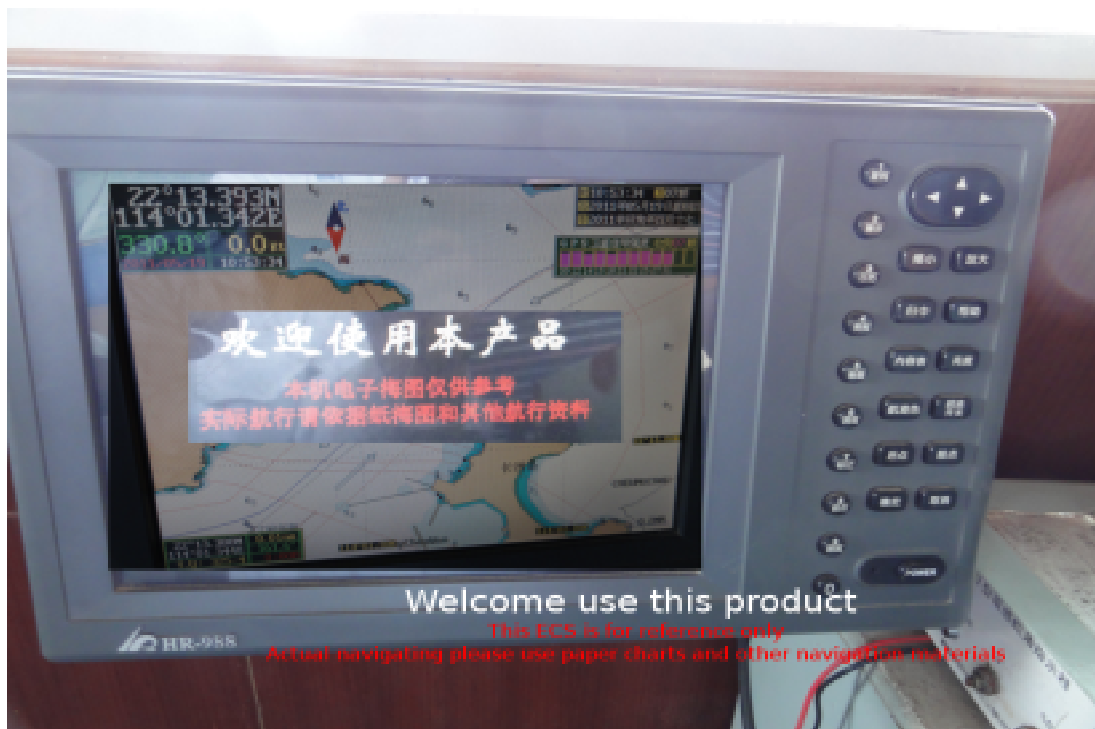
Fig.9- Electronic Charting System, Model: HR988, and Warning Notice for user

.2 The ECS equipment installed on board Zhong Fu Fa Zhan did not include in the ship’s certificate, and had not been assessed by the ship’s Classification Society or Flag Administration. The ECS (model HR-988) was not a type-approved equipment by Classification Society or flag Administration and it had not been updated after installation. When the system is switched on, a warning notice will issued to prompt the users that the equipment is only to be used for reference and paper charts and other official navigational materials

should be used for navigation. Apparently, the warning notice was ignored by the watch-keeping officers of the vessel who solely relied on the ECS out of convenience.

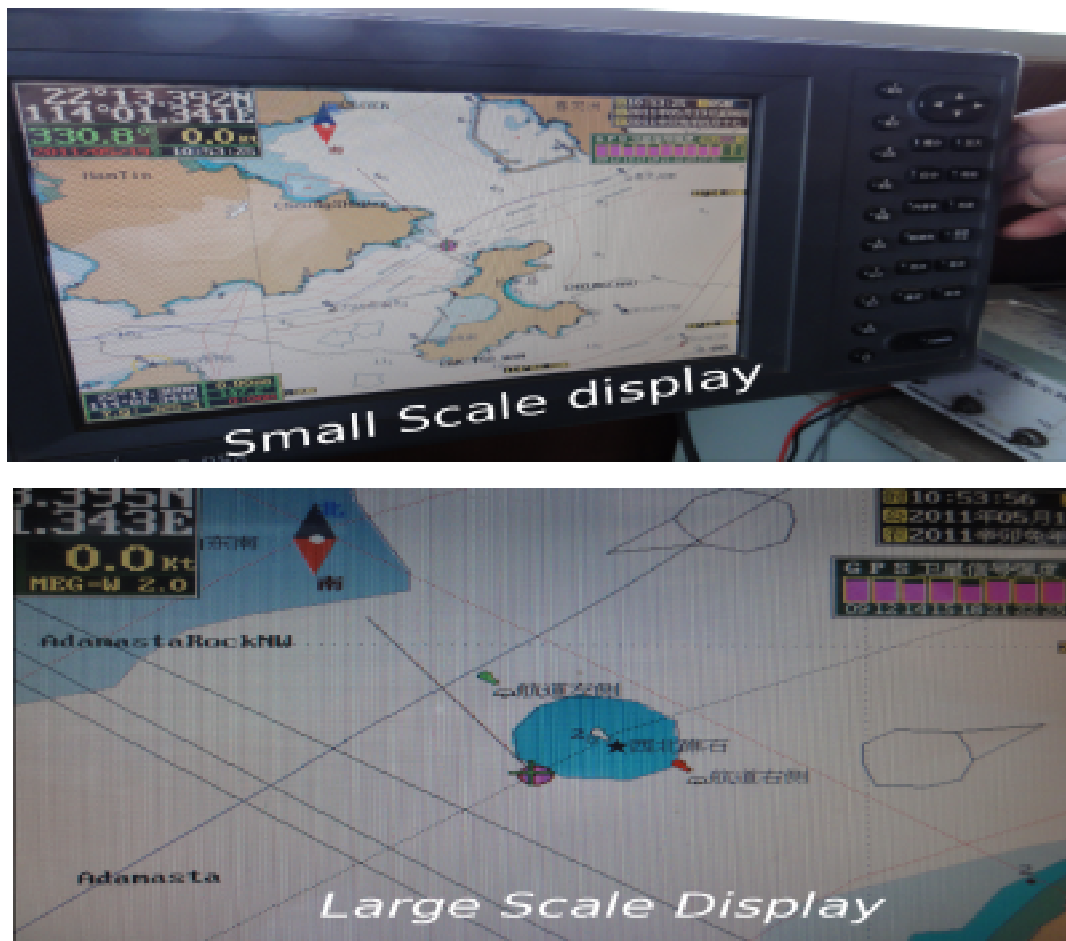
Fig.10 –The display of Adamasta Rock with related light buoys on ECS.

.3 Depending on the scale selected for the display screen of ECS (*Fig.10*), the showing of the Adamasta Rock NW light buoy and SE light buoy on the screen could be confusing to the navigation officers. When a small scale was selected, the Adamasta Rock and the shoal would show only one light beacon, and the marker buoys for the shoal could hardly be distinguishable on the screen. The individual marker buoy appears only when a larger scale is selected for the ECS display.

.4 Furthermore, the light buoys for marking the extent of the shoal were labeled incorrectly on the screen. The green Adamasta Rock NW light buoy with green light was named as Channel Port Side, and the red Adamasta Rock SE light buoy with red light was named as Channel Starboard Side. The equipment manufacturer might have interpreted the two light buoys incorrectly as the port and starboard hand buoys of a traffic lane.

.5 According to the Chief Officer, he used a small scale for display. Under such circumstance, the Adamasta rock and the two light buoys could only be shown as one light beacon on the ESC display screen.

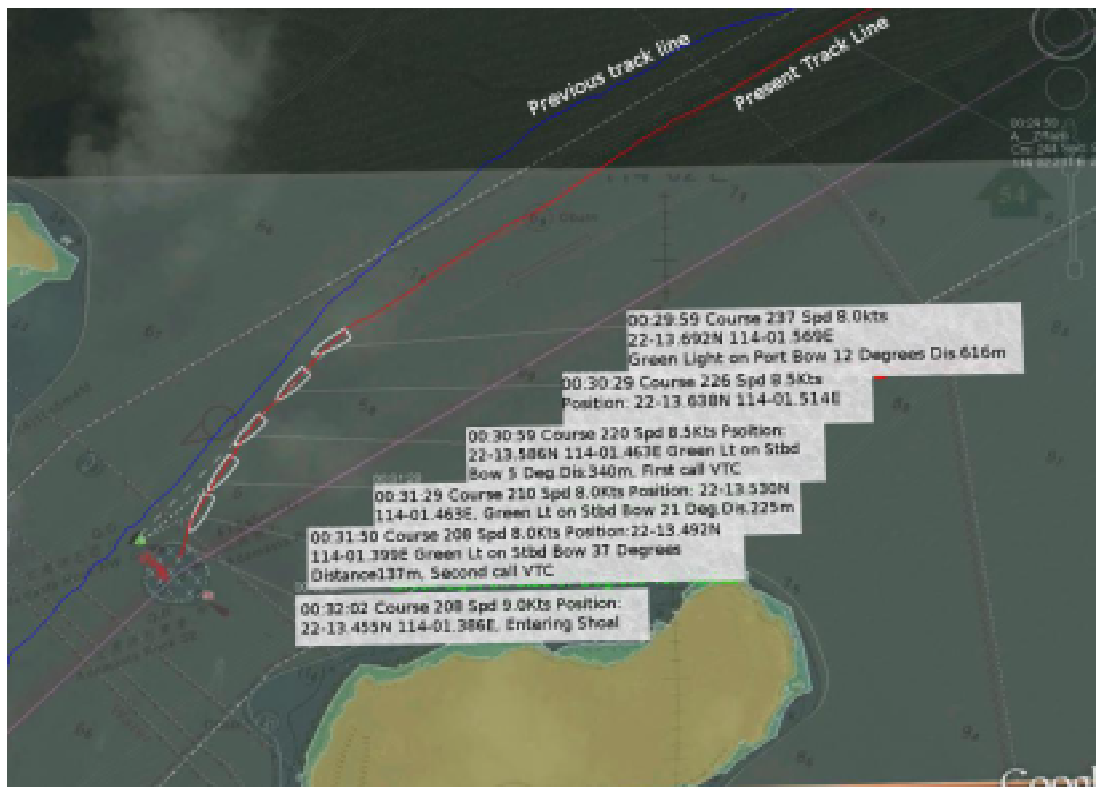
.2 At about three minutes before the vessel ran aground, the Chief Officer saw the green light of Adamasta Rock NW light buoy about 12 degrees on port bow. This light signal was not displayed on the ECS display screen as a small scale for the display was selected.

.3 Reconstructing the track made by the vessel using the images recorded by the VTC radar shown that about two minutes before grounding of the vessel, she started to alter course and moved towards the shoal of the Adamasta Rock. At that moment, the Chief Officer reported the ship's position to VTC for the first time. In the absence of a reply from the VTC after the first call, the Chief Officer reported to VTC again when the vessel was very close to the shoal having the Adamasta Rock NW light buoy on her starboard side with a bearing of just

over 30 degrees. Apparently, the Chief Officer was not aware of the danger that the vessel was entering into the hazardous waters between the light buoys.

Fig.11 – The movement of ZFFZ running into grounding on the shoal of Adamasta Rock

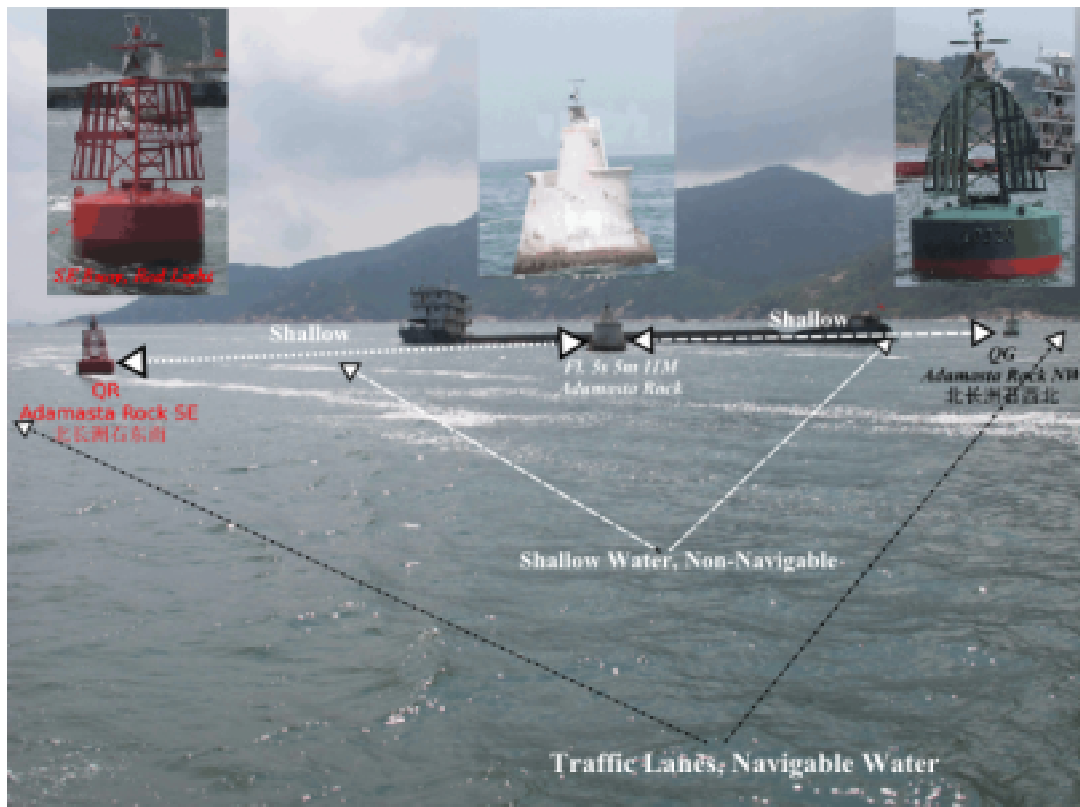
.3 The direction of buoyage in the Adamasta Channel is from southwest to northeast (*Fig.1*). The red Adamasta Rock SE light buoy is a port hand lateral buoy marking the port edge of northeast-bound traffic lane of the channel. However, the green Adamasta Rock NW light buoy becomes a port hand lateral buoy marking the port edge of southwest-bound traffic lane of the channel against the direction of buoyage system.

Fig.12 –The buoyage arrangement in Adamasta Rock, view from north

.5 It may not be easy for navigation officers new to the area to understand and interpret the lateral buoys and the buoyage arrangement correctly in the vicinity of Adamasta Rock. In this accident, the vessel was navigating towards the shoal between the Adamasta Rock NW light buoy (Green) and Adamasta Rock light tower (White) (*Fig.13*). The Chief Officer stated that he did not understand the conventional buoyage direction and the direction of buoyage system changes at the point of Lantau SE buoy. The Chief Officer might have visually observed the green light buoy (Adamasta Rock NW) as a starboard hand lateral mark and mistakenly steered the vessel into the shoal.

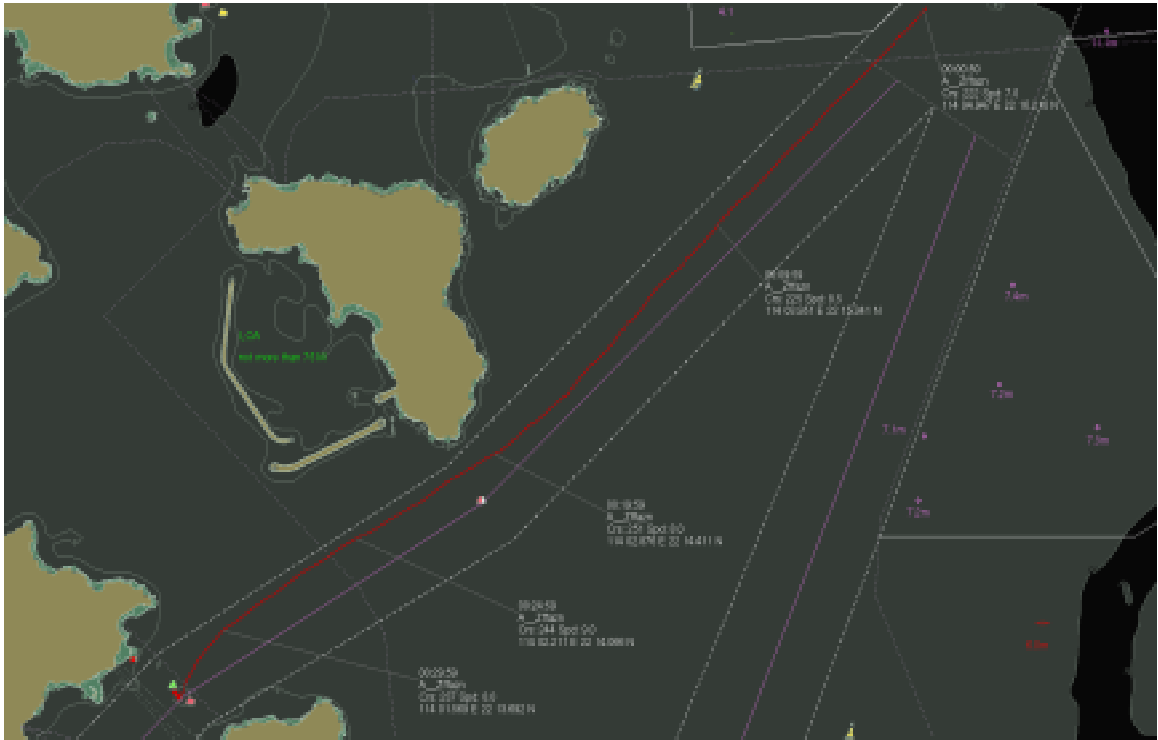
Fig.13-The VTC radar record of Zhong Fu Fa Zhan grounded at 0033 on 8 May 2011

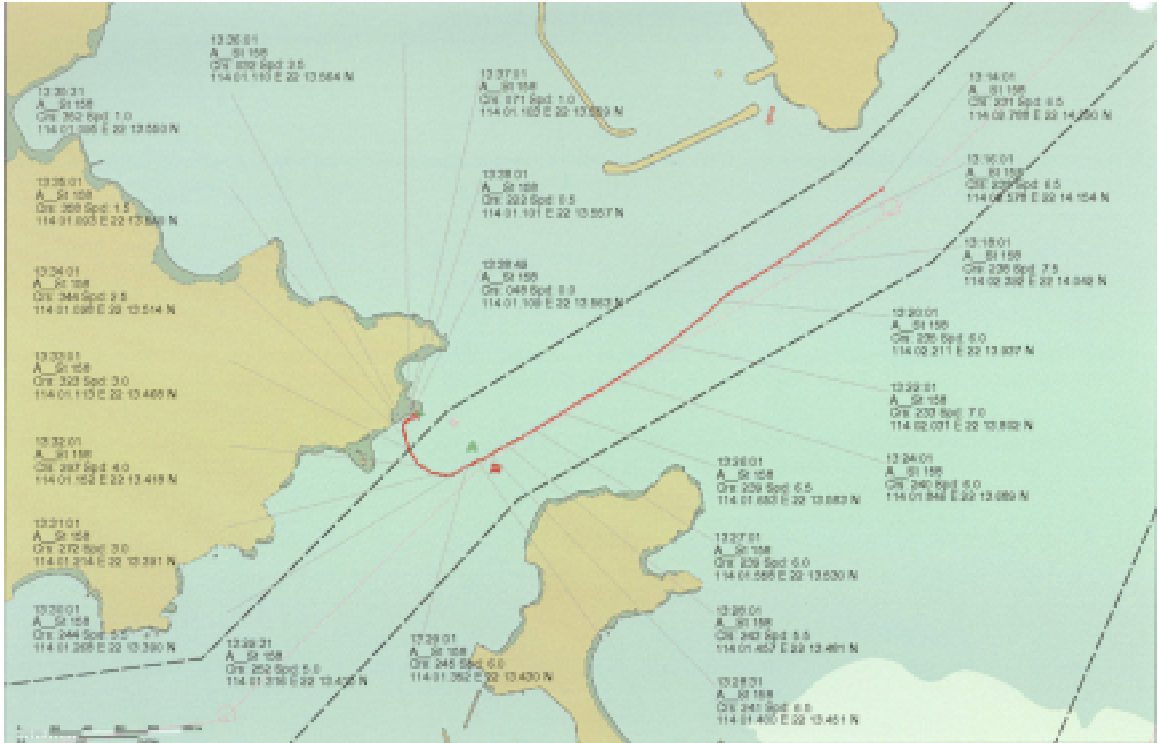
.3 It is noted that in both incidents, the vessels were proceeding along the southwest-bound traffic lane on the Traffic Separation Scheme with the green Adamasta NW light buoy on their starboard side and subsequently ran aground on the shoal.

Fig.14-The VTC radar record of Shi Tai 158 grounded at 1345 on 29 Jan.2010
