**Report of Investigation into the
sinking of Hong Kong registered
supply vessel Hai Yang Shi You 699
in approximately position
22° 06.626'N 114° 16.286'E,
about 3.3 nautical miles south of
Po Toi Island, Hong Kong
at 1700 on 25 July 2012**

Purpose of Investigation

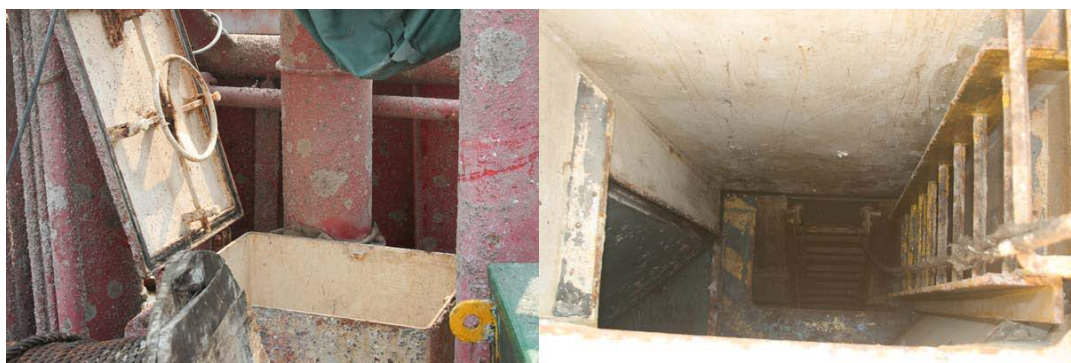
bilge water inside the cement compartment increasing. After inspection by the chief engineer and the fourth engineer, they found the access hatch cover of emergency escape trunk in way of the cement compartment was flushed open by wave and resulted in about eight tons of seawater flooding inside of the compartment. Due to strong wind and waves at sea, the crew was unable to attend and close the access hatch cover. The chief engineer immediately reported to the master and requested to turn the ship around to keep her port side leeward. The master turned around the ship and she followed the waves at sea. Then the crew closed the hatch cover and the vessel resumed the voyage thereafter.

Fig.3 – the escape trunk from the cement compartment to the main deck at port side midship

- 4.15 Later on, the master was reported that the access hatch cover for the emergency escape trunk in way of the cement compartment at midship port side was opened by wave again. He turned the ship around to head against the wind and wave so that the crew could close the hatch cover. As the access hatch cover was slightly deformed or with its seal deteriorated, the crew used a rope to secure the hatch cover in closed position from inside the compartment. The master was reported that about 10 tons of water entered into the engine room.

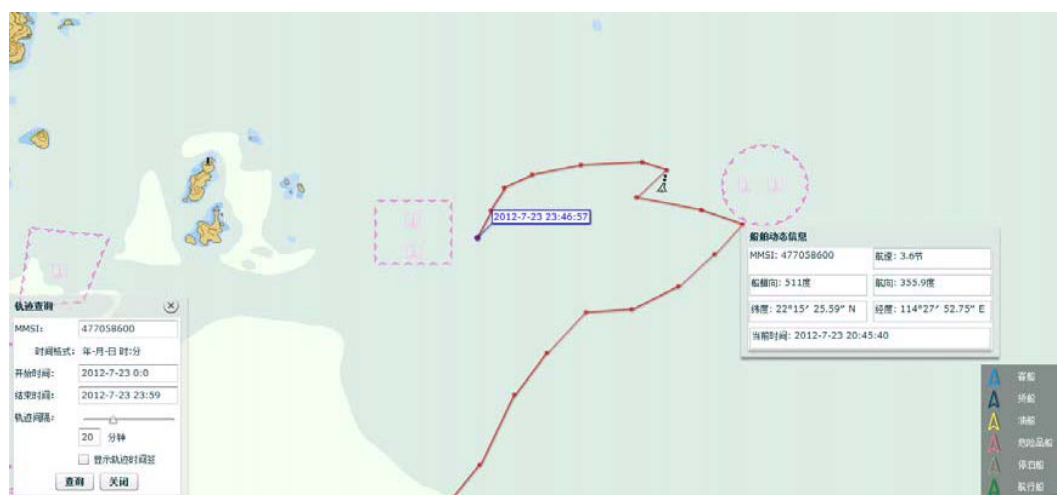
Fig.4 –AIS track of HYSY 699 showing change in course at 2045 hours.

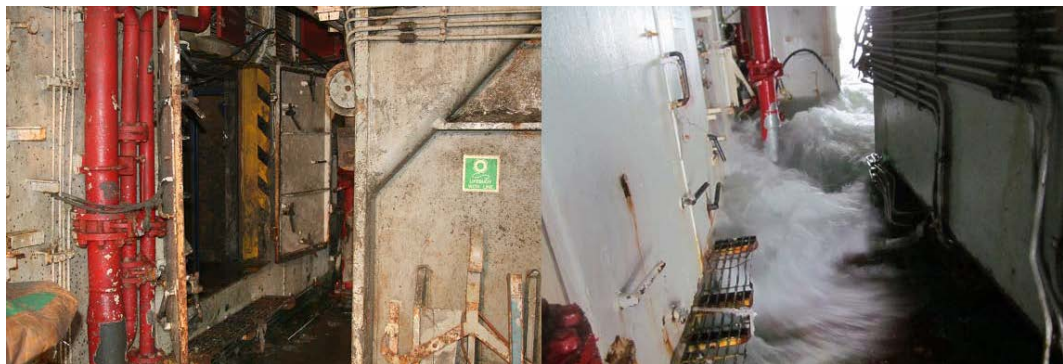
- 4.12 On 24 July 2012 at 0010, the repair of sea water pump was completed and the main engines operations resumed normal. At that time, it was found that a weather-tight door at aft of accommodation on the first deck was opened and sea water washed on the main deck entered into crew accommodation through the door. The weather-tight door was pushed opened by the oil drums, which had been broken loose from their securing position near the towing winch. The drums rolled and impacted on the door and as a result, the weather-tight door was opened and some of the oil drums distorted. The chief engineer reported to the master that small amount of water entered into the engine room through the engine room entrance door inside crew accommodation. The master requested all off-duty crew members to mop up the water inside accommodation and engine room and to remove the oil drums.

Fig.5 – the weather-tight door on the first accommodation deck facing aft (left: taken after salvage, right: taken by the crew deployed from *Blue Whale* after *HYSY 699* abandon ship).

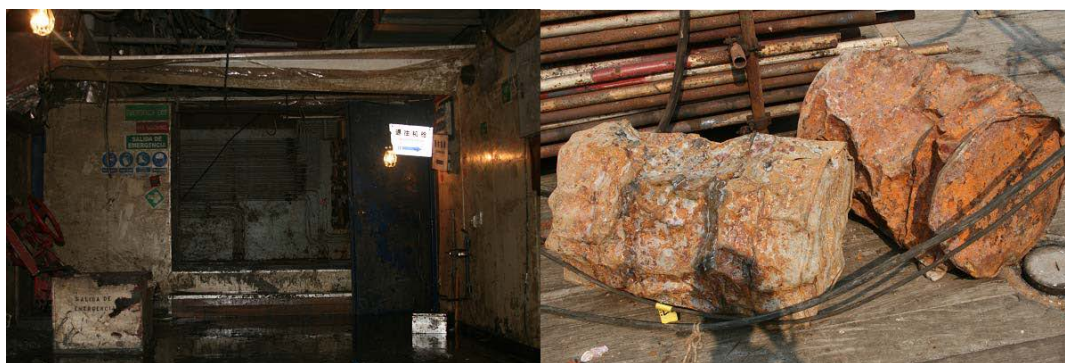
Fig.6 – left: the engine room entry door in accommodation / right: deformed oil drums after salvage.

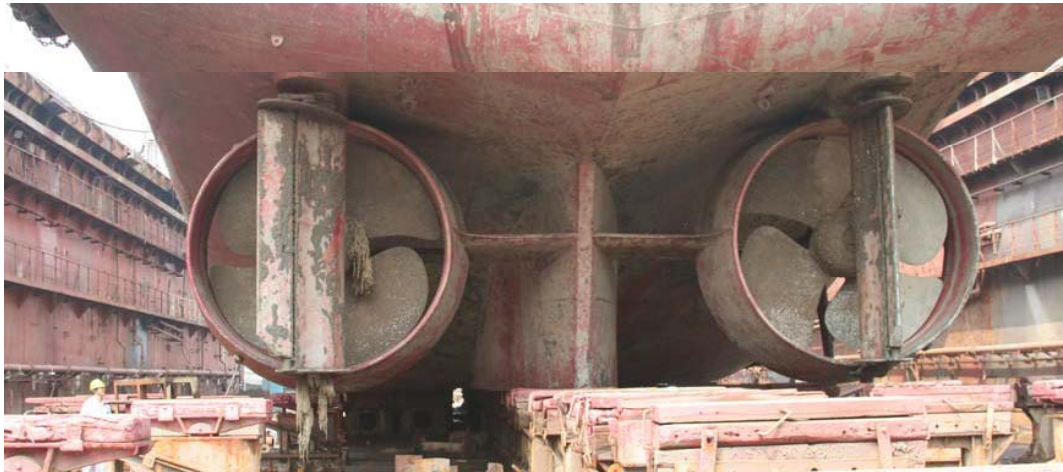
4.18 At the same time, the ship listed to starboard, the master ordered to transfer fresh water from tanks No. 1.4 to No. 1.3, and requested the chief officer to put the mooring rope which was about 70 metres in length at bow into water in order to adjust the ship's heading and reduce the rolling of the vessel. This action was not effective as expected. The master recovered the rope. It was also found that another mooring rope had fallen into the sea from starboard side at the midship position and it was fouled by the port propeller.

Fig.8 – port propeller was found fouled by a mooring rope.

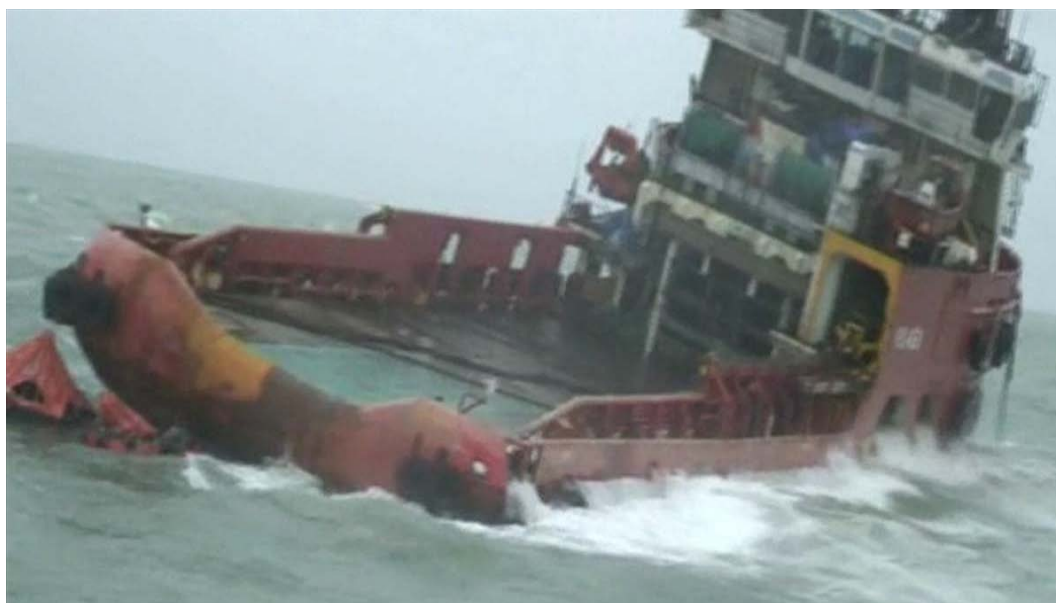
- 4.25 At about 1220, the rolling periods of *HYSY 699* was getting longer and the vessel's trim by head increased. At 1223, the master decided to abandon ship after considered that the prevalent situation of the vessel would pose risk to his crew's safety. At 1245 hours, all the crews abandoned the ship and boarded on the two liferafts.

Fig.9 – HYSY 699 listed to starboard severely at time of abandon ship.

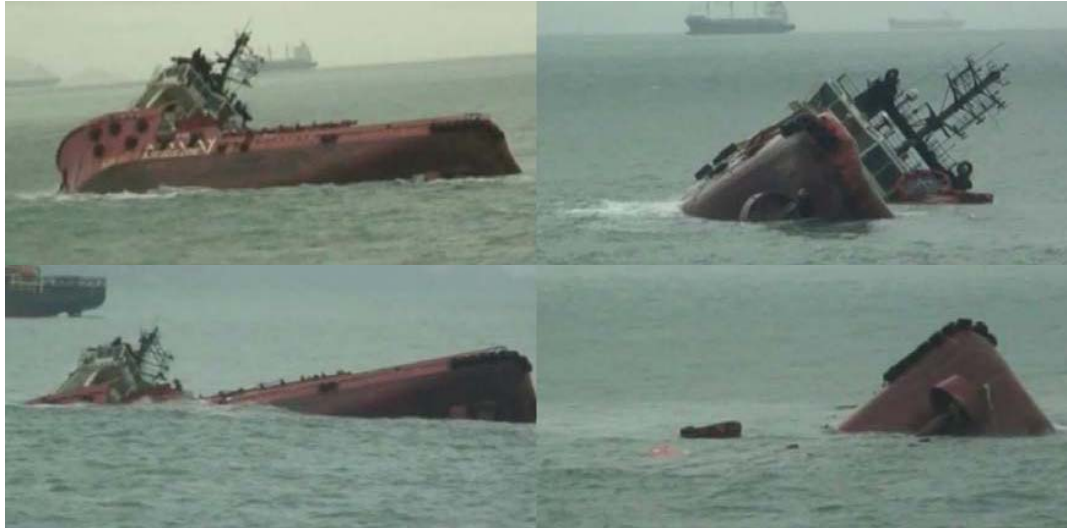
- 4.34 At 1605, Hong Kong Marine Department instructed *NHJ 116* to alter course right south immediately to tow *HYSY 699* away from the navigable waters near to shore. At 1614, *NHJ 111* came alongside *HYSY 699* and picked up all the five crew members of *Blue Whale*. At 1620, *NHJ 116* increased the towing speed to five knots. At 1630, the starboard deck railing of *HYSY 699* had been immersed in the water and the risks of the vessel sinking persisted. The master of *NHJ 116* increased the towing speed so as to clear her from the navigable waters near to the shore. At 1650, *HYSY 699* started sinking. At 1655, *NHJ 116* cut off the towline and moved away from *HYSY 699* and stood by in the vicinity. At 1700, *HYSY 699* sank in position approximately 22° 06.626'N 114° 16.286'E, at southeast of No. 2 precautionary area of the TSS in Dan Gan channel.

Fig.12 – the condition of HYSY 699 when capsized and sank.
