**Report of Investigation into the
Loss of Master of Hong Kong
Registered Log Carrier “*New
Lucky III*” at 35 Nautical Miles
Northwest of Taipei on 15
September 2012**

The Hong Kong Special Administrative Region
Marine Department
Marine Accident Investigation Section

15 September 2014

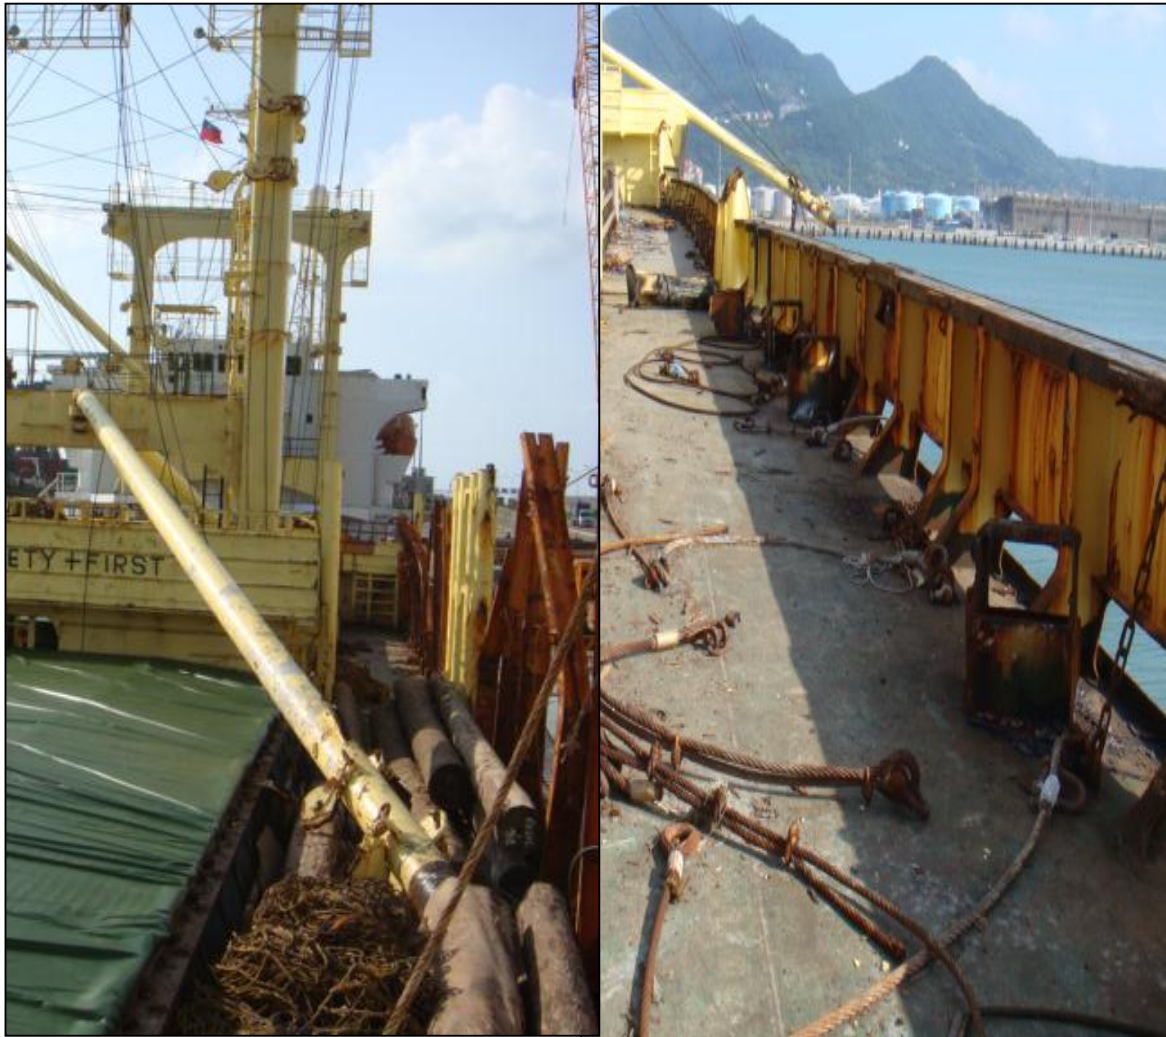
- 4.20 After the helicopter had winched up four of the crewmembers, the vessel listed further to starboard. The list was about 40 degree and the ship rolled heavily. Some lashing wires and uprights on deck on the starboard side were damaged and collapsed. Some logs on deck on the starboard side fell overboard and drifted away. A cargo survey carried out later on revealed that 456 pieces of log, equivalent cargo volume of about 1770 m³ was lost. Consequently, the starboard list of the vessel reduced. Soon afterwards, the Taiwanese Coast Guard rescue boats arrived on scene.

Fig.4 – Bended uprights & collapsed derrick on port side (left), starboard uprights removed (right)

5.3.5 The uprights on the starboard side in way of the cargo deck area were damaged and collapsed. The logs lashing wires parted and a total of 456 pieces of logs on deck (total volume 1770.307 m³ in 1775 tons) fell overboard. It was apparent that the starboard list of the vessel was reduced. The collapse / loss of deck cargo was considered as an unintentional jettison of cargo to improve the stability. The stability would be improved.

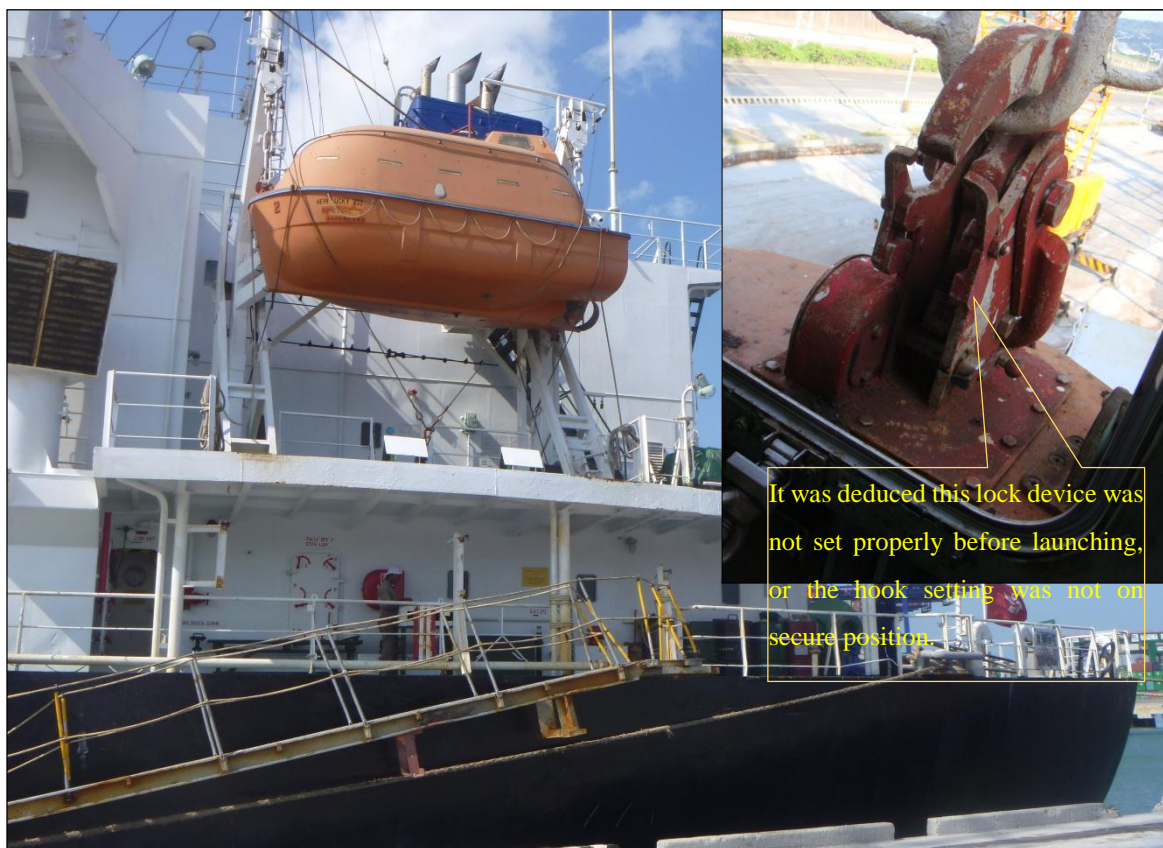
officer embarked the lifeboat and tried to enter it through the aft entrance door. The door was locked from the inside. He finally reached to the forward of the boat along the outboard gunwale. He tried to release the lifeboat hook outside with a hammer but in vain.

Fig. - 7 the port side lifeboat, and the lifeboat hook.

life-saving appliances (lifeboat and liferaft) on board were found not properly maintained. Such as the aft lifeboat hook was not set correctly and the painter of liferaft was not fastened to the ship structure.

- c) Voyage plan should include contingency measures that would be encountered during the voyage of the vessel;
 - d) Lifesaving appliances should be properly maintained in a readily operational condition; and

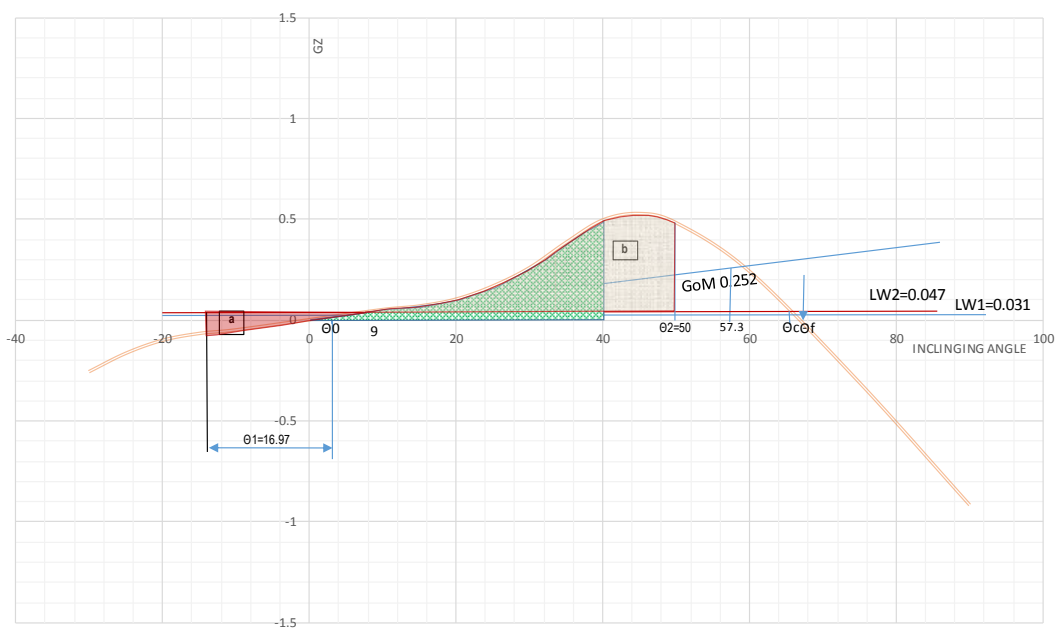
New Luck III Departure on 5 Sep.2012

IMO A. 206.				IMO A.562					
Area 0 to 40° or Θf		> 0.08	0.113	A (M2)	772	K	0.984	$\Theta 1$	16.97
GoZ (Max) (m)		> 0.25	0.526	Z (m)	8.17	X1	0.970	$\Theta 2$	50.0
GoM (m)		> 0.10	0.252	W (T)	10440.09	X2	1.000	Θc	65.5
Judgement			Yes	LW 1	0.031	S	0.035	ΘF	67.0
Θf : Angle of down flooding or 40 which ever is less				LW2	0.047	R	0.759	Area b	0.165
				OG (m)	0.358	Ang.x 0.	6.7	Area a	0.023
				T	29.864	$\Theta 0$ limit	16°	b/a ≥ 1	7.056
				C	0.390	$\Theta 0=$	3	Judge.	Yes
Angle limit: 16° or ang.x0.8 whichever is less

- .1 General stability criterions of IMO Res.A.206(VII) were all met: GoM =0.252 m, RMA from 0 to 40° = 0.113 m.rad, and GZmax=0.526 m;
- .2 Criterions of IMO Res. A.562(14) (Stability requirement in wind and waves) were all met: The Heeling angle Θ_0 3° and area b is greater than area a. Rolling period 29.9 S;
- .3 But the GoM of 0.252 m was found just on the margin line of Acceptable Zone in the permissible GoM chart.

2. It was found the GoM of 0.252 m was much less than the 0.64 m which was calculated by ship's staff. The incorrect height figures of deck cargo and KG data of Fresh water and Diesel oil were used in the ship's calculation.

Conclusion: The stability on departure condition met all the criteria of stability elements, and also in the Acceptable Zone of Permissible GoM chart. But it was on the margin line of Acceptable Zone.

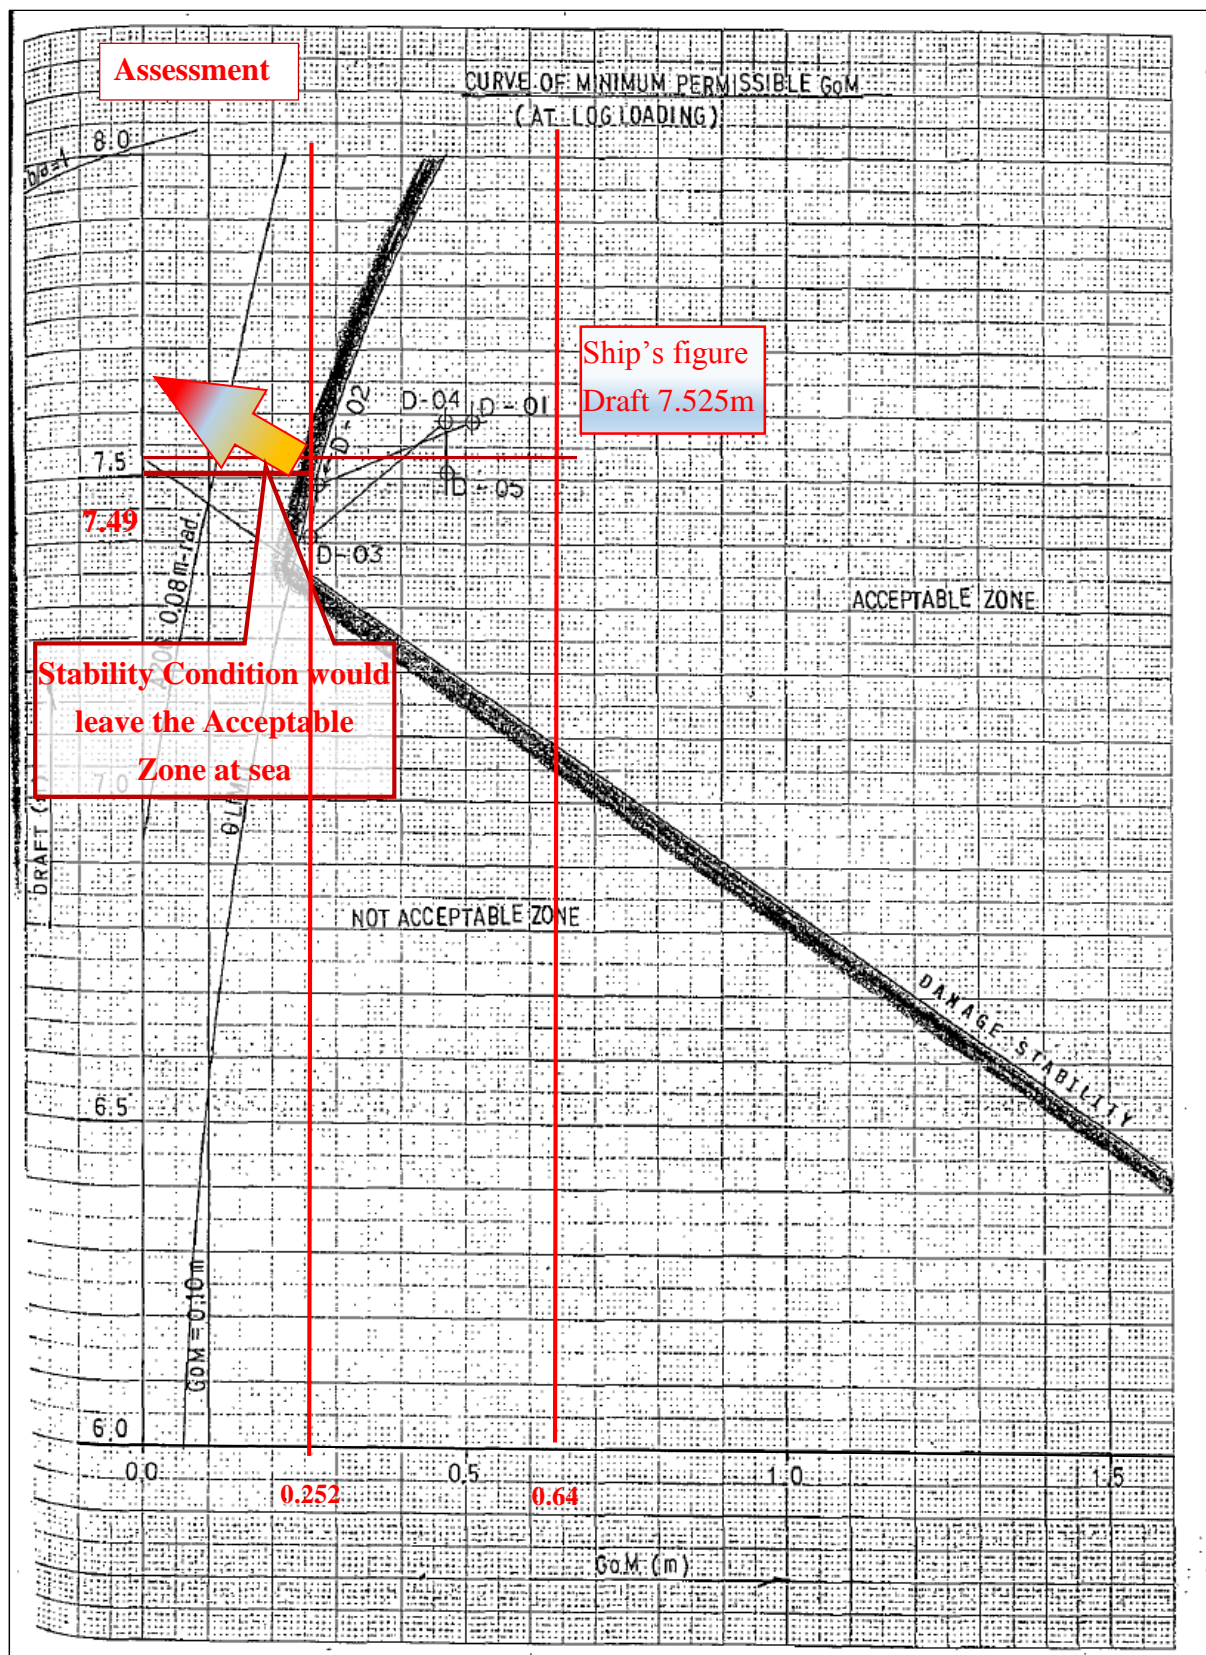
CURVE OF MINIMUM PERMISSIBLE GoM (AT LOG LOADING)

Considering the above adverse effects, the stability would be worsened from the departure condition. It was deduced that the stability condition on 15 Sep.2012 would not be not inside the Acceptable Zone any more.

By plotting the GoM of Assessment condition & ship's calculation to the Permissible GoM chart,

1. Assessment (on departure) : GoM 0.252 m was on the margin of Acceptable Zone;
2. Ship's assessment (Departure) : GoM 0.64 m was in the acceptable Zone, but the figure was not reliable due to multiple incorrect figures were used in the calculation.
3. Considering the displacement would be increased on her voyage (draft became more), and GoM would decrease. The stability of the vessel would leave the margin line of *Acceptable Zone* and fall into **Not Acceptable Zone** as the arrow indicating.
