Report of investigation
into the fatal fire accident
happened on board
the open cruiser, Certificate
of Ownership Number
110048 at Northwest of
Trio Island, Sai Kung
on 10 February 2013

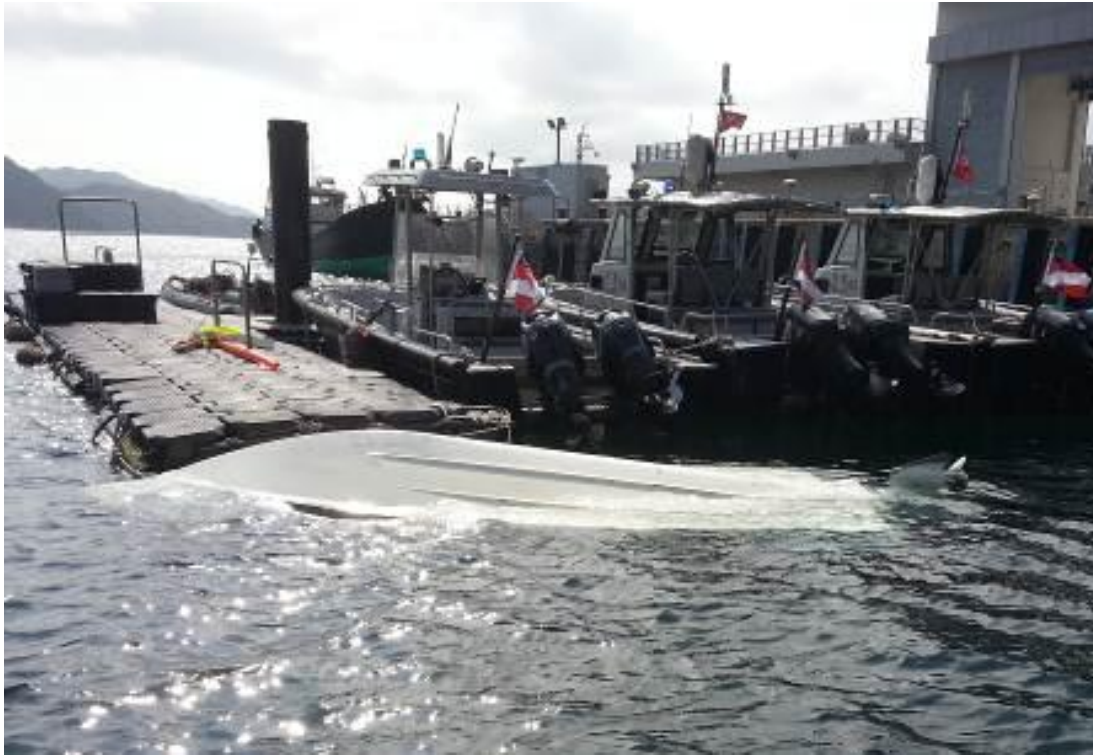
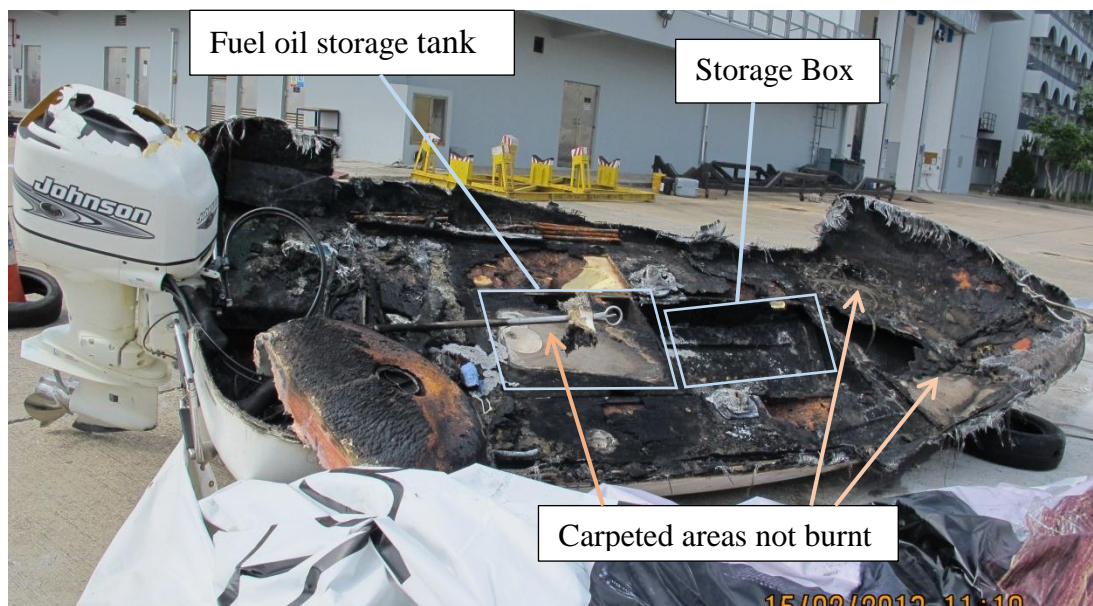
Fig. 4: The capsized vessel in the Marine Police base and was docked

- 5.4 In the incident, the blazing vessel drifted to northwest off Trio Island in Sai Kung and capsized. The capsized vessel was towed to the base of Marine Police in Tui Min Hoi, Sai Kung for inspections. The whole vessel was seriously damaged in the fire (see Fig. 4).

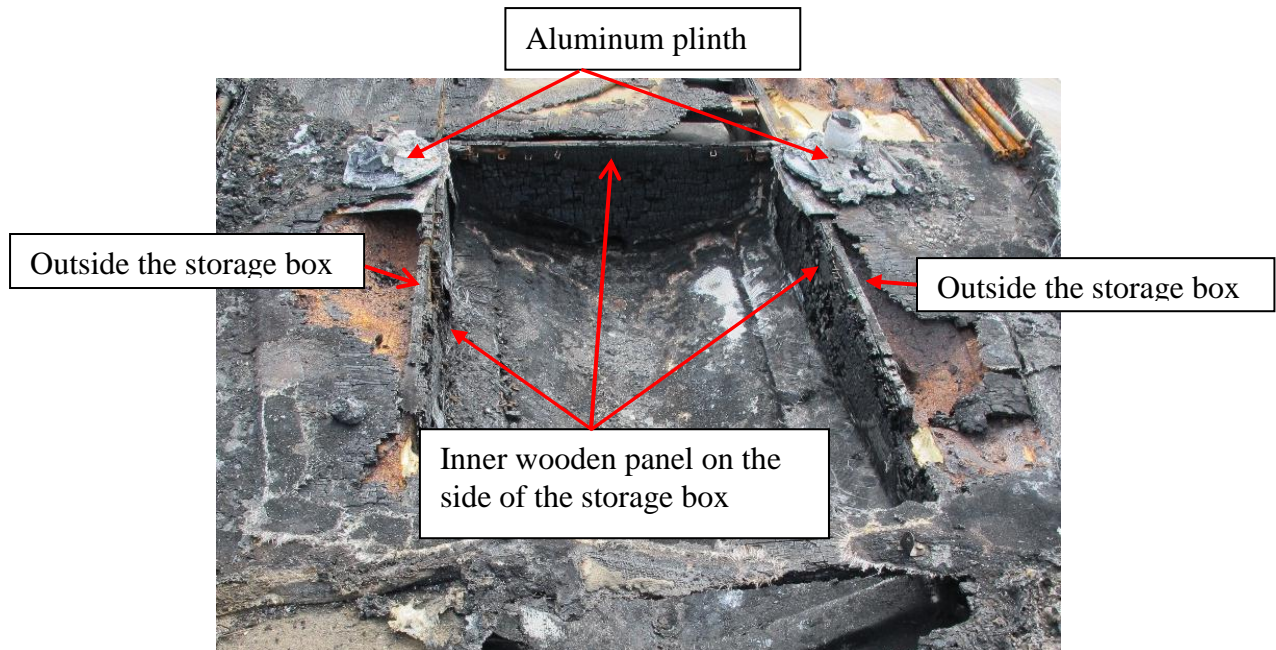
Fig. 5: The completely charred storage space

- 5.5 The interior of the storage box was completely charred with more damage at the front end while its outside was not burnt so seriously (Fig. 5).

- 5.6 The two aluminum plinths for the front seats located beside the storage box were melted, indicating that the fire temperature was higher than 660 °C in that area (660 °C is the melting point for aluminum).
- 5.7 The outboard engine and the engine starting battery located at the aft end of the vessel were not damaged by the fire (see Fig. 6).

- 5.18 The storage box was made of wood with a lid on top and it was constructed of the same material throughout. It was found that the front end of the box was burnt down more severely than the other part indicated that the front end of the box had been burnt for a longer period of time.

- 5.20 It is probable that there was fuel leakage from the fuel containers inside the storage box. It is believed that the fuel leakage was of small amount only due to the fact that, if the leakage amount was large, fuel oil inside the box would be passing through the drain hole at the bottom of the box to the bottom of the hull. Should the fire have started, the bottom part of the hull would be burnt seriously. However, it was found that there were no burning marks in the fuel tank compartment to which the storage box drained, indicated that the leakage amount of fuel was small. Hence, the small amount of gasoline leaked from the fuel container(s) vapourized and filled up the interior space of the storage box. The fire was started when the vapour was ignited.

- 5.21 According to the wife of the deceased, the Coxswain was a heavy smoker. It was quite probable that the Coxswain was smoking while operating his boat. The cigarette accidentally ignited the gas vapour inside the box and started the fire.

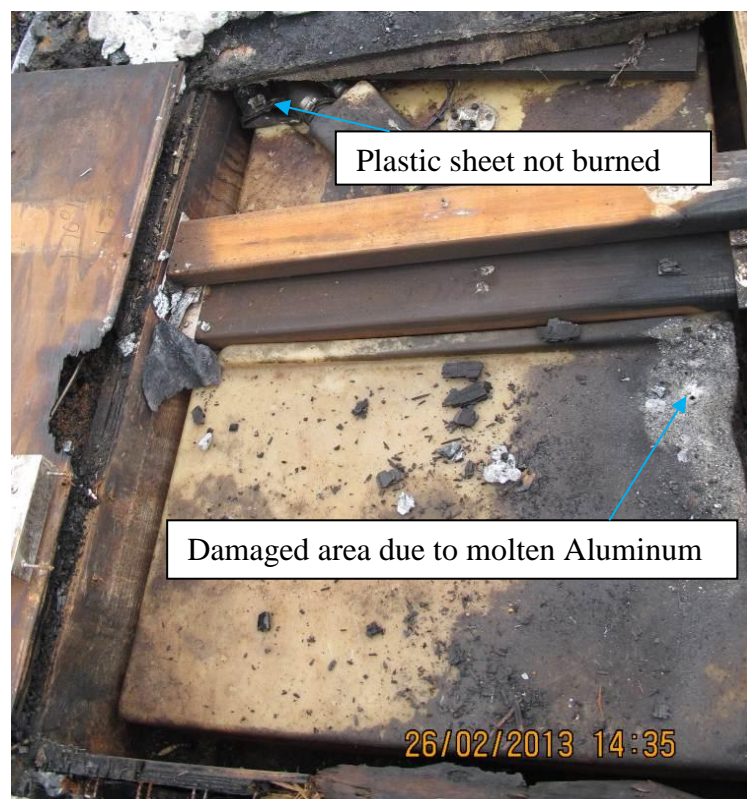
Fig. 7: Top view of the fuel oil storage tank

- 5.10 Although the upper part of the vessel was burnt seriously, the plastic fuel oil storage tank under the deck was not damaged by fire. Unburnt plastic sheet was found at the top corner of the fuel oil tank (Fig. 7) which indicated that the fire did not spread to this part of the vessel before it was put out.
