**Report of Investigation into
the fatal accident on board
Hong Kong Registered Ship
Ocean Amber at Richards Bay,
South Africa
on 20 February 2013**

Marine Accident Investigation Section
Marine Department
The Hong Kong Special Administrative Region

1 September 2015

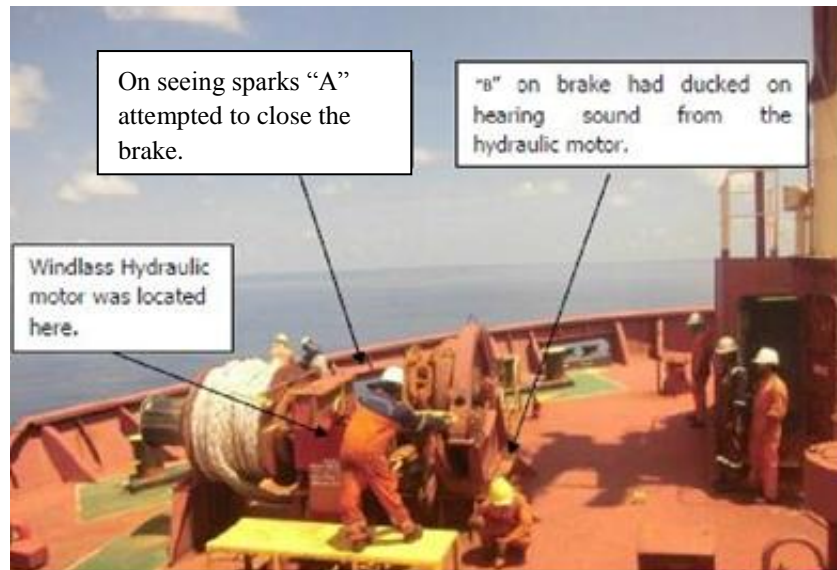
- 4.12 When “B” saw fire sparks (probably from metal grinding), which lasted for a few seconds, emerging from a position close to the windlass hydraulic motor, “A” attempted to apply the brake on the port anchor windlass (Fig.4). Suddenly, the windlass hydraulic motor exploded. “B” ducked down immediately once he heard the abnormal sound. “A” was unfortunately hit by debris against his neck and jaw. He limped towards starboard side and lied on the deck near No.1 cargo hold booby hatch.

Fig. 4: Photograph re-constructing the actions of “A” and “B” at the time of the accident

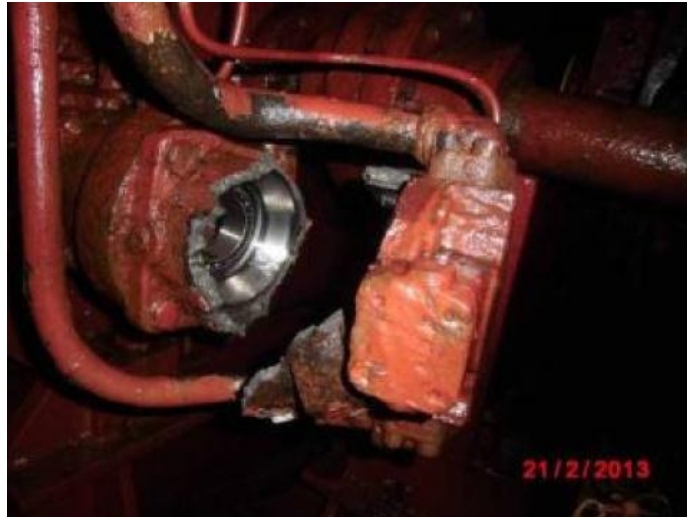
- 4.15 The port windlass hydraulic motor was completely damaged. Ship staff dismantled the starboard windlass hydraulic motor and switched over to replace the damaged one on port side in order to lift up the port anchor. At 0922 hours on 23 February 2013, when the port anchor was heaved up from the water, it was

Fig. 5: The damaged port windlass hydraulic motor

- 5.16 The port anchor windlass was driven by a high speed windlass hydraulic motor which was coupled with a planetary reduction gear box with gear ratio of 1168:1. Such a high gear ratio would result in severe over speeding of the windlass hydraulic motor if the port anchor chain probably started to run out a few link in a flash not noticeably just before the explosion by external forces with the windlass hydraulic motor engaged with the chainwheel. Over speeding of the port windlass hydraulic motor in the reverse direction would result in severe rise of hydraulic pressure inside the motor due to the positive displacement pumping action.

- c) frictional force due to anchor chain touching of ship's hull;
 - d) fouling of anchor by an abandoned anchor chain on the seabed; and
 - e) severe rise of hydraulic pressure inside the port windlass hydraulic motor by runaway of the port anchor chain that probably started in a flash before the explosion.

- c) physical guards and barriers should be made around the windlass hydraulic motors to protect personnel involved in anchoring operation from the potential explosion of the windlass hydraulic motor; and

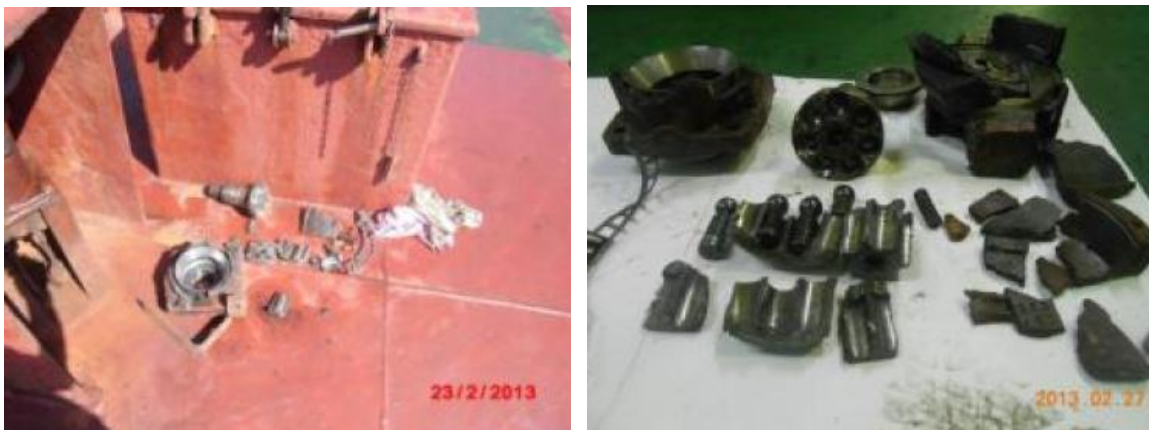
- 4.16 On 26 February 2013, the *Vessel* was berthed at Richards Bay coal terminal. The deceased was landed and handed over to local authorities for autopsy.
- 4.17 The damaged port windlass hydraulic motor and the broken parts of the motor are shown in Fig.5 and Fig.6.

Fig. 6: The broken parts of the port windlass hydraulic motor

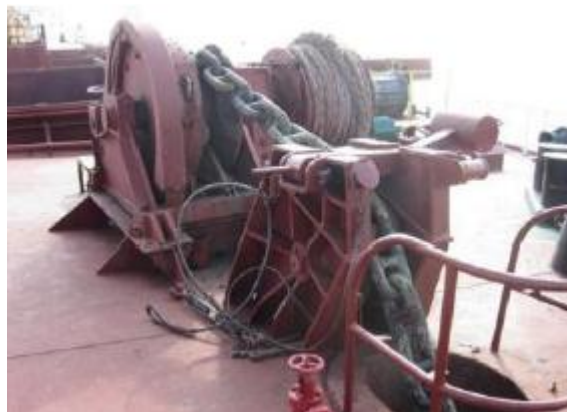
Fig. 7: Port anchor windlass

- 5.8 The *Vessel* was provided with two sets of stockless High Holding Power Anchors each weighing 7,425 kg. Each anchor was connected to a 78 mm diameter anchor chain (Grade K3) of length 11 shackles. The type of anchor windlass was 1906-8816So (Central Hydraulic System) manufactured by Friedrich Kocks GMBH, BREMEN under TTS Kocks (TTS) and certified by Lloyds Register (Fig. 7). The type of driving winch was 8816So. The maximum pull was 434 kN and the maximum depth was 194 m. The average speed from a depth of 82.5 m was 9 m/min. The brake holding power at chain lifter was 2,068 kN.

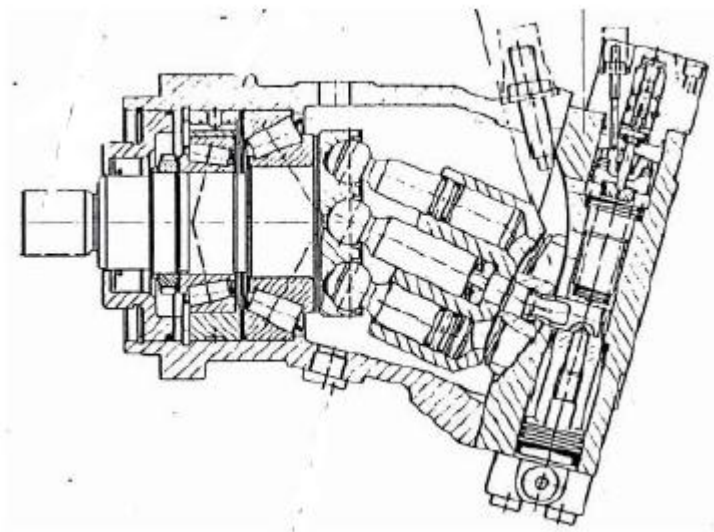
Fig. 8: The sectional drawing of the windlass hydraulic motor

5.19 According to recommendation made by the maker, safety guards may be helpful to protect operators in case of explosion occurred. The recommendation was accepted and both port and starboard hydraulic motors were fitted with safety guard.

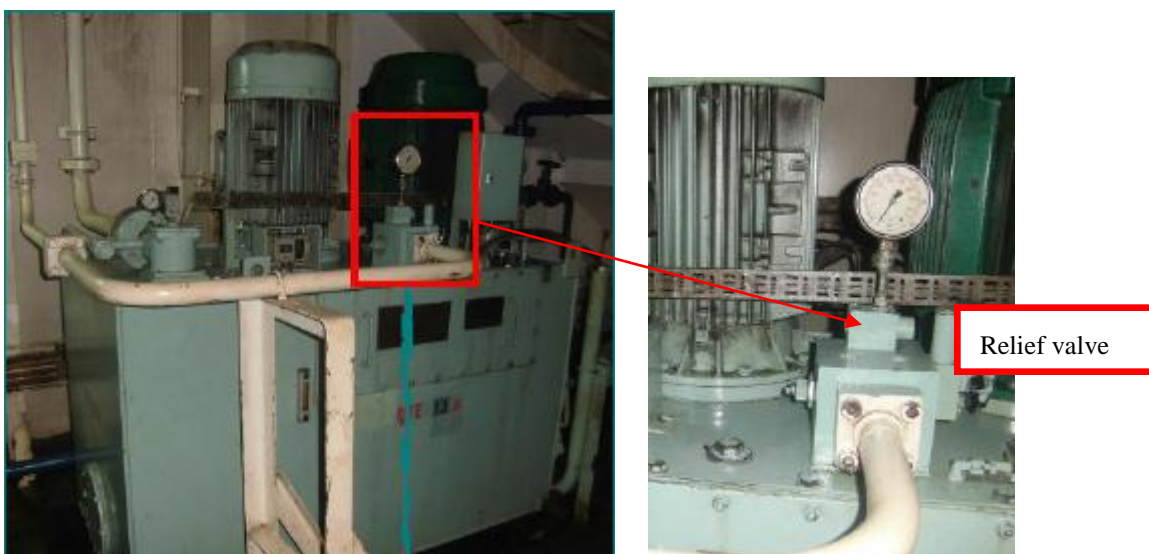
- 5.10 There was a pressure relief valve (Fig. 9), set at a relief pressure of 280 bars, to protect the hydraulic power pack, which was installed inside the fore peak store, from over-pressure. There was no pressure relief valve fitted on the windlass hydraulic motor.
- 5.11 It was a class requirement that over pressure protection be provided on the discharge side of the hydraulic pump. In this case, a pressure relief valve was fitted in a closed circuit through which the hydraulic oil would be discharged back to the system oil tank once the pressure relief valve was activated. The arrangement complied with the class requirement.

Fig. 9: Hydraulic Power Pack in Fore Peak Space
