Report of investigation

into the death of a Seaman on board

*“Equator Peace”*

on 24 May 2013

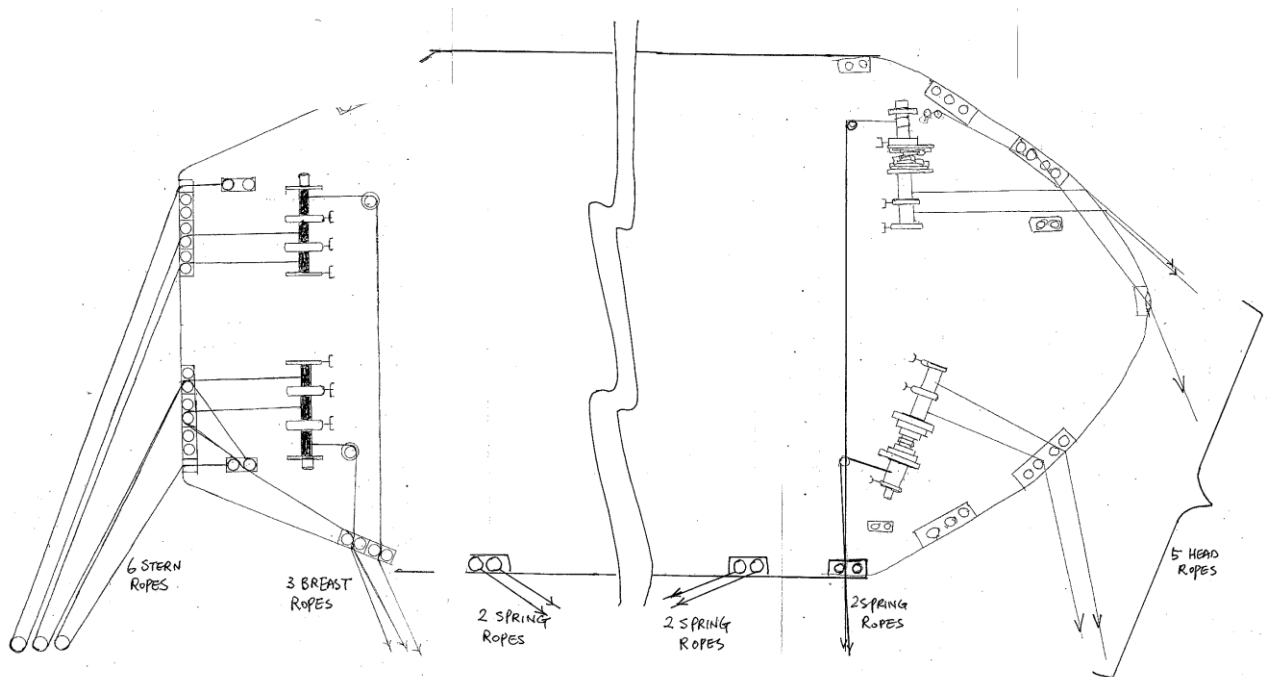
Before arriving at the berth, the master agreed with the pilot that the vessel should be berthed with a mooring ropes arrangement of 6-3-3 forward and aft respectively. However, during the mooring operation, one of the forward spring mooring ropes was found fouled on the fender and rendered useless. The vessel was finally moored with 5 head ropes; 2 breast ropes and 2 springs in the forward (5-2-2) and 6 stern ropes; 3 breast ropes and 2 springs in the aft (6-3-2). Details of the mooring arrangements for Forward and Aft ends were shown in Fig. 3.

Fig. 3 Mooring Arrangements in Forward and Aft of the vessel

According to the mooring guidelines, vessels of size larger than 145,000 DWT should be moored with a 6-3-3-3-3-6 pattern, i.e. 6 head ropes, 3 forward breast ropes, 3 forward spring ropes, 3 aft spring ropes, 3 aft breast ropes and 6 stern ropes. Such arrangement was also agreed between the master, the Pilot and the Terminal Management before berthing. However, during berthing, one of the mooring ropes was fouled but it was not replaced with the spare mooring ropes. Instead the mooring arrangement was reduced to 5-2-2-2-3-6. Such reduction in number of mooring ropes increased the tension exerted on all mooring ropes and made the defected breast rope more vulnerable to parting.

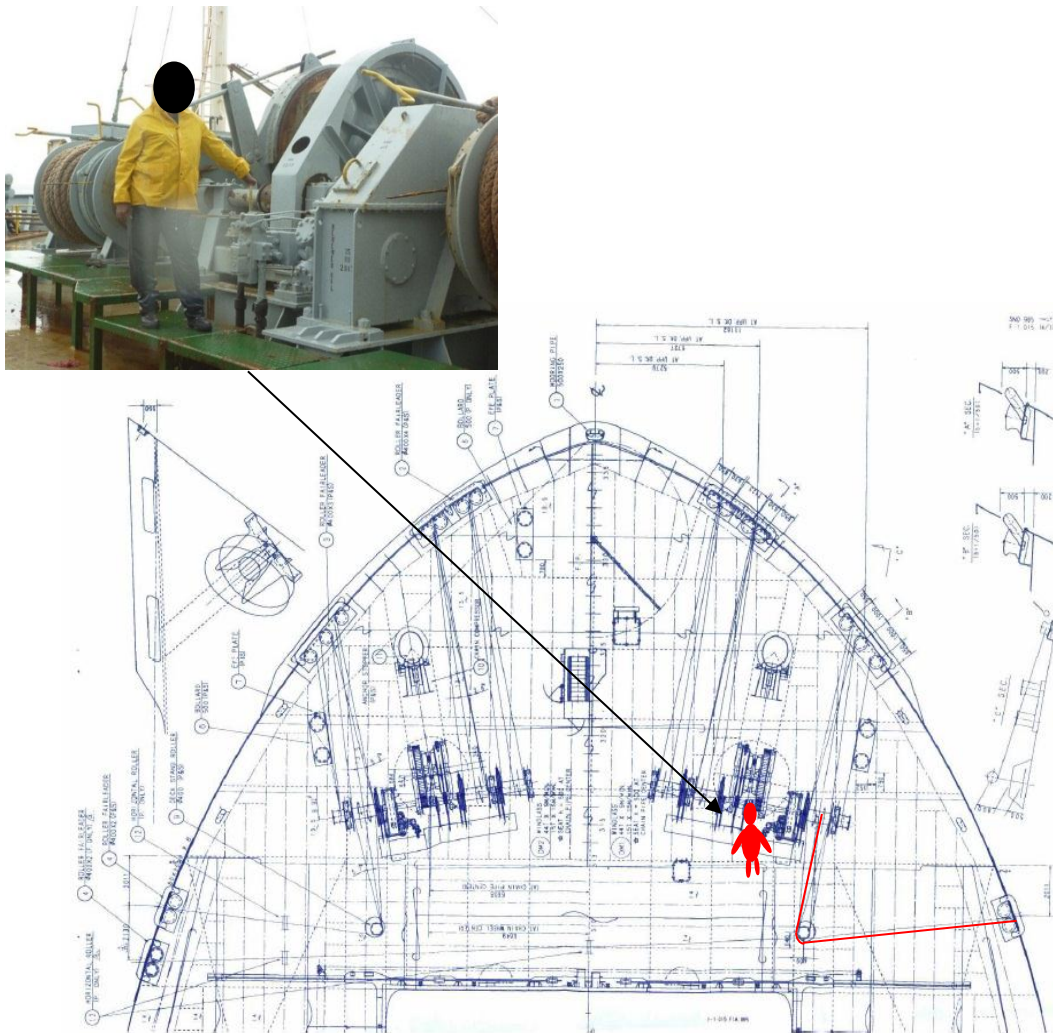
- 4.4 The third officer called the second officer by radio and asked him to stop the motor of the stern mooring winch and ordered the OS to switch on the second motor for the mooring winch. He then went to gear up the portside winch to tighten up the head ropes. At the same time, the third officer ordered the OS to tighten up the breast rope which was connected to the starboard winch. The OS went to the operation position on the platform of the starboard winch as shown in Fig. 4 and started to tighten up the breast rope.

Fig. 4 The position of the OS before being struck by the parted mooring breast rope

- 5.18 The SMS manual required that the person in charge should ensure that Staff were stationed in safe areas, having due regard to the likely lash back zones of parted ropes. The third officer, being the person in charge of this operation, he failed to observe the said requirement.

- i) to inform the master, officers and crewmembers of the vessel the findings of this accident investigation;
- ii) to ensure the deck mooring arrangement be planned in such a way to prevent crew members staying within snap back zones while controlling winch;
- iii) to ensure the crewmembers to observe company safety procedures to avoid persons from staying within the snap back zones of mooring ropes at all times;
- iv) to provide instructions and procedures in the Safety Management System for the inspection and maintenance of mooring ropes and the criteria for their replacement;
- v) to provide prompt support to the shipboard management upon requisitions of essential stores and provisions; and
- vi) to carry out additional safety audits to ensure good maintenance of mooring equipment on board and all relevant safety procedures are followed.

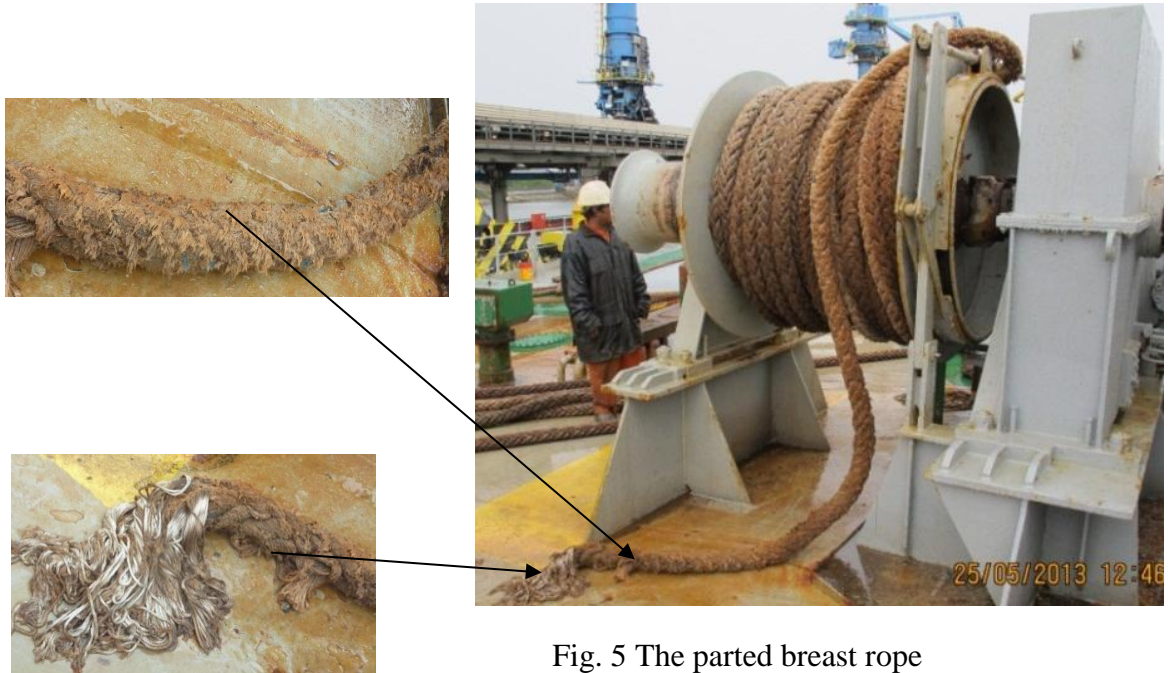
- 4.5 During this operation at 1800 hours, the starboard forward breast rope suddenly parted (as shown in Fig5) and the parted mooring rope struck the OS on his head and the OS suffered from serious head injuries.

Fig. 5 The parted breast rope

- 5.17 In the two attempts to pull the bow of the vessel alongside, only the starboard breast rope was used. Owing to the shorter lead of the starboard breast rope, the tension induced on the starboard rope was larger than the tension in the port rope. Such aggregation of tension in the rope increased the chance of parting.

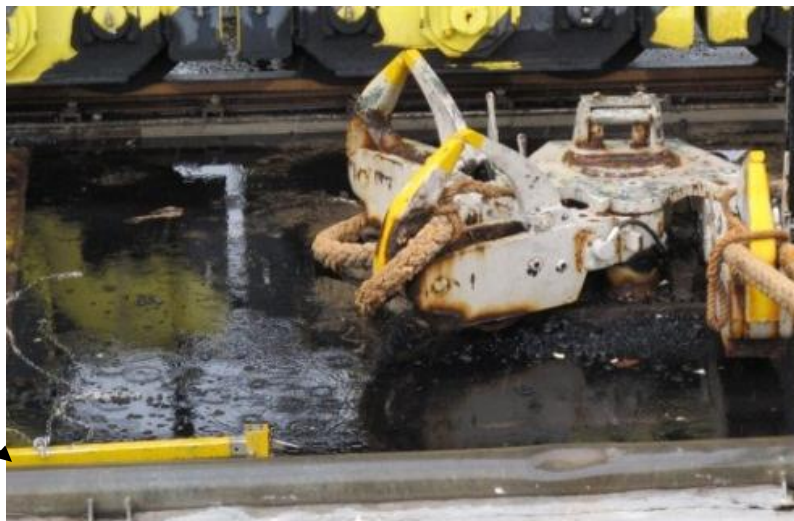
Knocked  
down rails

- 4.6 When the forward breast rope parted, a section of the parted rope struck a panel under the unloader\* beside the jetty and also knocked out some of the railings. The panel door was deformed and the railings were pulled out from the anchoring position as shown in Fig. 6 & Fig. 7.

Fig. 6 Rails in ways of the parted rope were knocked out form their anchored positions

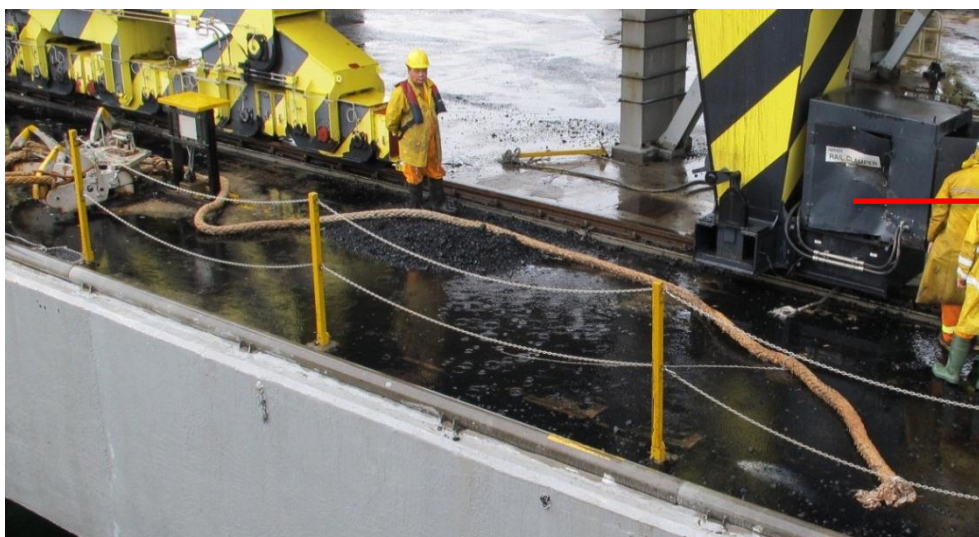
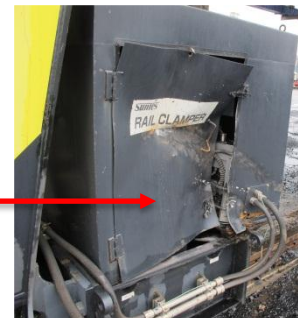
Fig. 7 The damage caused by the parted mooring rope on the shore equipment

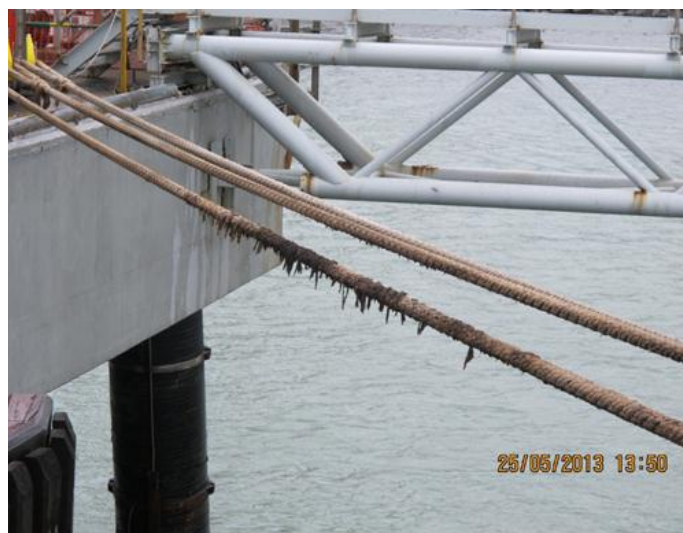
Fig. 9 showed that one of the stern ropes suffered from abnormal wear on the surface of the rope causing darkening of the surface and damages to the surface yarns.

Fig.9 One of the Stern ropes showed sign of chemical damage on the surface

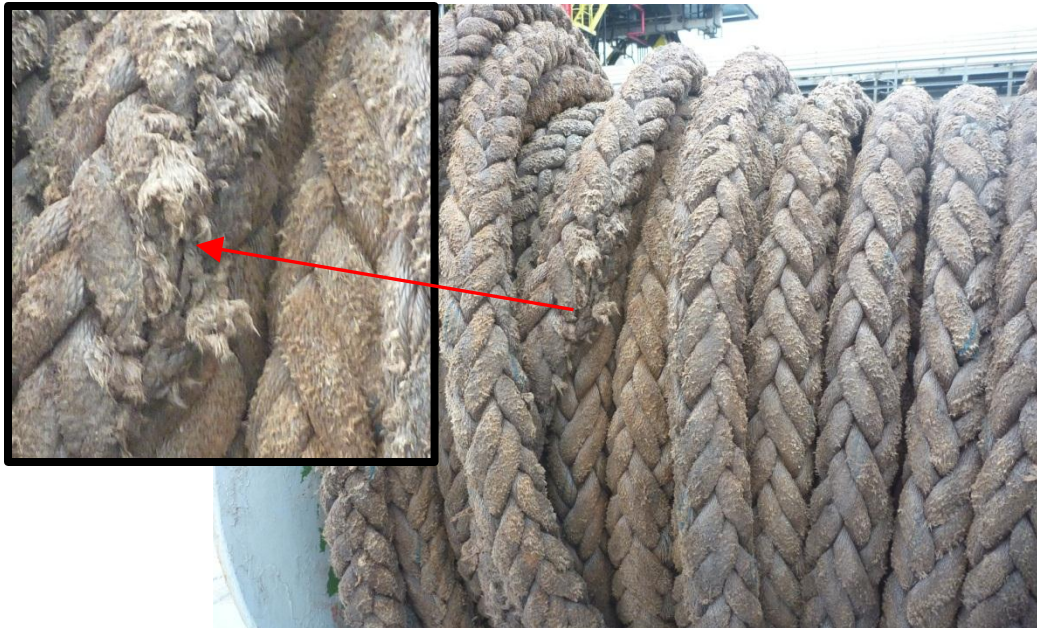
Fig. 10 showed the condition of a spring mooring rope loaded on a drum of the forward spring mooring winch. Two out of the 8 strands were cut through.

Condition of a mooring rope which was loaded on the drum of the forward spring mooring winch. Deep cuts were found on two strands.

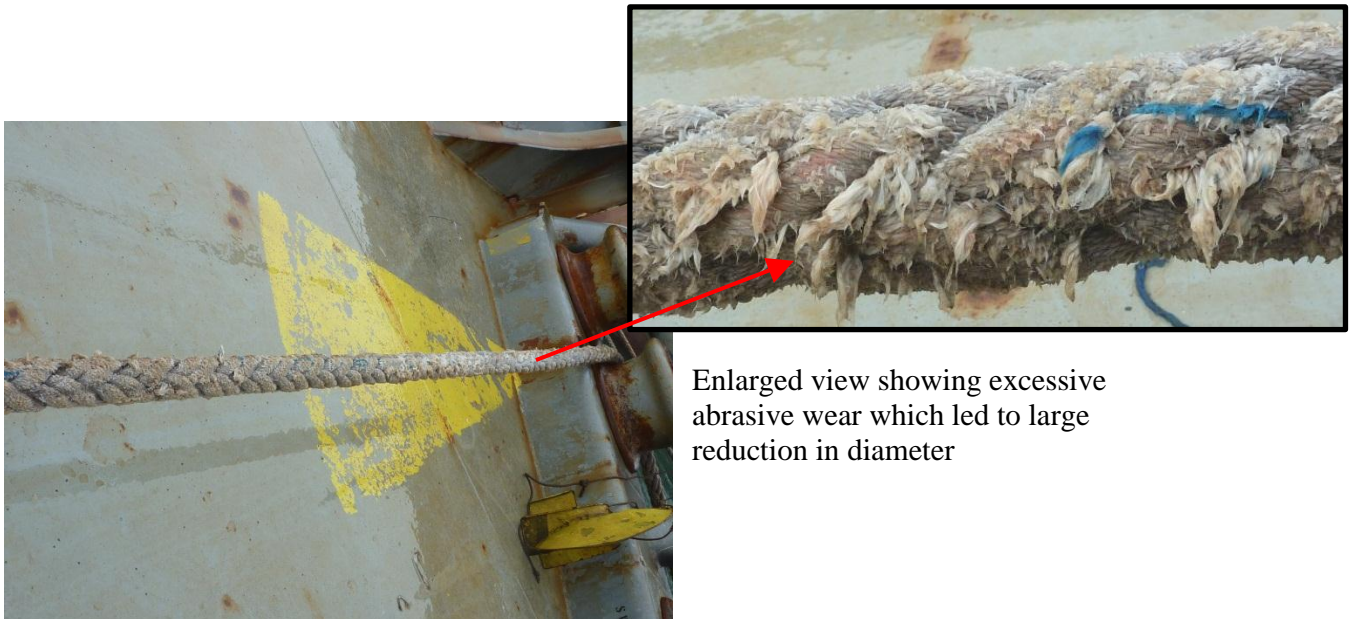
Fig. 11 indicated the condition of the remaining forward breast rope. The enlarged view showed that the rope suffered from serious abrasion and there were positions with large reduction in the diameter.

Enlarged view showing excessive abrasive wear which led to large reduction in diameter

Fig. 11 Condition of the remaining forward breast rope

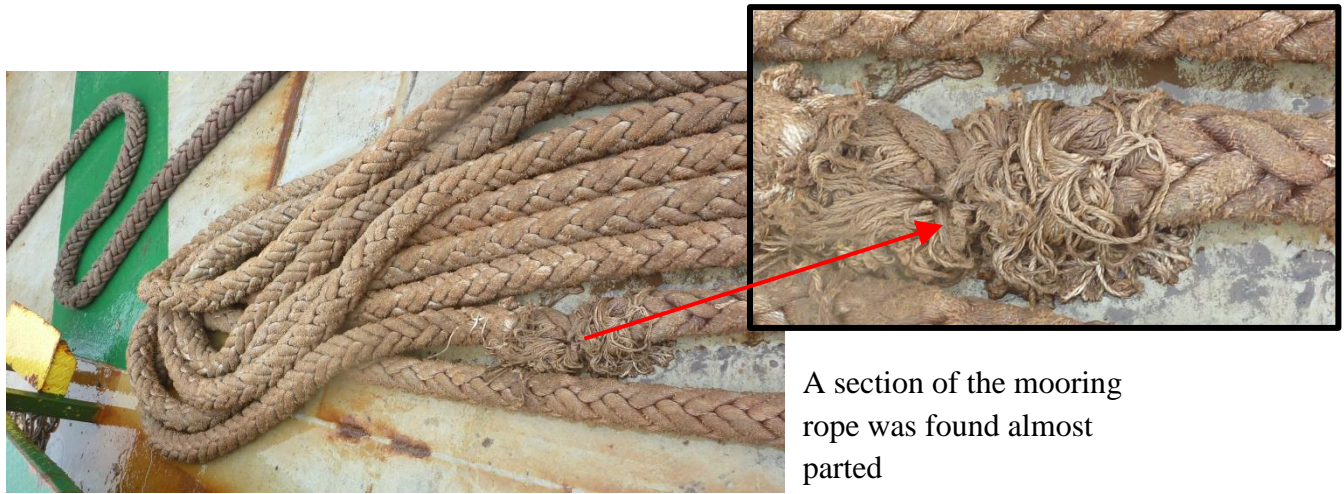
Fig. 12 showed a mooring rope lying on the deck. A section of the rope was found almost parted.

Fig. 12 General condition of a mooring rope found on deck of the vessel

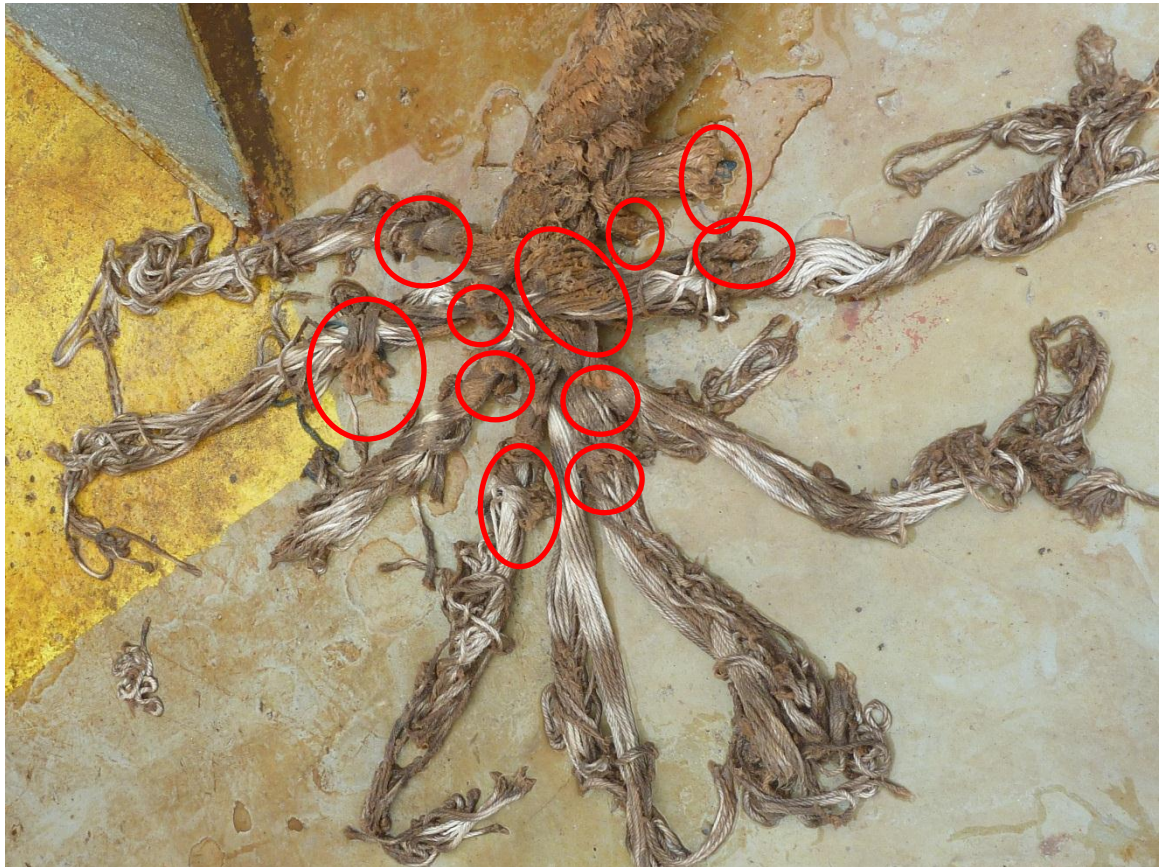
5.12 The general condition of the mooring ropes on board was poor. Fig. 13 showed the condition of the mooring rope at the position of parting with all the strands spread out. The damages are highlighted with red circles indicated the positions where the yarns of each strand that was shorter comparing with the other yarns in the same strand. The shorter yarns were not over-strained in the parting in the accident. The ends of the short yarns were also stained to a brownish colour which meant that they had been worn down for a long time before the mooring rope was finally parted. All these signs indicated that the condition of the rope was poor before it parted. Furthermore, the surface yarns of the remaining portion were found various damages with hairy appearance. (Fig. 14)

Fig. 13 Photo showing the condition of the strands at the position of parting

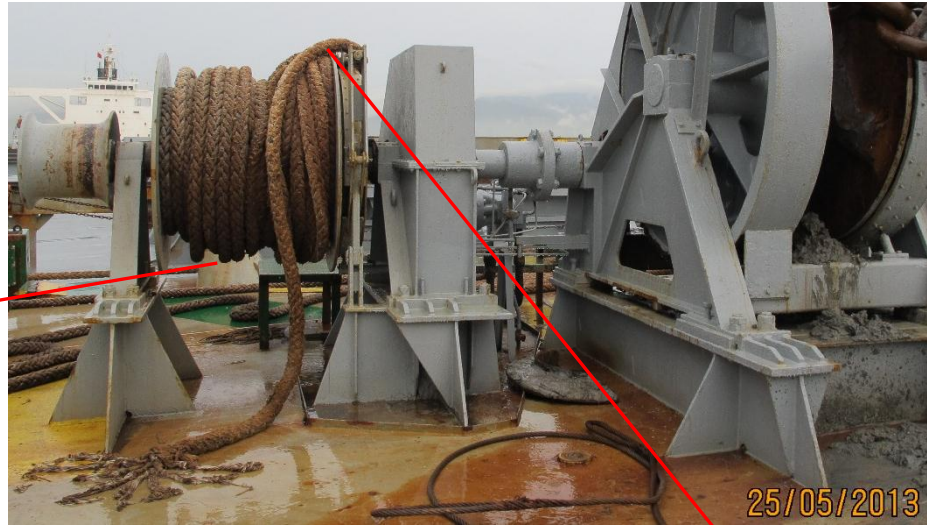
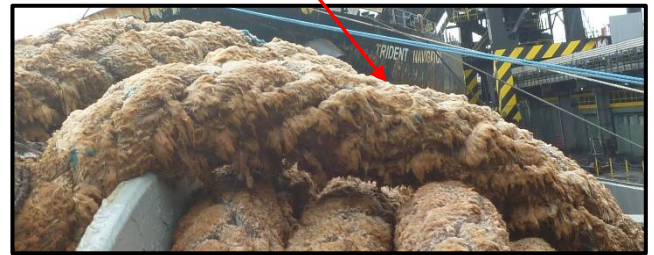
Abrasive wear  
on the rope

Surface yarns were seriously  
damaged resulting in a hairy  
appearance

Fig. 14 Photo showing the section of the parted mooring rope remained on board
