**Report of Investigation
into the fatal accident
on board Hong Kong
Registered Ship “*Pacific
Endeavor*”
at Zhenjiang, China
on 21 June 2013.**

Marine Accident Investigation Section
Marine Department
The Hong Kong Special Administrative Region

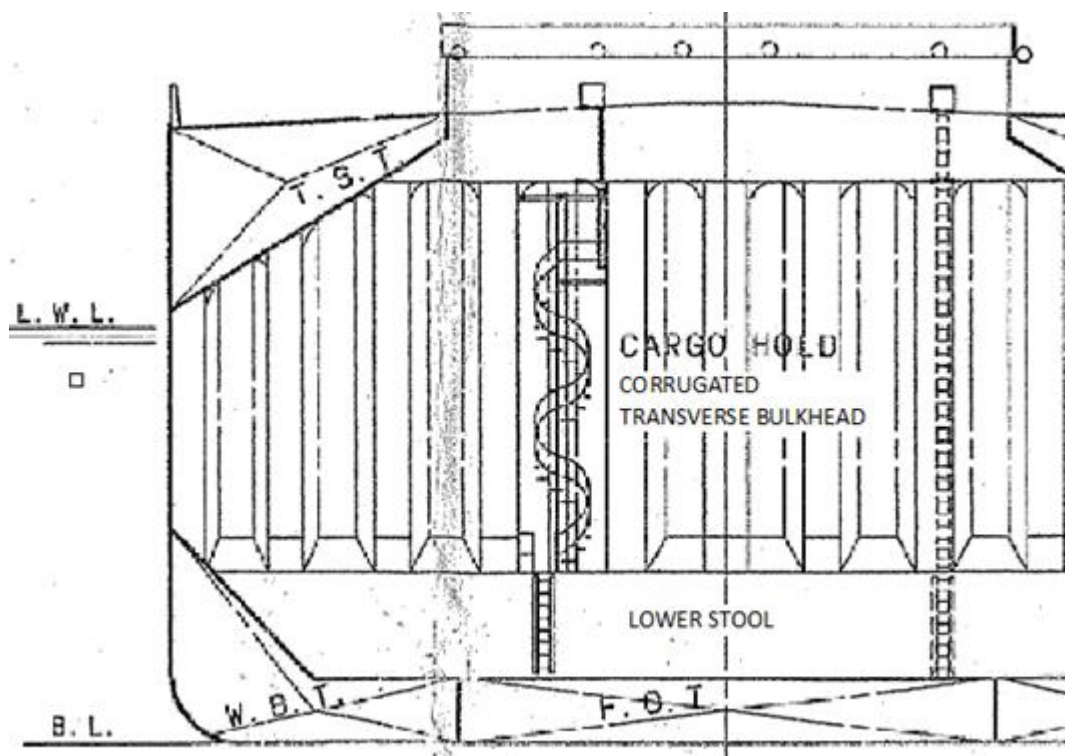
Fig. 2: No.3 Cargo Hold Aft View

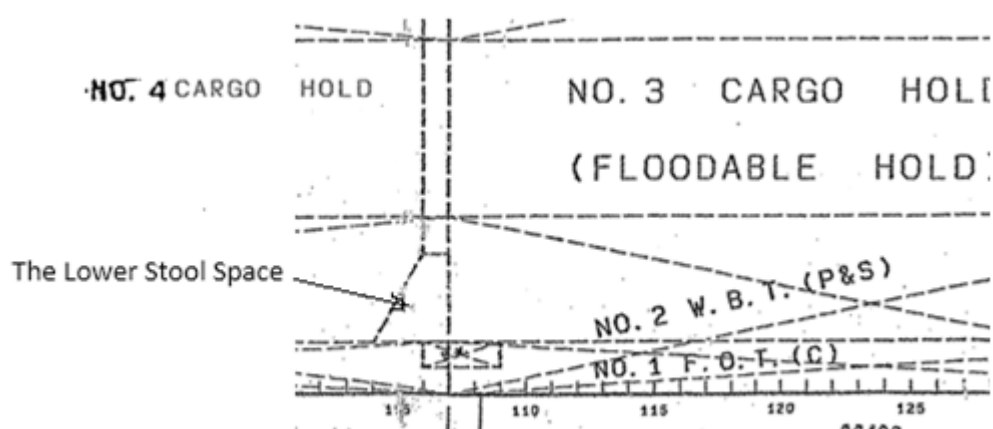
- 5.8 Transverse Bulkhead Lower Stool Space between cargo hold No.3 and No.4 (hereinafter referred to as the Lower Stool Space) where the deceased was found, was a void space (Fig. 3).
- 5.9 The "Lower Stool Space" had watertight boundaries and had access only from cargo hold No.4.

Fig. 3: The Lower Stool Space

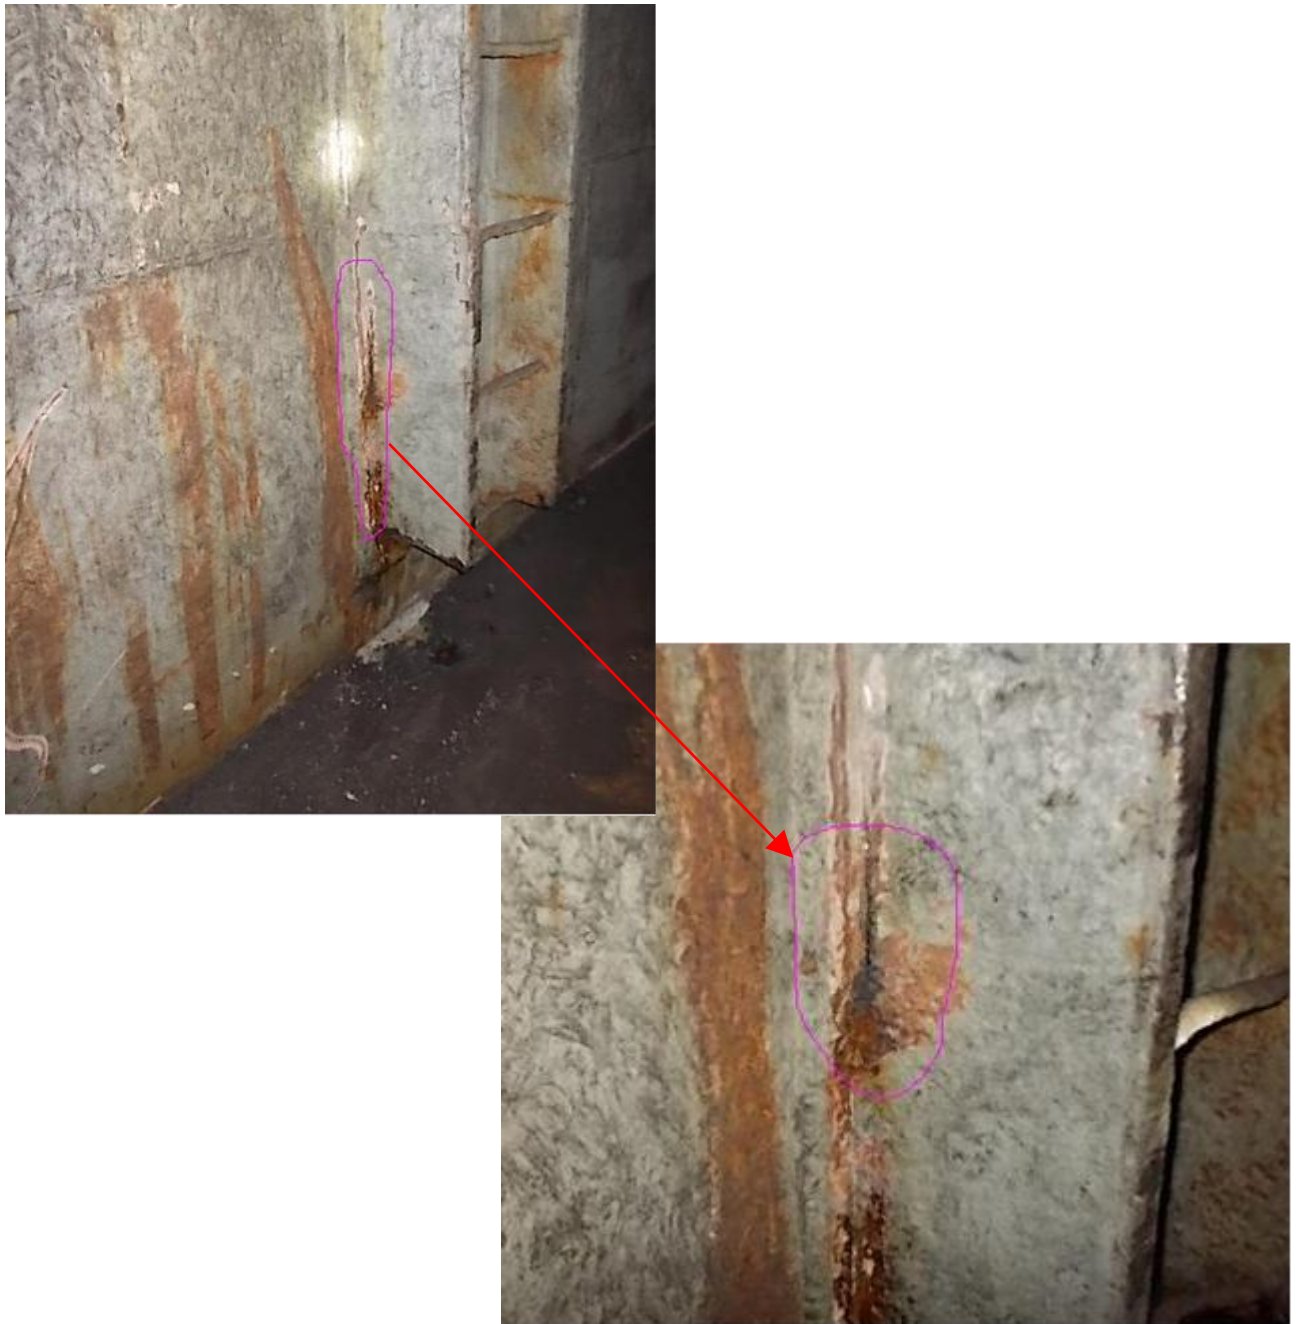
- 5.10 On 21 June 2013, the Third Officer reported to the Chief Officer on his finding of water leaking from the “Lower Stool Space” during his inspection in No.3 cargo hold. The water seeped (shown in Fig. 4) at one metre high above inner bottom from the fillet weld joint that attached the No.3 cargo hold aft access ladder onto the bulkhead lower stool plating.

Fig. 4: Suspected area of water seeping out.

5.11 Under normal condition, no water should entered inside the “Lower Stool Space”. To check for water level by opening the access cover on boundary was risky as water pressure might possibly be built up inside the “Lower Stool Space” when water was seeping out at about one metre high.

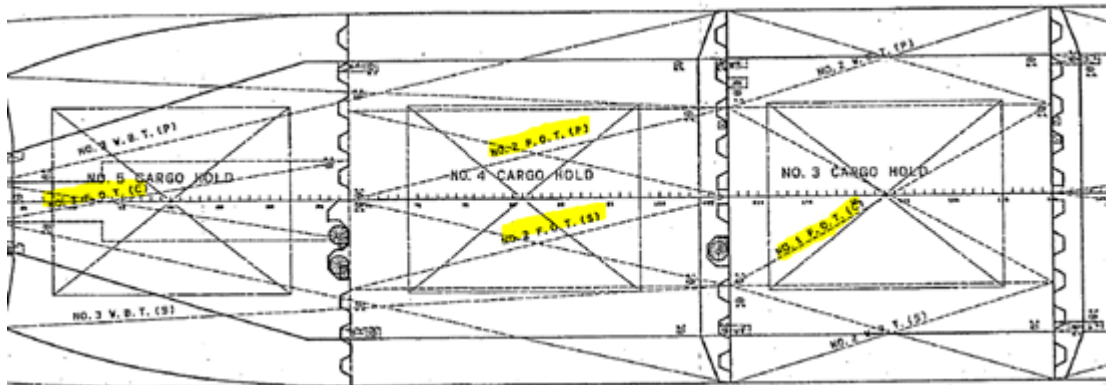
5.14 Coal was categorized as Group “B” (classed MHB) due to its potential chemical hazardous when in bulk quantity. Coal may create flammable atmospheres, may heat spontaneously, may deplete the oxygen concentration, may corrode metal structures. The situation was worsen on board by the heated fuel oil tanks underneath the cargo holds (No.3, No.4 and No.5) as shown in Fig. 5.

Fig. 5: Fuel Oil Tanks Arrangement.

- 5.19 Toxic, flammable gases such as carbon monoxide, hydrogen and methane, were odorless in nature. They could be emitted from the cargo “Coal” and accumulated amply in the cargo holds during the 9 days voyage from Muara Jawa, Indonesia to Zhenjiang, China. The gases emission could be accelerated by the heating from the fuel oil tanks underneath the cargo holds.
