Report of investigation
into the fatal accident
on board Hong Kong registered
Bulk Carrier “*Grand Ocean*”
on 26 June 2013

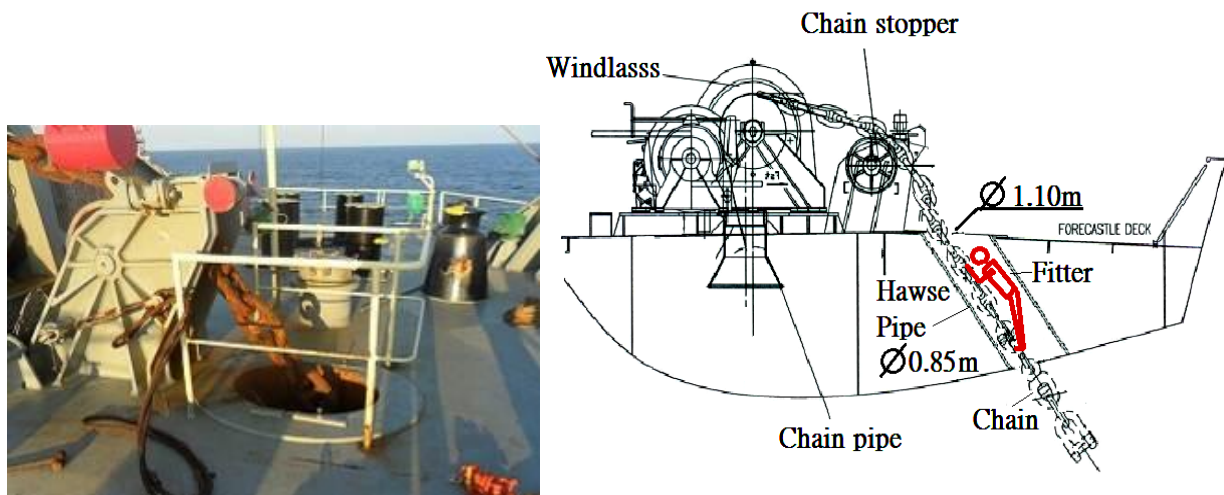
Fig.2

- 4.8 After trying to release the starboard anchor several times but failed, the fitter entered into the hawse pipe again. Before the fitter went into hawse pipe to check the conditions of the anchor, the chain stopper and brake had been engaged. However, the section between the stopper and the anchor was hanging loosely. (see Fig.2).

- 4.9 Unfortunately, the anchor was jerk suddenly and pulled the anchor chain. Consequently, the fitter crushed between the chain and the wall of the hawse pipe. He was injured and in unconscious condition. The chief officer rescued the injured fitter from the hawse pipe immediately.

- 5.11 Before the fitter entered into the hawse pipe, the senior officers on the scene had assessed the risk of the anchor falling down, and they had therefore locked the anchor chain by engaging the brake of the windlass and the chain-stopper. However, they failed to identify the possibility of a jerk of the anchor and its chain due to a loose hanging.
- 5.12 When the fitter entered into hawse pipe, with internal diameter only 0.85m, his movement was very limited. Thus, the fitter could not manage to dodge the jerk. Even though the anchor chain moved a short distance, the fitter would suffer from serious injuries in such a narrow space.

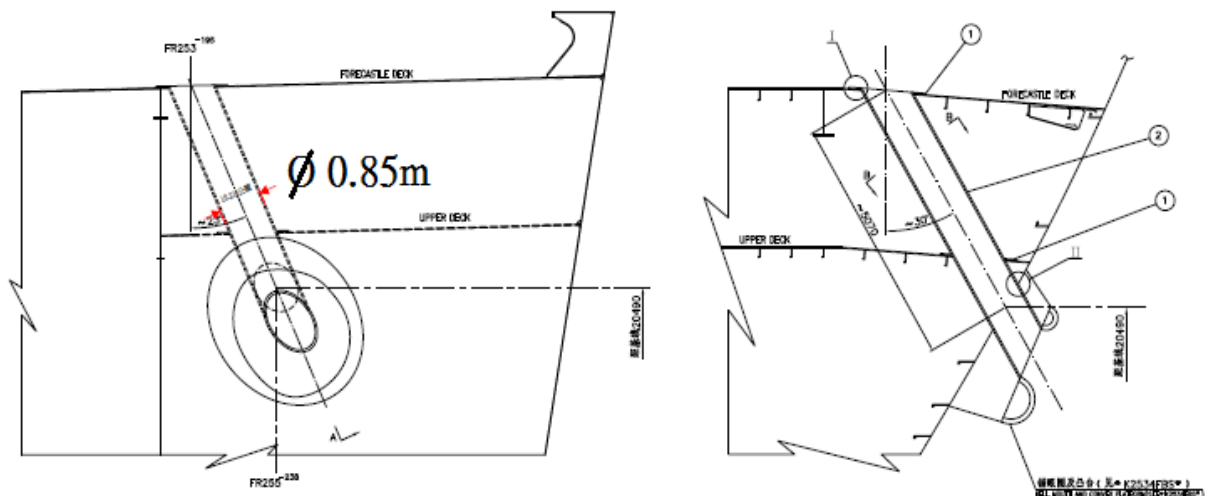
Fig. 4 Hawse pipe structure drawing

- 5.8 The length of tubular hawse pipe is 6.1m with 0.85m internal diameter. The hawse pipe consisted of pre-fabricated castings which were welded to the shell and deck to prevent chafing on anchor chain. Additional stiffening in way of the hawse pipe was required at the side shell.
