Report of investigation
into the death of the seaman II
after falling overboard from the
Hong Kong registered bulk carrier
“Joyous Society”
at Panama Canal
on 8 August 2013

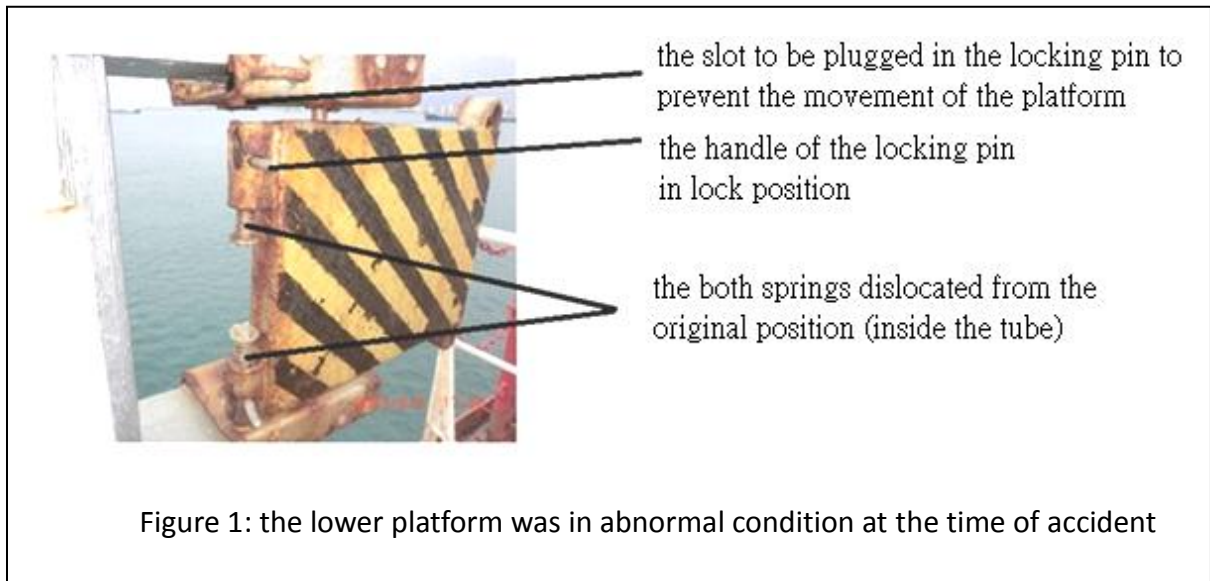
- b) The high risk work over the ship's side while the ship was underway was carried out by an inexperienced and unsupervised seaman II; and
 - c) Lack of the proper maintenance to the accommodation ladder causing the lower platform not to be locked and secured in position properly and to turn over while the seaman II was stepping on it.

- 5.7 At time of the incident, the lower platform turned over when the seaman II stepped on it. The springs of the locking pins in the lower platform of the accommodation ladder had been dislocated from their original positions so the locking pins could not be plugged into the slot. As such, the lower platform had not been properly locked

and secured in position (figure 1).

- 7.1 A copy of the report should be sent to the master and the management company of the vessel drawing their attention of the findings of this incident and lessons learnt, in particular, the management company of the vessel should ensure the shipboard working procedures are implemented and the maintenance work of the ship equipment is properly carried out.
- 7.2 A Merchant Shipping Information Note (MSIN) should be issued to promulgate the lessons learnt from this accident.

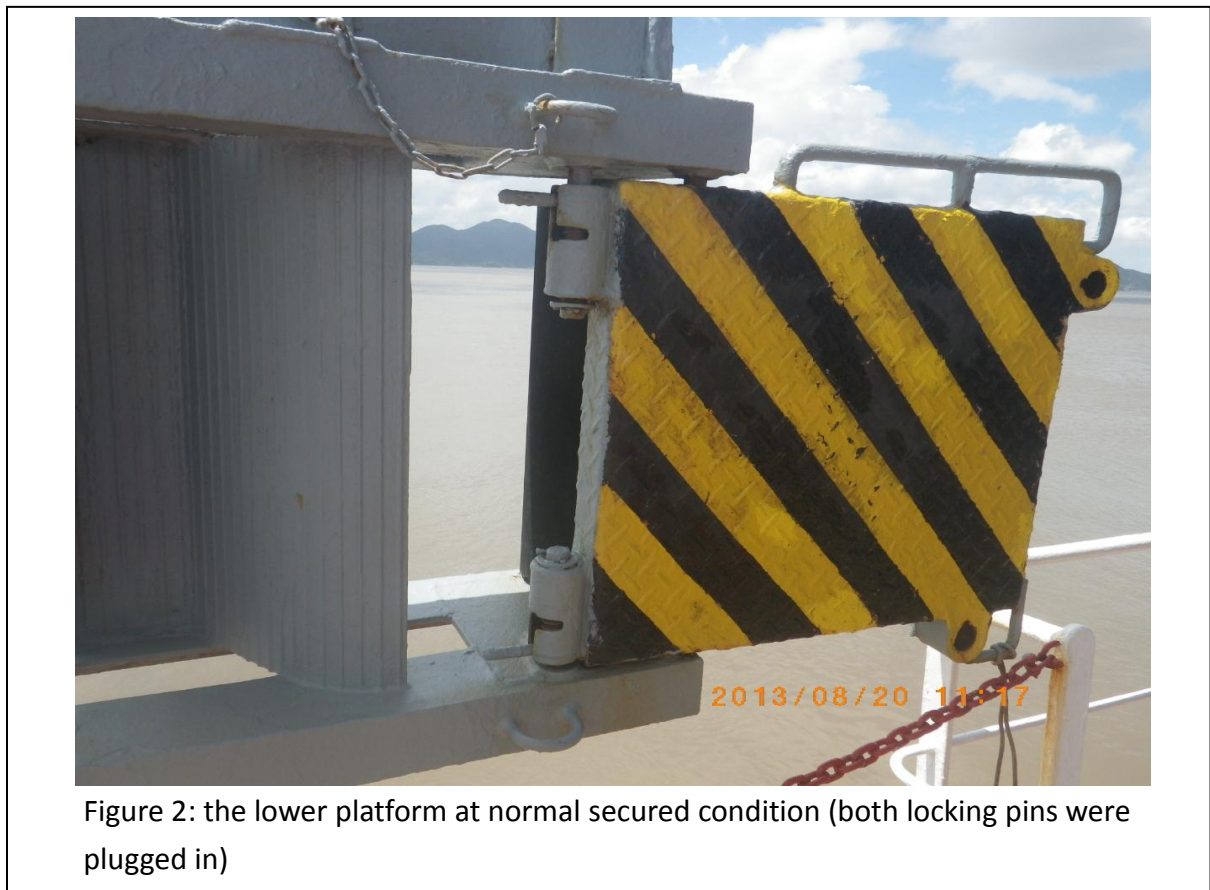
- 5.8 The lower platform of the accommodation ladder was so designed that the platform could be adjusted at different angle and locked by two pins so as to secure the platform in position (figure 2). If the maintenance to the accommodation ladder was carried out properly, the spring loaded locking pins would have been plugged into the slots on both sides. The lower platform would not turn over when the seaman II was stepping on it and this accident might be avoided.
